Fatigue Damage of an Urban Expressway Steel Girder Bridge Constructed in 1964

FATIGUE DAMAGE OF AN URBAN EXPRESSWAY STEEL GIRDER BRIDGE CONSTRUCTED IN 1964

Kazuya BESSHO¹, Yuya NISHIKAWA¹, Yoshihiko TAKADA², Masahiro SAKANO³

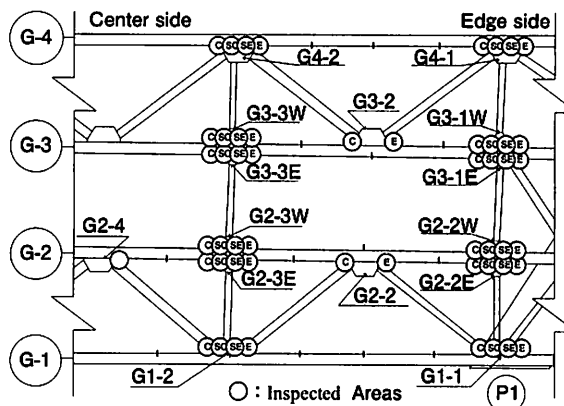
Fig. 4 Locations of gusset plates and inspected areas

Before the fatigue tests, magnetic particle tests are conducted to detect the fatigue cracks which could have occurred under service loading. Toes of turn-round weldment are inspected in the welded joint which connects the gusset plate to the web of the main girder. The total number of inspected toes of turn-round weldment is 53 in 15 gusset plates. Fig.4 shows locations of gusset plates and inspected areas.

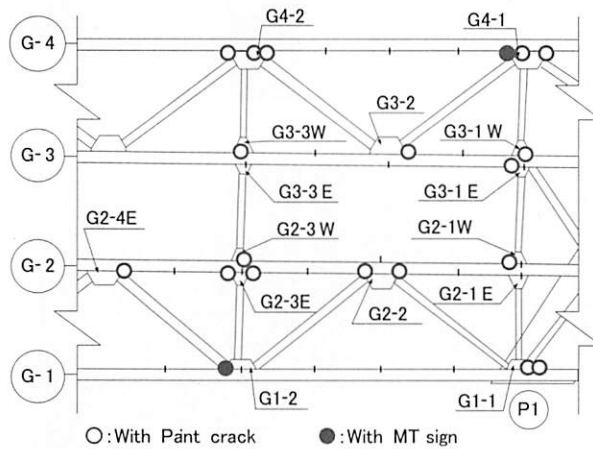
Fig. 5 Results of magnetic particle test

Fig.5 shows the result of magnetic particle tests. MT signs that may indicate fatigue cracks were observed at 2 weldments among the 18 turn-round weldments with paint cracks. Several paint cracks were observed at the G1-2-C gusset plate.

A MT sign of 8mm length was observed under a 83mm paint crack at the G1-2-C gusset plate. A MT sign of 4mm length was observed under a 23mm paint crack at the G4-1-C gusset plate. Photos.1~4 shows paint cracks and MT signs in the G1-2-C and G4-1-C gusset plates.

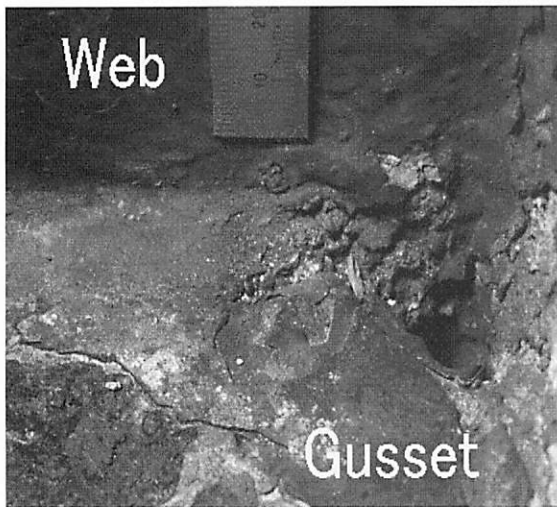
In the 5 blue areas we could not judge the shape and length of the paint crack because of burning and deterioration.

Photo. 1 Deterioration of paint

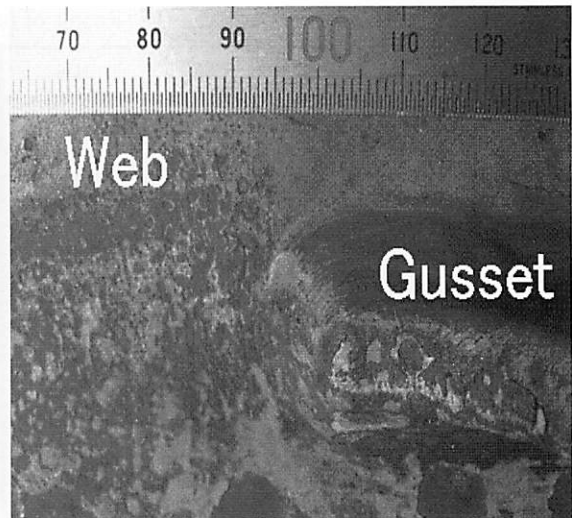
Photo. 2 Paint burned

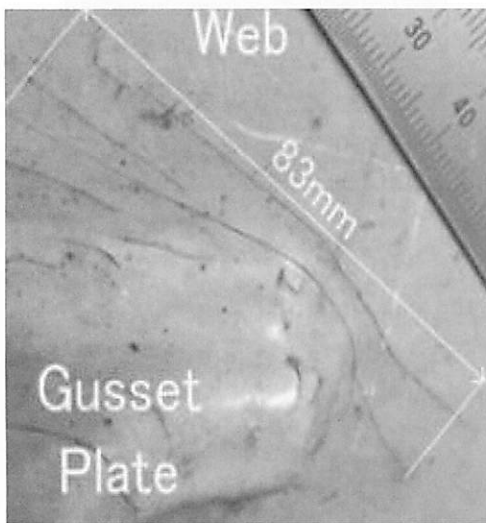
Photo. 3 Paint cracks on G1-2-C

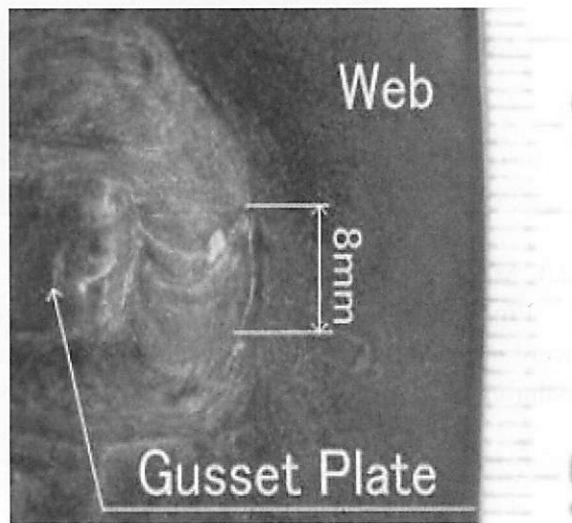
Photo. 4 MT sign on G1-2-C

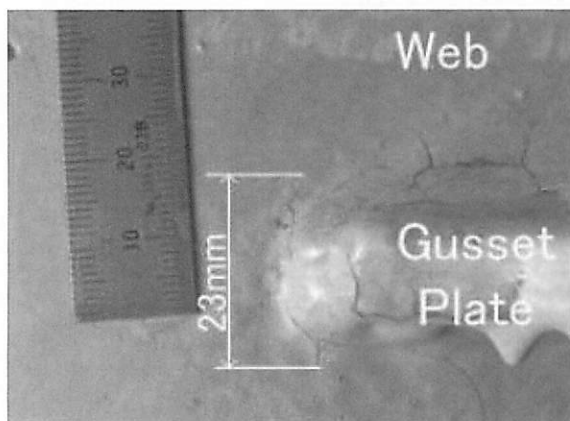
Photo. 5 Paint crack on G4-1-C

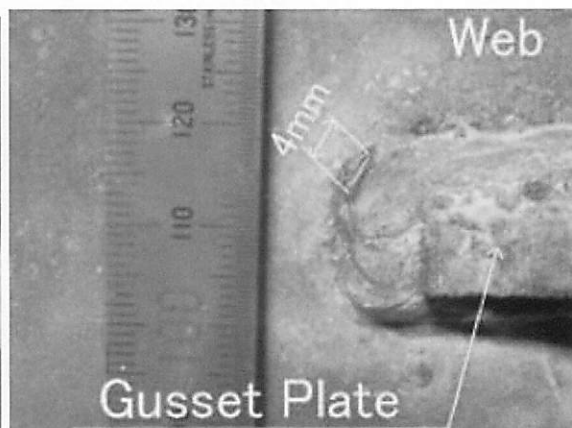
Photo. 6 MT sign on G4-1-C
