Failure of cargo aileron's actuator

G. Zucca, M. Amura, L. Allegrucci, M. Bernabei

Italian Air Force, Flight Test Centre, Chemistry Department, Military Airport M. De Bernardi, via Pratica di Mare, Pomezia (RM), 00040, Italy

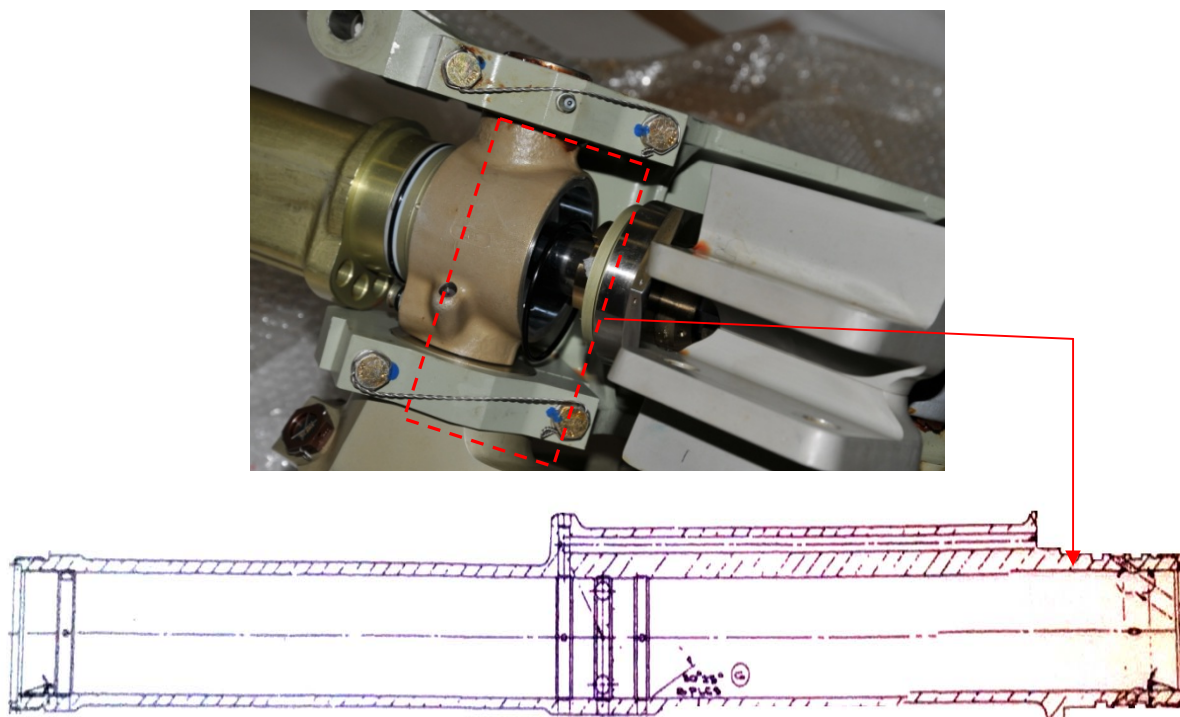
The subsequent inspection highlighted a rupture on the Dual Booster Actuator (DBA).

This component function is the ailerons deflection. Being a primary importance actuator for the aircraft controllability, it is connected to both the hydraulic systems for safety reasons. The main parts of the DBA are the piston rod and the external case. Two bronze caps are placed at both ends, and they are fixed in position by means of two retainers. The DBA is hinged to the aircraft by a cylindrical support fixed at one end of the actuator case, named trunnion. The fracture surface was located at the actuator case end on the trunnion side, over the retainer (Fig. 1). This paper illustrates the failure analysis of the aforementioned actuator.

Figure 1: Rupture position.

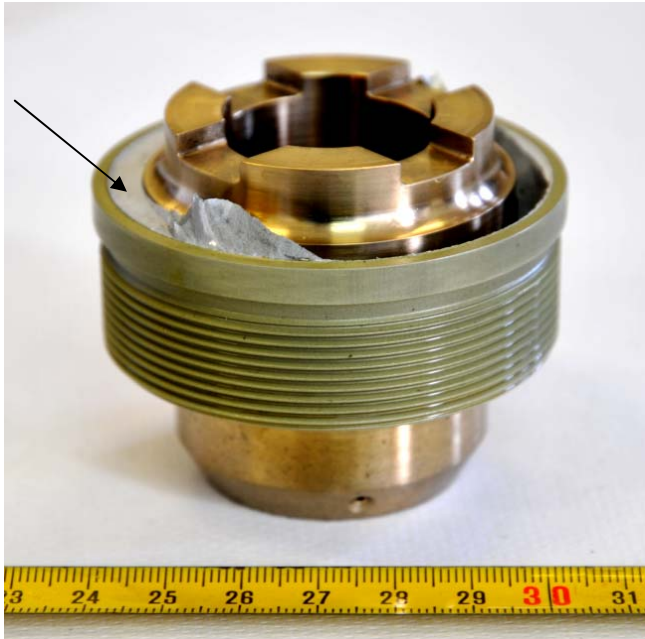
The cap was found entangled inside the detached fracture surface and some force was needed to remove it (Fig. 2). However, no damages were produced in this operation. The two fracture surfaces showed the same features. The fracture started from the external surface, and propagated toward the internal one. The fracture surface was divided in two zones, named A and B (Fig. 3). Zone A was rough, dull, characterized by coarse grains and it was oriented at about 45° to the transversal section. Moreover, a plastic deformation, associated to the final phase of the failure, was

Figure 2: Cap entangled inside the fracture surface.

The two parts have an average mechanical interference of 25 μm . This was the reason of the tight fit observed during disassembly operations between external case and cap.

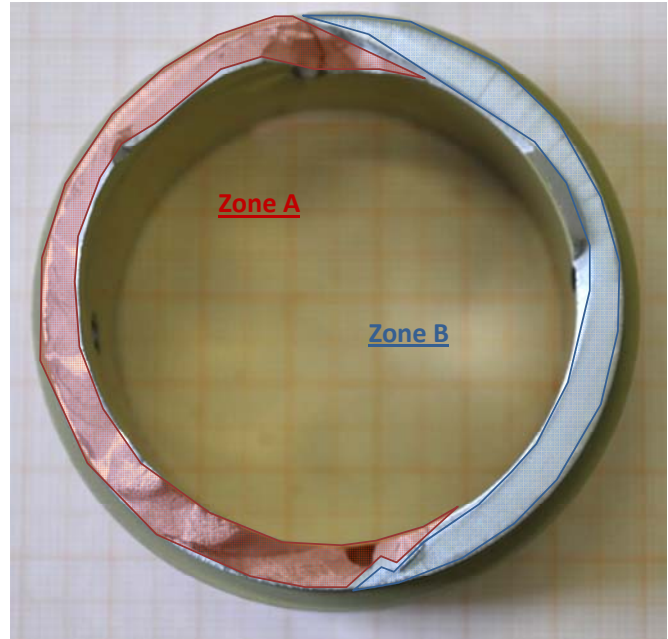
observed. Therefore, Zone A was the region of the final, unstable fracture. Zone B was characterized by a fracture surface flat, smooth and bright with beach marks typical of fatigue crack growth. (Fig. 4). On the external surface's edge there were ratchet marks, showed by black arrows in Fig. 4. However, also in the 45° orientation areas, there was a small flat area running all around on the external side (black arrow in Fig. 5) showing ratchet marks.

Figure 3: Fracture surface.

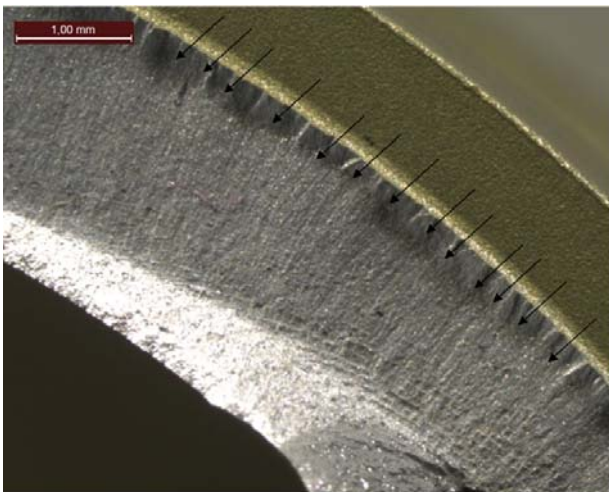
Figure 4: Beach marks and ratchet marks on the surface's edge.

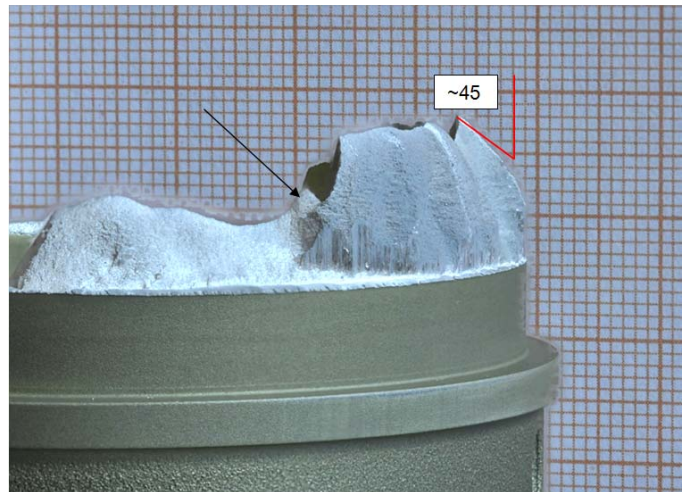
Figure 5: Fracture detail.

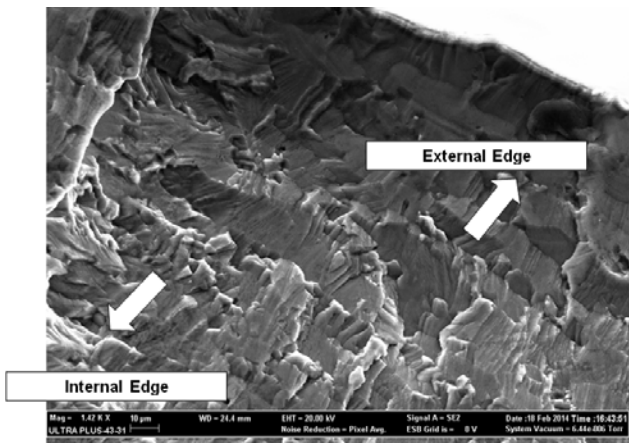
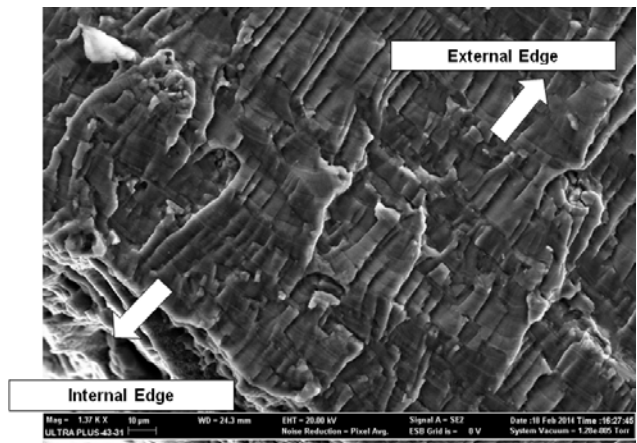
FESEM observations of the Zone B of fracture surface confirmed the presence of the fatigue crack mechanism Fig. 6 and Fig. 7. Multiple initiation sites of the fatigue crack are all around the external edge of the fracture surface. Zone A showed dimples and microvoid, these are evidences of unstable fatigue crack propagation (Fig. 8) [1].

Figure 6: Area of fatigue crack propagation.

Figure 7: Area of fatigue crack propagation.

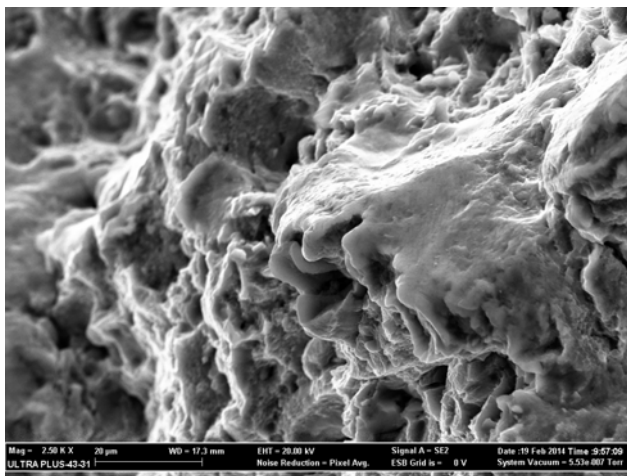
Figure 8: Dimples and microvoid.

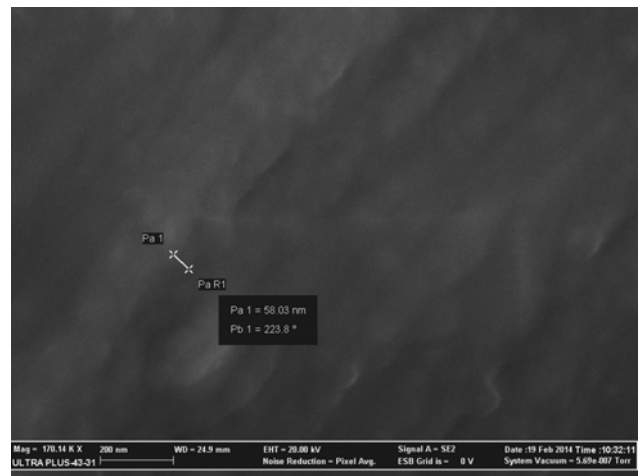
Figure 9: Striation spacing.

In Zone B in the stable propagation phase of the fatigue phenomenon the striations spacing was about 60 nm (Fig. 9) [2] [3].

The evaluation of striations spacing features an high-cycle fatigue, compatible with vibration during flight [8] [3].

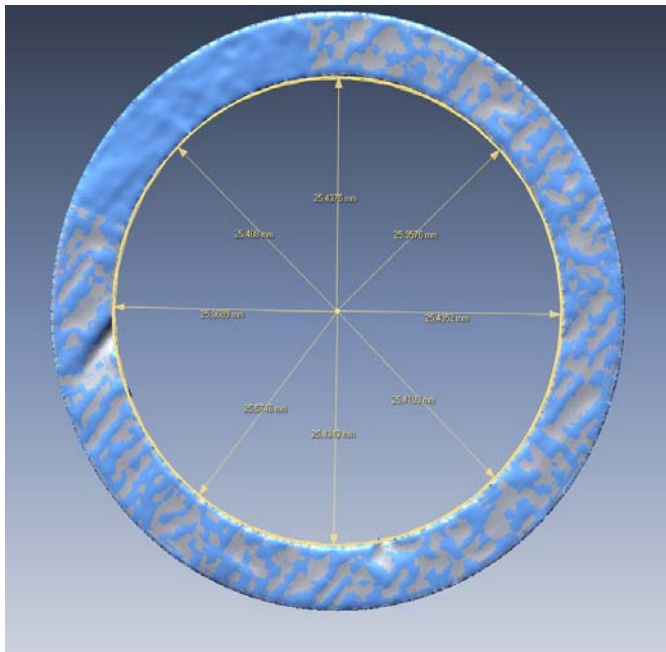
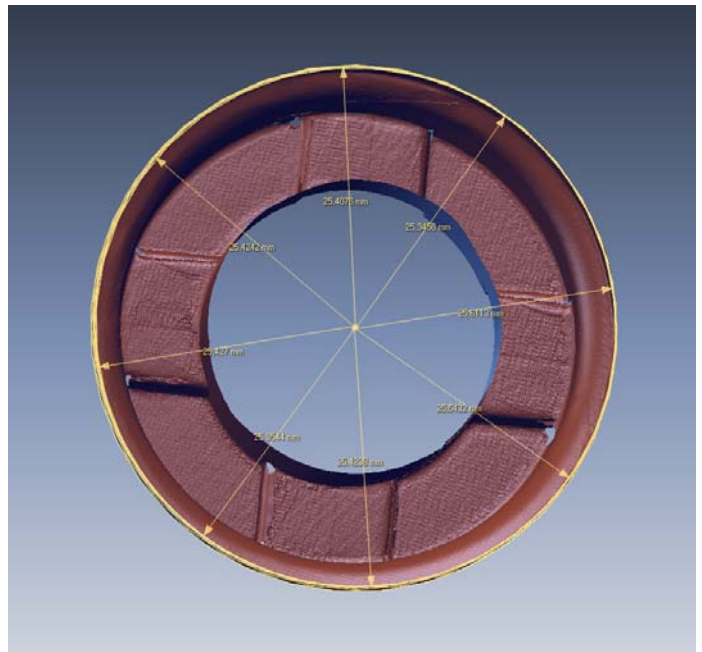
Figure 12: Actuator Case internal diameter measurements.

Figure 13: Cap external diameter measurements.

Therefore, the required gap should be comprised between 25.4 to 101.6 μm .

The Dual Booster Actuator failed because of a high-cycle multiple initiation sites fatigue mechanism. This was due to stress intensification caused by dimensional non conformances. Recommendations were issued in order to improve dimensional controls.

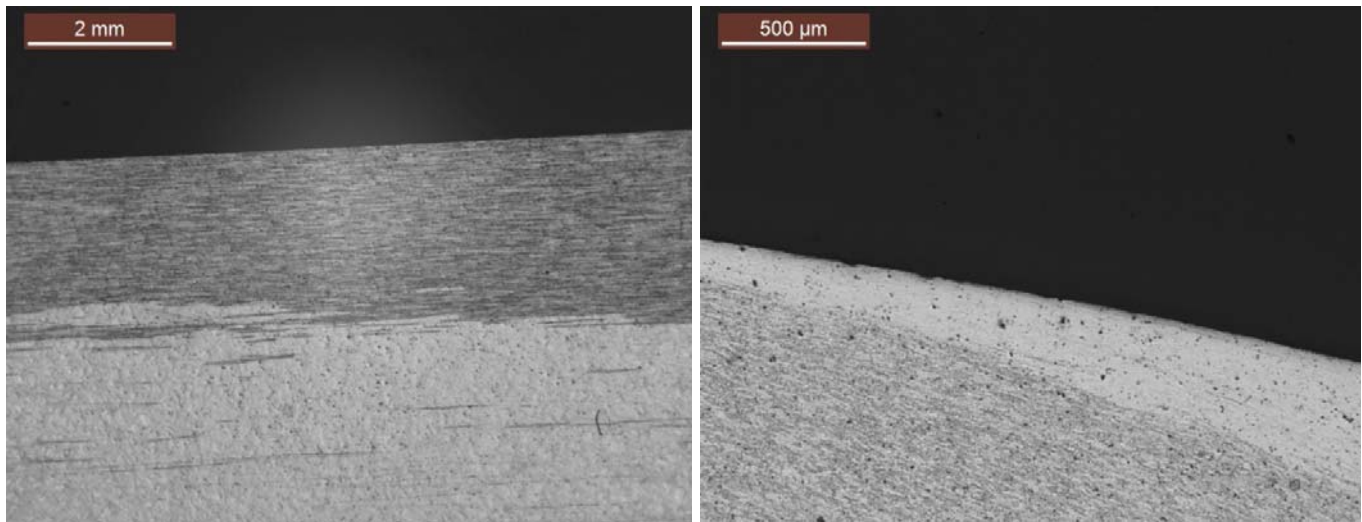
A Microstructural examination, were performed on two sections of actuator case made orthogonally and parallel to its axis. The examination, revealed the joint zone between the two halves of the actuator case, showing two different microstructures [4]. Transition is showed in Fig. 14. Hardness test will evaluate mechanical consequences of this anomaly. Another section, near the oil chamfer was analyzed, in order to evaluate the shot peening treatment required by design.

Figure 14: Transition between two halves of the actuator case.

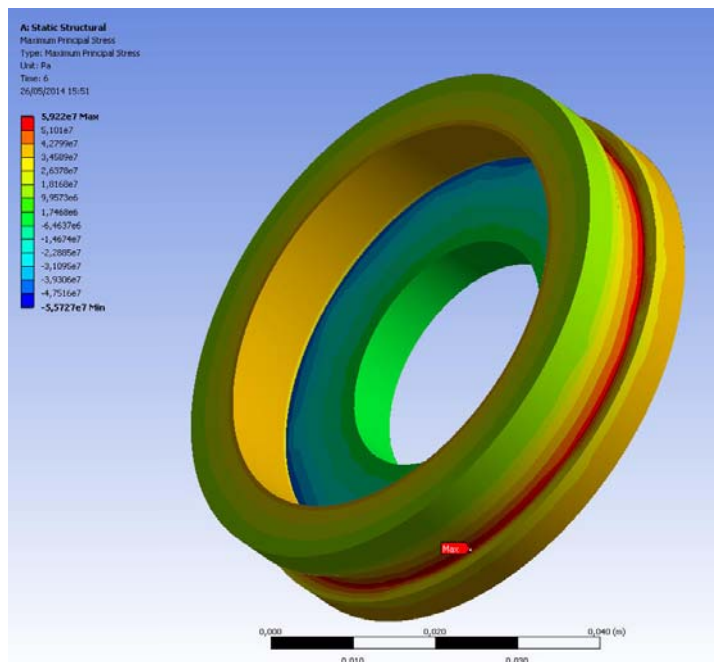
Numerical results showed how just the perfect fit was enough to increase the stress value of about 60 MPa. In the real condition of forced coupling (about 25 μm interference) the stress increase would be higher. Stress map Fig. 16 shows how the maximum stress is reached on the outer edge of the case Assy. A parametrical simulation was carried out increasing the gap between the actuator case and the cap. Results showed that the stress became null at about 50 μm of gap (Fig. 17).

Figure 16: Stress Map.
