# Damage investigation on welded tubes of a reforming furnace

E. Guglielmino, R. Pino, C. Servetto, A. Sili

*In this work the creep damage of radiant tubes of a reforming furnace has been investigated. The considered furnace contains a battery of tubes constructed by butt welding three spun cast pieces, made of ASTM 608 HP-Nb alloy. They are designed to operate at temperatures of about 900°C, pressures of about 30 bars and times of the order of 100000 h. Tubes were inspected during the plant stops scheduled every two years, in order to identify and replace the damaged ones with the aim to ensure conditions of safe operation in the furnace. They were selected through a criterion based on measures of the internal diameter deformation performed in situ by Laser Optic Tube Inspection System (LOTIS). For a verification of this method, optical and scanning electron microscopy observation, Vickers microhardness and creep tests have been carried out on samples taken from tubes put out of service.*

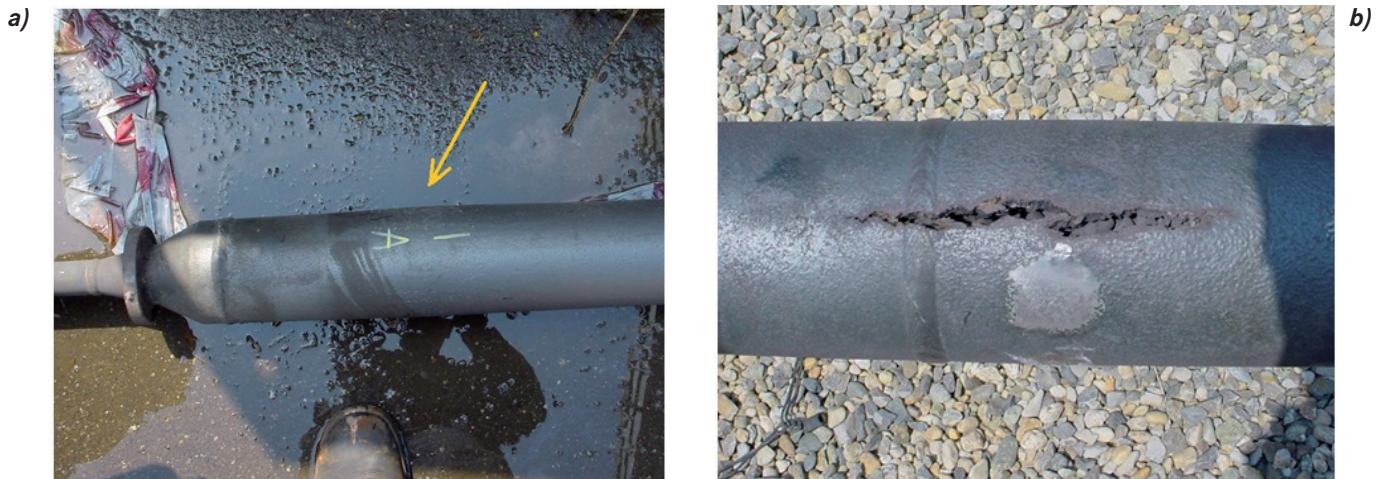
Two examples of tube damage are given here: the yellow arrows in figure 2a indicates a tube section that underwent creep expansion; figure 2b shows a large longitudinal crack across a butt welded joint.

**Fig. 2 – Examples of radiant tube damage: a) creep expansion of a tube section; b) large longitudinal crack across a butt welded joint.**

The tubes put out of service after 114000 hours show highly oxidized surfaces along all their length and zones located in the lower part which have undergone creep deformations detectable also by visual inspection. These zones are mainly near the catalyst grid, where the diameter expansion is clearly observable (fig. 2a).

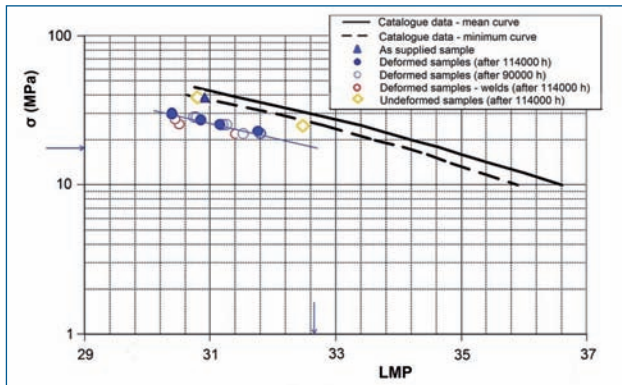
- the experimental point of the as supplied material (blue triangle) is on the minimum curve of the manufacturer catalogue,
- results of samples taken from undeformed zones (yellow rhombus) are similar to the as supplied material,
- results of samples taken from deformed zones (blue circle) are well below those of the undeformed material,
- samples cut transversely to the welded joint (red circle) behave in agreement with the previous ones.

The experimental diagram  $\sigma$  vs. LMP shows that specimens with welds have behavior similar to the base material with the same diameter deformation. However they differ in creep ductility: rupture elongation in creep test resulted around 3-5% for samples with welds, while it was 20-30% for samples of base material.

The residual life of decommissioned tubes can be obtained thanks to the curve extrapolated from experimental data: entering with the hoop stress  $\sigma = 17.5$  MPa, the corresponding LMP value, equal to about 32.6, allows to calculate the rupture time at a given temperature. For example, with temperatures of 900, 920 and 940°C, the corresponding rupture times are respectively 10, 3.2 and 1 year. Then rupture time after long time service is strongly dependent on temperature changes that are in the range of measurement errors typical of pyrometer systems used in reforming furnaces.

**Fig. 5 – Creep test results: Larson Miller diagram.**

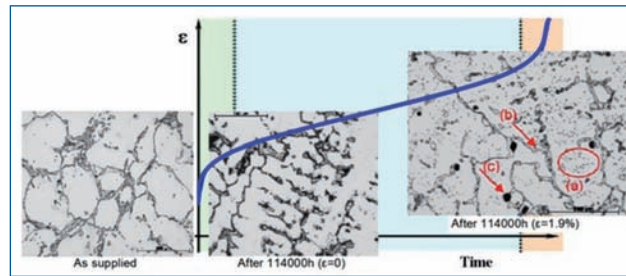
- The as cast microstructure is characterized by austenitic dendrites, well outlined by a network of coarse carbides precipitated in the interdendritic spaces.
- The microstructure of samples cut from undeformed zones of a decommissioned tube is nearly similar to the one of as cast alloy, so it can be referred to the first creep stage.
- The microstructure of samples cut from deformed zone

( $\epsilon = 1.5-2.0\%$ ) is characterized by a precipitation of fine secondary carbides inside the austenitic grains, optically observable at high magnification, and by nearly circular isolated microvoids.

Isolated microvoids appear during the steady state creep. In particular the absence of aligned microvoids, formed by the coalescence of two or more microvoids [21], can be considered as an indication that the final creep stage has not yet started.

**Fig. 6 – Microstructures of the ASTM 608 HP-Nb alloy, in relation to the respective level of creep deformation. In the case of material after 114000 hours of service it can be outlined: a) fine carbide precipitation inside grains, b) primary carbide at grain boundary, c) nearly circular microvoids.**

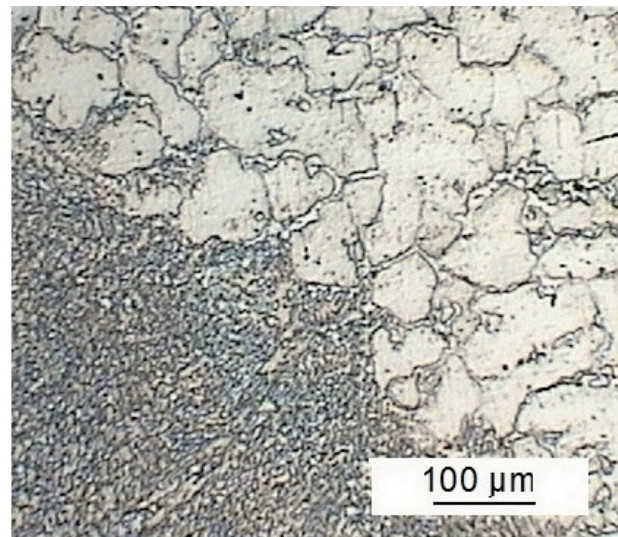
In welded sections, no evidence of particular structures was detected at the boundary between base metal and molten zone (fig. 7). The latter appears to be characterized by very fine carbides aligned with the heat flow direction.

**Fig. 7 – Optical micrograph of the boundary between molten zone and base metal in a welded joint (tube decommissioned after 114000 hours).**

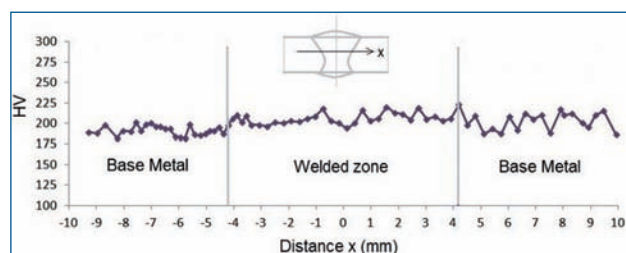
Regarding microhardness survey, it was noticed a remarkable softening after 114000 hours of service compared to values of about 400HV measured in the as cast material: microhardness values through base metal and molten zone are around 180 HV (fig. 8).

**Fig. 8 – Vickers microhardness (200g -15s) in a welded section (tube put out of service after 114000 hours).**

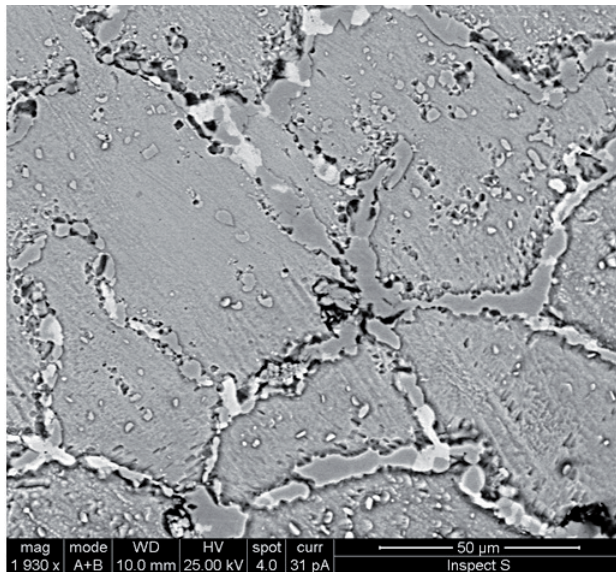
In samples taken from deformed zones, grey precipitates are located both inside grains and at their boundaries (fig. 9). These particles are recognized as Cr carbide through EDS measurements. The HP alloys underwent phase transformations due to thermal activation during service at temperatures between 1123 and 1325 K and primary Cr carbides  $M_7C_3$ , instable at high temperature, transform into intragranular and intergranular  $M_{23}C_6$  precipitates [23]. Another change regards the white precipitates at grain boundary that in deformed samples have dimension and volumetric fraction greater than in the as cast alloy; more-

over EDS measurements give high concentrations of Nb, Ni, Si. As quoted in literature [33, 34], Nb carbides are not stable in the range of service temperatures, between 700 and 900°C, transforming into Ni-Nb silicates known as G-phase. Unlike the Nb carbides that give good creep properties, the G-phase coarsening is followed by reduction of creep resistance [3]: this negative effects can be

**Fig. 9 – SEM micrograph of a sample taken from a deformed zone (tube decommissioned after 114000 hours).**

ascribed to the interface between G-phase and matrix that becomes a preferential site for creep damage [7]. Luckily this phenomenon can be overlooked in the HP grades microalloyed with small quantities of Ti, that reduce the G-phase volume fraction [7].
