## CORROSION OF STAINLESS STEEL WATER STORAGE TANKS EXPOSED IN COASTAL ATMOSPHERIC CONDITIONS

The results of corrosion survey for stainless steel tanks used in water storage at various areas are presented. More severe corrosion is observed for the area with higher airborne salinity. Damages are revealed at both outer and inner surfaces for tanks made of Type 304 and 201 steels exposed in coastal conditions. Corrosion products examined by visual inspection and SEM-EDX technique showed relatively distinctive characteristics for the outer and inner tank surfaces which are attributed to different corrosion mechanisms initiated by corrosive chloride accumulated on steel surfaces. Airborne salinity is considered the main source causing corrosion of Type 304 and 201 stainless steel tanks.

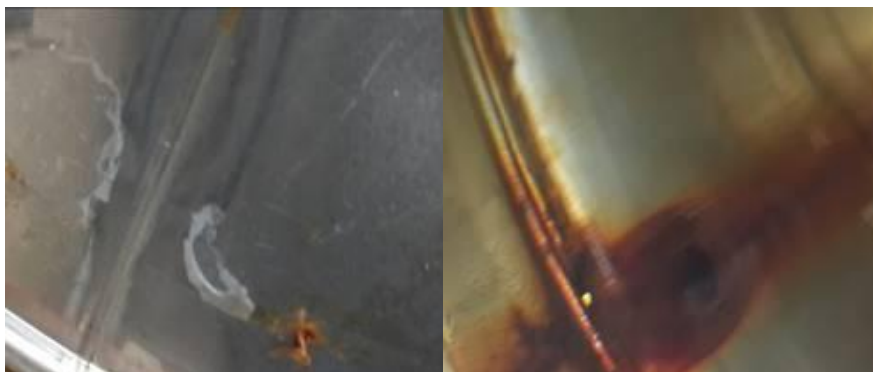
In fact, the vertical water tanks were for a long time designed with the upper part (usually above water level) made from Type 201 steel. The corrosion damages of both steels are demonstrated in field images of Figure 1 and Figure 2. It is clear that more extensive corrosion was registered for Type 201 compared to Type 304 steels when exposed in the atmospheric

Figure 1. Field images of the outer (left) and inner (right) surface of Type 304 steel tank in Hai Phong.

Field survey of Type 304/201 grade steel water storage tanks exposed in rural and coastal conditions shows strong influence of environmental parameters on corrosion. Severe damage was observed for the tanks in coastal conditions with high TOW and airborne salinity. Type 304 steel grade was more corrosion-resistant than Type 201 steel grade and the outer surface suffered more damage than the inner surface of the tanks. Chlorides are considered the main chemical factor in destroying stainless steel passivity under coastal conditions. As a result, Type 304 and especially Type 201 stainless steel grades are not recommended for use as water storage tanks in coastal conditions.

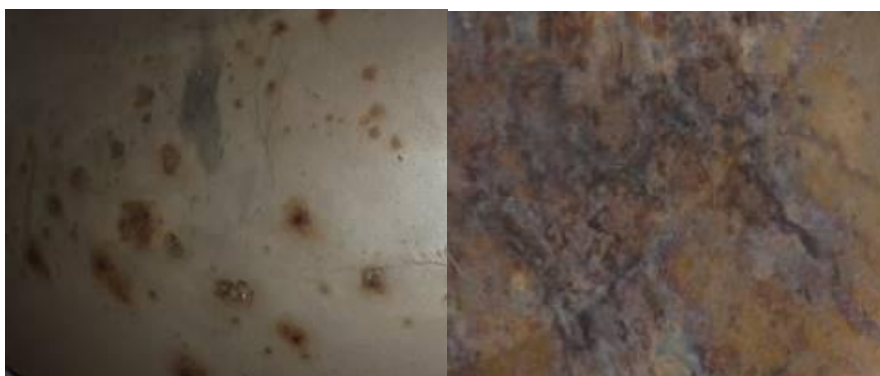
conditions of Hai Phong. Specifically, different rust appearance in the outer and inner surface was exhibited: deep pits with red color corrosion products were formed in the first case and shallow spots with preferentially grey color in the latter case (Fig. 2).

Figure 2. Field images of the outer (left) and inner (right) surface of Type 201 steel tank in Hai Phong.

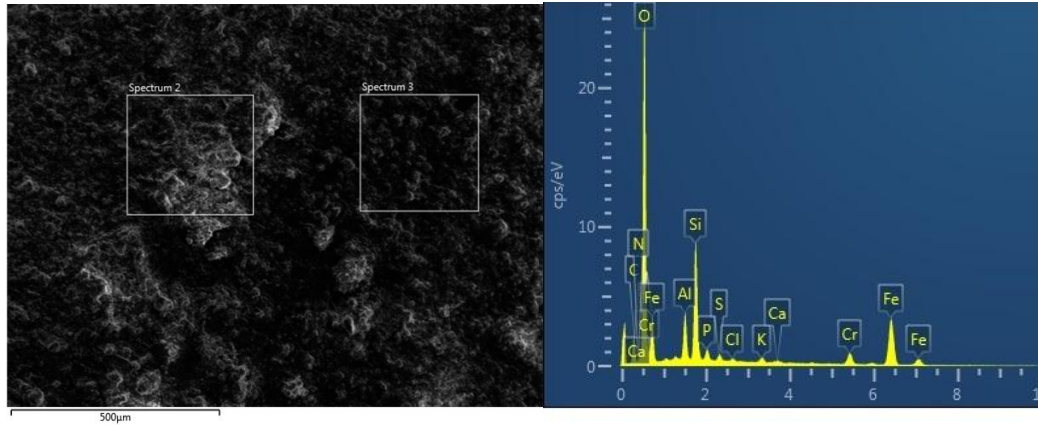
The chemical composition of corrosion products taken from tanks exposed in Hai Phong shows some specific features: chlorine is detected in minute quantity of 0.24 % on the outer surface (Fig. 3, Tab. 5) and no chlorine is detected on the inner surface (Fig. 4, Tab. 4) of Type 201 tank.

Figure 3. SEM and EDX spectra (Spectrum 2) for corrosion product on the outer surface of Type 201 steel tank exposed in Hai Phong.

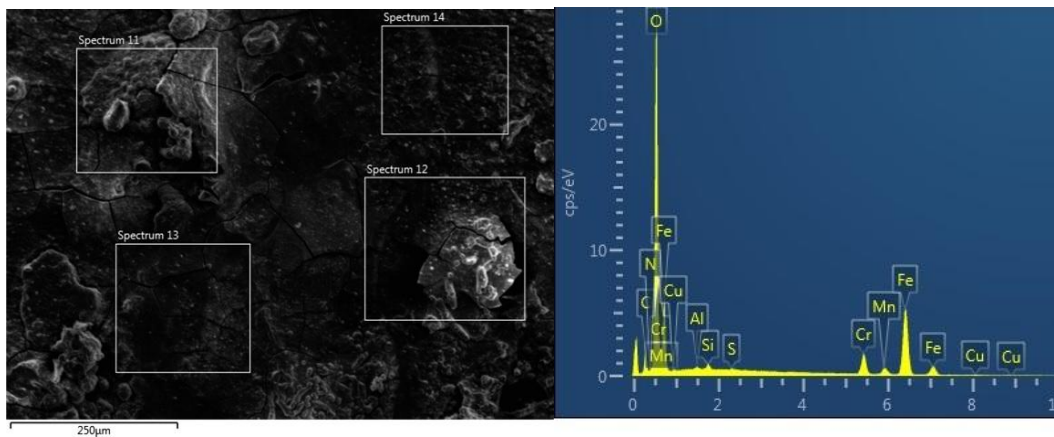
Figure 4. SEM and EDX spectra (Spectrum 12) for corrosion product on the inner surface of Type 201 steel tank exposed in Hai Phong.

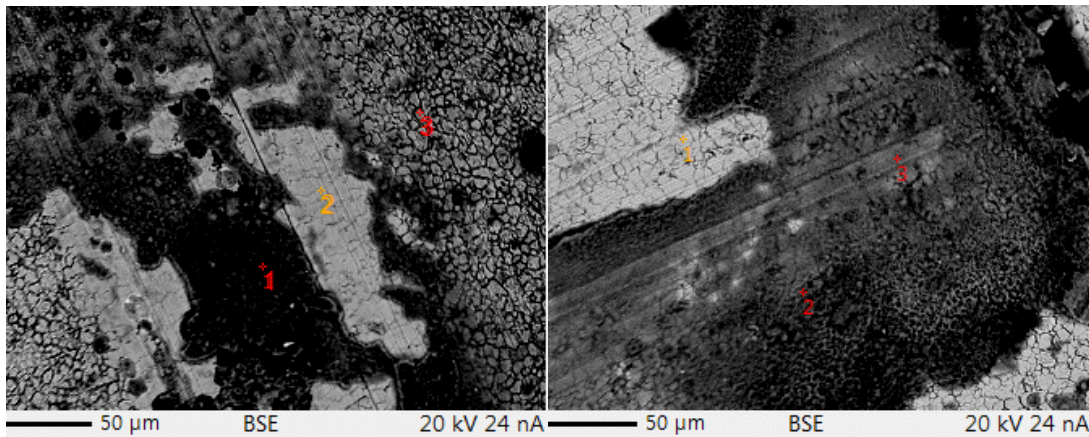
*Figure 5.* SEM image of analyzed areas for outer (left) and inner (right) steel surfaces.

Similar to the results of EDX method, chlorine content was not detected for corrosion product taken from the inner tank surface, while a relatively small amount was revealed on the outer tank side (Tab. 6). It is necessary to emphasize that corrosion products were taken for analysis from the upper part and covered inside the tank; and chloride, if any occurred, could not easily be washed out by potable or rain water during application.

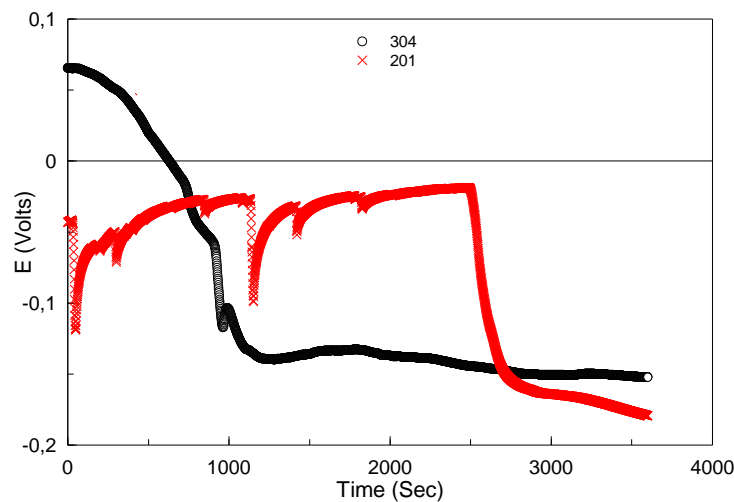
As clearly shown in Figure 6, the OCP potentials of Type 304 sample are more positively shifted than Type 201 steel, which showed more stable passive film in chloride solution. This output is commonly explained by higher chromium content in Type 304 alloy composition. Meanwhile, the lower protective ability of Type 201 passive film is attributed to decreased nickel content and increased manganese inclusion, which deteriorate the surface oxide film in the test medium. However, due to the repassive nature of the films, the OCP are quickly restored after falling. With copper alloying component, the repassivation ability of Type 201 sample is higher expressed than Type 304 steel, but is not sustained and came to a sharp fall after 2500 s of immersion in chloride solution. Indeed, the film's repassivation process is disturbed by the presence of chlorides which promotes the initiation of localized corrosion (e.g. pitting), thereby decreasing the durability of the self-protection provided to stainless steel [10]. Nevertheless, the passive films are still formed at this point and afterwards with more positive potentials comparing to  $E_{cor}$  of iron.

Figure 6. The OCP potentials of Type 304 and Type 201 steels in 3.56 % NaCl solution.

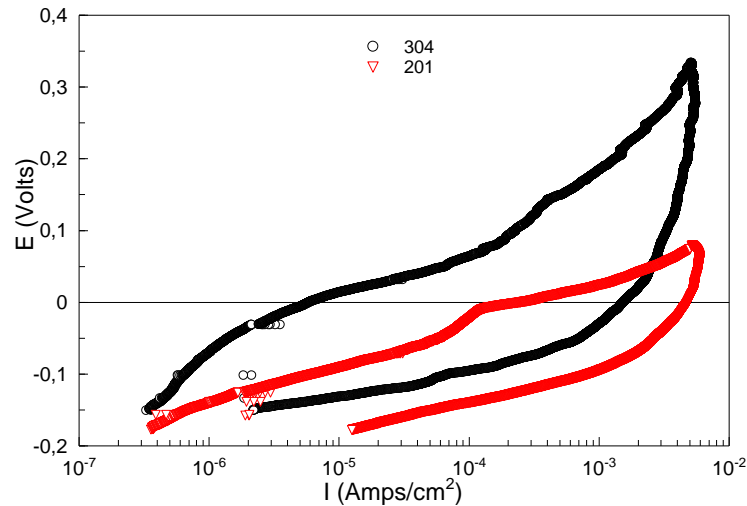
Based on Figure 7, the course of forward scan indicated the higher susceptibility to pitting corrosion of Type 201 grade comparing to Type 304 grade steel. Furthermore, corrosion rate is anticipated to develop more intensively for Type 201 when its passive film is damaged. This is also demonstrated by the course of backward scan to more negative potentials where the pits on Type 201 sample hardly repassivate (extremely slow decrease of current to reach passivation). Therefore, a distinctive behavior was revealed for two steel types due to clear differences in  $E_{pit}$  despite the insignificant shift in OCP.

Figure 7. Potentiodynamic curves of Type 304 and Type 201steels in 3.56 % NaCl solution.
