## Ground Failure Investigation over Abandoned Coal Mines: A Case Study

# Ground Failure Investigation over Abandoned Coal Mines: A Case Study

**SYNOPSIS:** The slurry backfill operation for the Rock Springs subsidence control project is briefly described. The extent of ground failure and building damage is presented. The scope of the ensuing geotechnical investigation to indicate any possible cause and effect relationship between the pumped slurry backfill operation and observed damage is described. The general and specific findings regarding the damaged area are discussed. Conclusions from the investigation are presented.

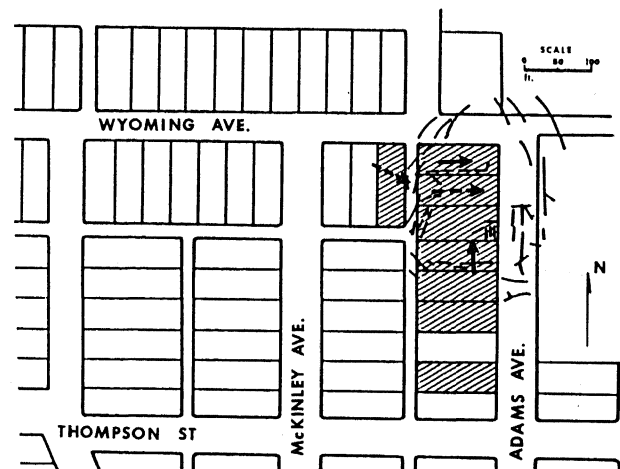
Fig. 3 Surface Damage Adams Avenue Area.

The Adams Avenue residences exhibited architectural damage and some moderate to severe structural damage. The architectural damage usually consisted of vertical and diagonal cracking at window and door openings and at sheetrock joints; horizontal stairwell cracking of plaster covering wood sill plates; and mis-aligned doors and cabinets.

The structural damage was usually concentrated at basement level. The most common problem being vertical, horizontal and diagonal foundation wall cracking. A few cracks were as wide as 1 1/2 inches. Most of the observed foundation wall cracking was less than one-quarter inch wide.

The damage at the Adams Avenue area was evaluated to indicate possible causes. Most of the damage at the Adams Avenue residences was consistent with a downward movement of the structure.

The extent of surface damage was assessed. Crack movements were monitored and measured. Surface ground cracks were surveyed and mapped (Fig. 3). Rotary and core drilling was performed around the affected area and the residences reporting damage. Boreholes were inspected with a video camera. Soil and rock samples from coring were tested.

In light of all the information gathered, except for mine subsidence, all possible sources of ground movement were eliminated as the cause of the observed surface damage. The evidence obtained from the investigation indicate that the most conceivable cause of movement at Adams Avenue was mine subsidence (University of Wyoming, Suprenant, 1985).

The Adams Avenue subsidence event developed a nearly classic mining induced subsidence trough, i.e. an ovaloidal surface fracture pattern (Fig. 3). The size of the ovaloid defined by tensile surface cracking indicates a pillar failure area in the mine approximately 100 ft. wide and 260 ft. long.

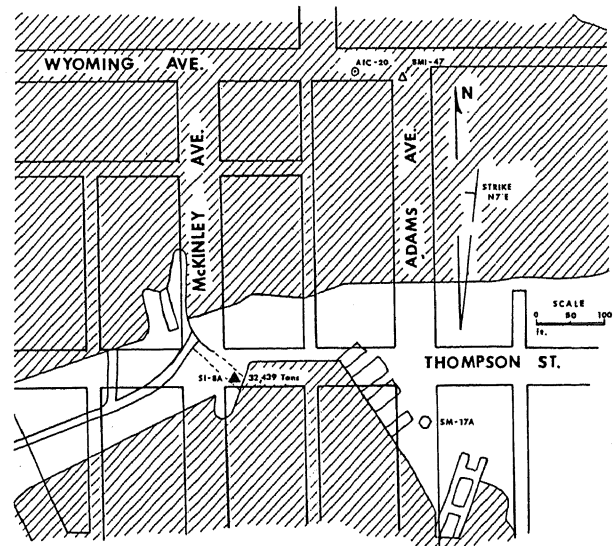
Fig. 4 Mine Workings Overlay.

The nearest injection hole to the Adams Avenue site is SI-8A (Fig. 4). The injection hole is located over a NW-SE entry across the fault pillar. The south side of the fault pillar has about 40 ft. of upthrow. The mine floor elevation at this location is approximately 6320 ft. This injection hole received 32,439 tons of slurry.

The pressure at the base of hole SI-8A, approximately 90 ft. below the surface, was about 39 psi during active slurry injection.

This pressure is more than sufficient to push slurry 20 ft. vertically, which corresponds to 140 ft. horizontally in the updip direction.

As the slurry discharges, in the NW-SE entry, solids would be deposited equally in the downdip and updip direction. On the south side of the fault pillar, the slurry can easily reach the area where blocked entries are shown on the mine map. Based on the drilling experience in the

region, the mine maps proved to be inaccurate. It is possible to have one of these entries crossing the fault pillar to the north side under the Adams Avenue area. Mine floor elevation at the entry on the south side would be at 6330-6340 ft. and on the north side at 6300 ft. updip from the Adams Avenue area. Following this path, it would be possible to have slurry and/or water from the slurry in the mine workings under the area reporting subsidence damage. The inspection hole SMI-47 at the intersection of Adams Avenue and Wyoming Street, which was dry before the start of backfilling, had six feet of water above mine level immediately after the first damage report.

During the investigation, water from inspection hole SMI-47 after the subsidence event should have been analyzed to determine its origin. Furthermore, exploratory drilling should have been done to determine if additional entry ways across the fault pillar were present. These two tasks would have helped in the assessment of cause and effect relationships between the slurry backfill operation and the subsidence event of Adams Avenue.
