## Failure and Repair of the Slope of Railway Embankments and Expansive Soils

# Failure and Repair of the Slope of Railway Embankments and Expansive Soils

**SYNOPSIS:** This paper mainly discusses the stability of the slope of the four sections of railway embankments of expansive soils, describes their basic condition and the properties of the soil materials, analyzes the types and causes of slope failures, discusses the repair of such slopes, and the remedial measures to prevent recurrent of the slides, and sums up experience of using expansive soils to construct railway embankments.

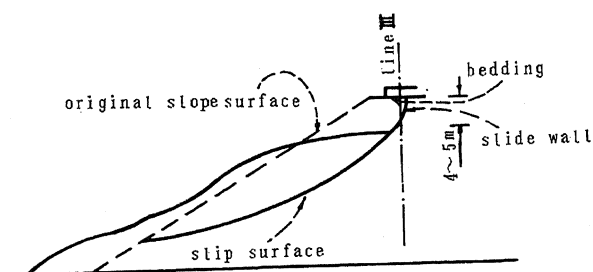
Figure 1

There are three sets of tracks on the embankment, which was completed in 1973. The upper approximately ten meters of the embankment at 1v:1.5h are steeper than the lower portion at 1v:1.75h. Transverse 2.5m wide stone-filled drains have been placed in the slope, spaced at approximately 8 meters. The drains are approximately 1.5 to 2.0m deep. Between them are arch-shaped drains. A retaining wall was constructed at the foot of the slope.

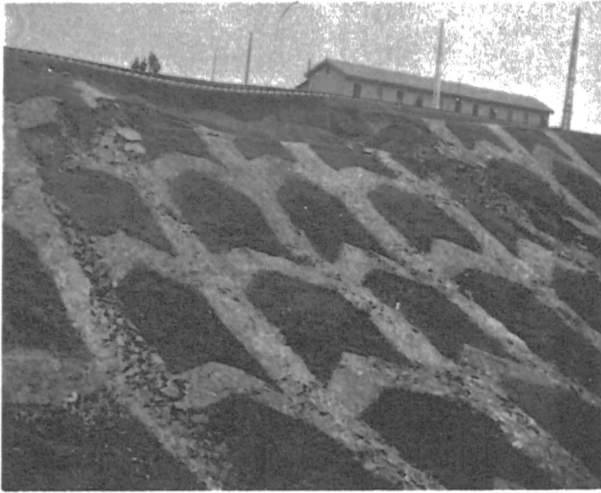
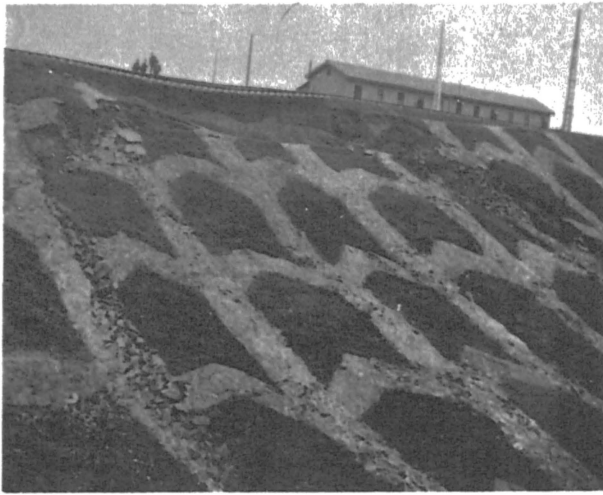
Figure 2

The rainy season in the region of the embankment is from July to September. On the 11th of October, 1980 a slide occurred on the slope of the embankment. See Fig. 2. The slide was about 50m wide, and about 4 to 5m thick. The slide scarp was about 0.3m on the 12th, 2.0m on the 19th, and about 4 to 5m high by the 21st of October. The drains on the slope and the retaining wall at the foot of the slope were damaged, and the rails were suspended from their ends, due to the removal of support by the embankment.

1. It is unstable to construct such a high embankment with the expansive soil with a slope of 1:1.5 to 1:1.75. A stability analysis based on the saturated undrained shear strength shows that the factor of safety is less than 1.
2. Since there was poor drainage on the surface of the embankment, water accumulated under the ballast bedding. Such accumulation seeped into the embankment, softening the soil.
3. Water accumulation under the ballast bedding softened the embankment and allowed penetration of ballast into the bedding, causing a ballast pocket. See Fig. 3. In turn, this pocket became a reservoir for further accumulation of water and fed the water into the embankment.

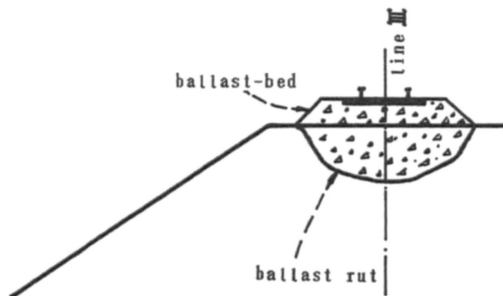
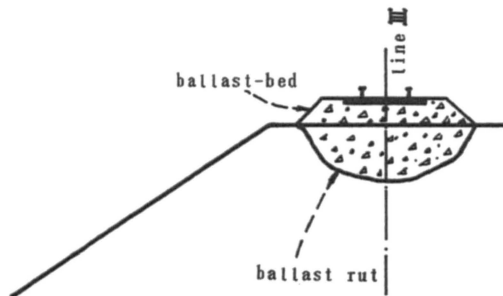
Figure 3

4. The original density of the embankment was low and not uniform, since compaction had been attempted with earth-hauling machinery, and probably without proper rolling. Moreover the slope surface was not well protected so that shrinkage cracks formed in the dry season, with rain infiltrating these cracks during the rainy season.

5. The rock drains on the slopes were apparently too shallow.

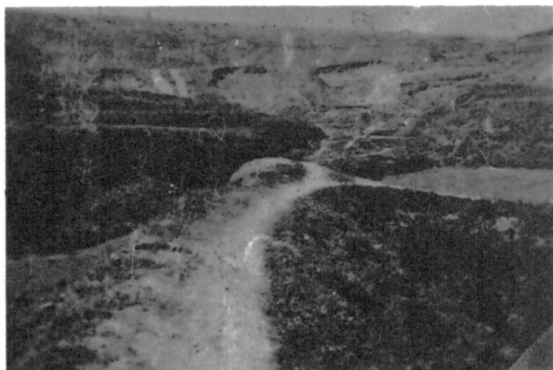
Figure 6

The failure consisted of multiple shallow slides in the middle sections of the slope during the rainy season of 1974. These slides covered more than half the area of the slope between the above referenced stations. The slides initially took the shape of a horse's hoof, and were relatively small in area. See Fig. 6. The individual slides were about 10-20m wide, and 0.8-2.0m thick. As they developed, several of the slides joined and overrode one another, and then continued to expand up the slope. It was anticipated that if not repaired promptly, sliding would result in the rails losing support.

It was evident that this failure resulted from a shallow layer of the slope becoming saturated due to water seepage, rapidly reducing the shear strength of the soil. Specifically:

1. The rainy season of 1974 was long and rainfall was heavy.

2. Compaction of the embankment had been done using hauling equipment rather than with rollers, and the compaction was poor and non-uniform.

3. Shrinkage cracks had appeared before the rainy season, and had not been repaired at the time of the rains.

4. The slope was too steep. Soil tests on a sample which had been permitted to swell in water gave shear parameters of C = 10 KPa and φ = 4 degrees. A stability analysis was made with the assumption that the slip surface was a plane, and the factor of safety of the slope was determined to be less than one.

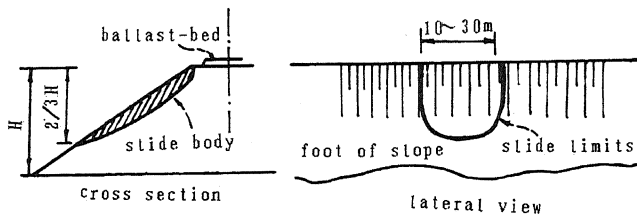
The failures appeared chiefly in the form of shallow slides. Generally these slides were limited to the top two-thirds of the embankment with a width of 10-30m and usually about 1 to 1.5m in thickness. Slide scarps were generally 1.0-1.5m in height. Fig. 8 shows details.

It was obvious that the failures of the slopes were the results of poor compaction of the slopes, lack of protection for the slope surface, and surface water seeping into the slope through shrinkage cracks or hollows in the slope and shoulder of the crest. In some cases water had accumulated in ballast pockets, and was aggravating the problem.

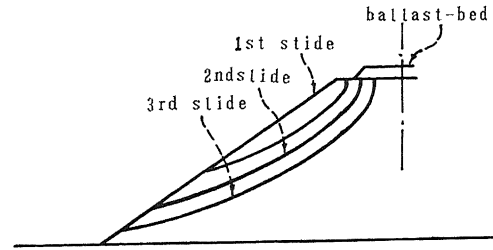
Fig. 9

As shown in Fig. 9, at some places the surface water caused successive shallow slides which eventually undermined the track at the top of the embankment.

In addition, slides occurred with slide scarps 2-3m high beneath the tracks, with slide bodies 30-40m in width and 2-3m thick. These formed because the saturated ballast pockets 1-1.5m deep were squeezed outwards under the loading of the trains. Both surface water and water that had accumulated in the ballast pockets served to saturate the embankment.

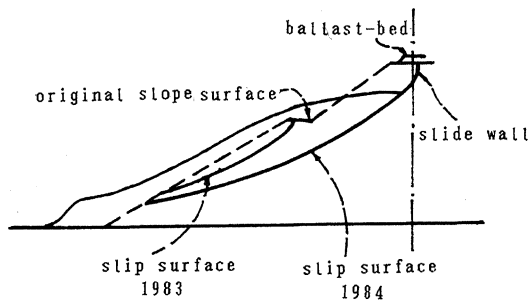
Figure 11

Three shallow layer slides occurred on the slopes in the rainy season of 1981. A large amount of surface water had seeped into the slope. Makeshift measures were taken to effect a quick repair; timber piles were driven through the slide and straw bags packed with soil were placed to be a counterweight for the side. Each of the three shallow layer slides began to migrate upwards, so that the slide body became about 30m wide, 1.5-2m thick with slide scarps about 1.5m high. Fig. 11 depicts this.

In September 1984, as the slide was being repaired, it rained almost continually for 20 days. A large slide about 60m wide, 4-5m thick with a slide scarp 3m high occurred from the top of the embankment, resulting in loss of support and suspension of 20m of rail.

1. The design slope was too steep. Using the saturated undrained shear strength of the embankment soil, a stability analysis showed that the factor of safety was less than 1.
2. Neither drainage ditches on the embankment surfaces nor slope protection was provided. Large ballast pockets had formed under the track and surface water had seeped into the slope from the pockets.
