# Effect of Foundation Deformations on The Damage of a Masonry Villa (Case History)

**SYNOPSIS** Cracks in the masonry walls of a one storey villa due to foundation deformations are investigated in this paper. In spite of the fact that the soil formation in the site was found to be almost uniform, hogging deformation profile took place in the strip foundation due to unequal loading. Analysis of the walls together with their supporting soil, as one integrated system, showed that very small foundation deformation can produce tensile stresses in the wall higher than its tensile strength. Repair of the cracks was proposed and carried out successfully.

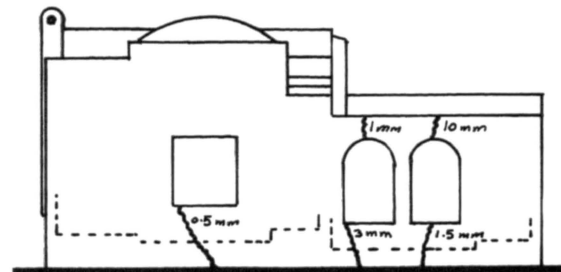
Fig. 2 North Elevation

Six month after construction i.e. in 1979 some cracks were noticed on the exterior walls of the building. The crack widths were measured and were found to be increasing with time for a period of 15 months. Fig.(2) and fig.(3) show the pattern of the major cracks and their widths on the north and south walls when the cracks almost seized to increase in width. Fig.(4) and fig.(5) show photographs of the south wall and part of the north wall while cracked. The crack patterns on the walls, with wider cracks at top than at bottom, indicated that as if the foundations of the building underwent a hogging settlement profile. In order to study the reasons of cracks it was decided to undertake a soil investigation for the site.

- Casting top concrete beams properly connected to the masonry walls all around the building.
- All cracks wider than 0.3 mm were injected with epoxy mortar.
- All smaller cracks were just sealed with epoxy paint.

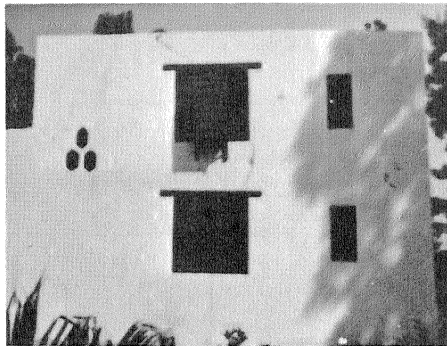
Fig. 4 Photograph of The South Wall  
( Before Repair )

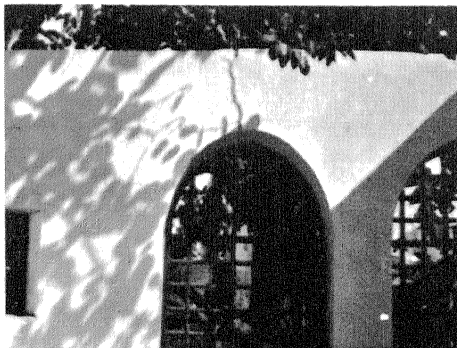
Fig. 5 Photograph of Part of North  
Wall ( Before Repair )

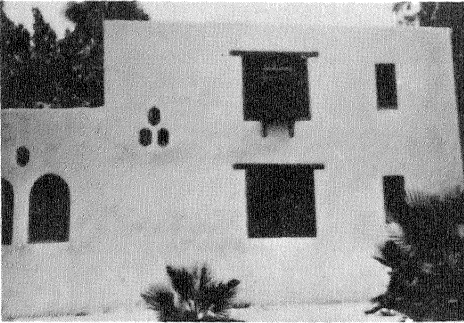
Periodical observation of the building showed that the performance of the carried out repair was satisfactory and no further cracks were developed. Fig.(12) and fig.(13) show the walls after repair.

Fig. 12 South Wall After Repair

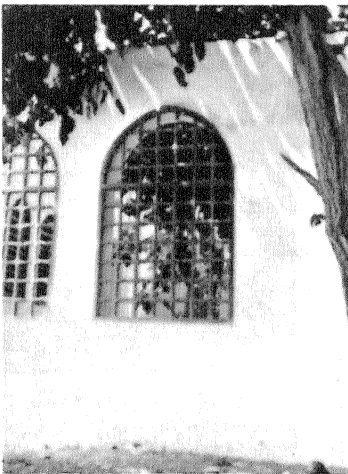
Fig. 13 Part of North Wall After Repair.
