A CASE STUDY ON EXPANSIVE SOILS AND ROCKS OF AL-KHOD IN NORTHERN OMAN

Paper No. 1.05

The paper presents a brief damage case study of house number 18 based on its damage assessment made in October 1996. The aims of this investigation are to study the mechanism of structural damage to the building, to establish the cause of such damage, and to recommend the appropriate measures to be taken for construction of buildings founded on expansive soils and rocks.

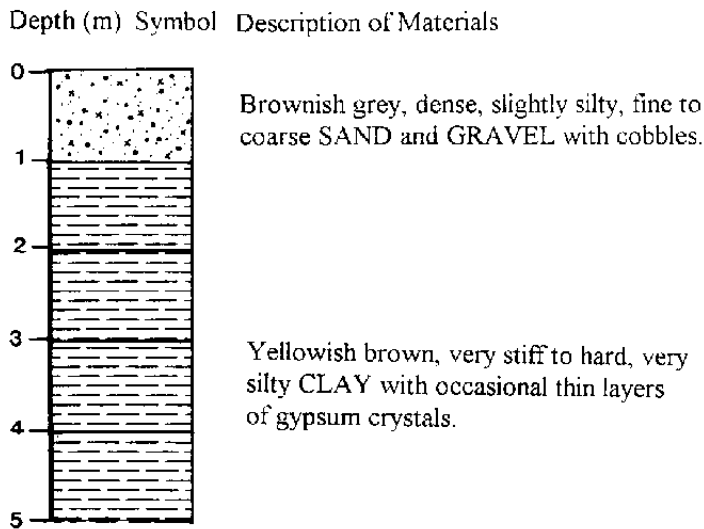
Fig. 1 Typical soil profile.

A soil survey was carried out by COWIconsult (1988) to investigate the soil conditions and determine the cause of cracking in the houses. Two deep trial pits were excavated to recover samples for laboratory testing. Two boreholes were carried out by Yahya Costain (1988) near house numbers 19 and 20. The soil profile of the two boreholes is similar, therefore, a typical bore log is shown in Fig. 1.

A soil investigation work carried out by Swissboring (1994) for a site which is located approximately 500 m west of the damaged houses indicated a 6.0 to 13.0 m thick stratum of yellowish brown, very stiff to hard, very silty CLAY with scanty thin layers of gypsum crystals. The clay layer is in turn underlain by a 5.0 to 15.0 m thick layer of yellowish brown to light grey, very stiff to hard, very silty CLAY, interbedded with MUDSTONE and thin layers of gypsum crystals. This layer is underlain by a 3.0 to 6.0 m thick layer of black, very hard, silty CLAY/MUDSTONE.

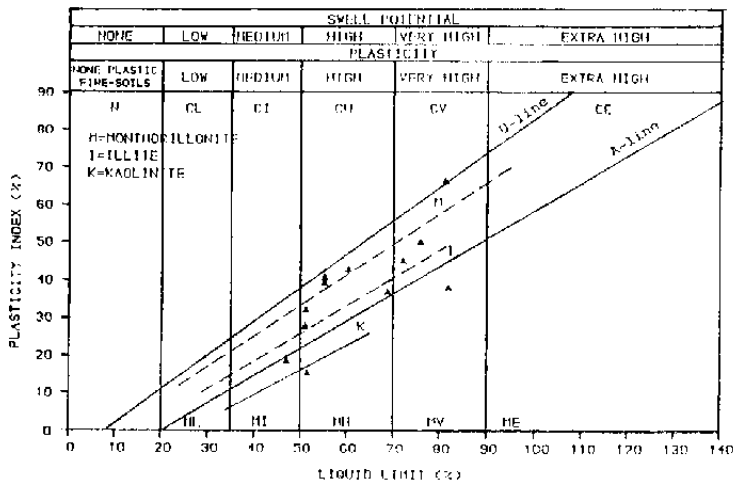
Fig. 2 Swelling potential classification (Dakshanamurthy and Raman, 1973) and mineralogical classification chart (Holtz and Kovacs, 1981).

From the chart, it is seen that samples MQV1, MQV2 and MQV4 were found to be located in the kaolinite zone, and sample MQV3 in the illite zone. On the other hand, samples MQV5, MQV6, MQV7 and MQV9 are located in the zone between illite and

montmorillonite, and samples MQV8, MQV10, MQV11 and MQV12 are concentrated in the montmorillonite zone.

Atterberg limits have been employed in this paper to determine indirectly the swelling potential using the criteria developed by Dakshanamurthy and Raman (1973). From the results shown in Fig. 2, it is seen that with the exception of one or two samples, all samples were found to be located in the *high* to *very high* ranges of swelling potential.

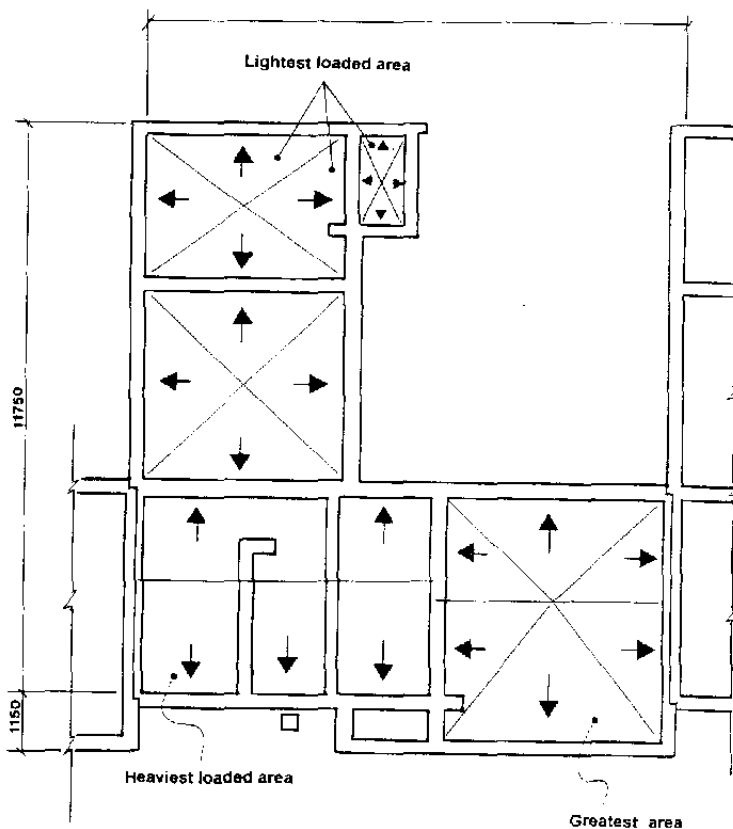
Fig. 3 Plan of house number 18.

It was observed that almost all the exterior walls are free from the cracks except a few hairline cracks. It seems that there is negligibly small changes in the moisture content of the soil under the walls in the front face of the structure and the front walls are carrying heaviest loads on them due to the largest rooms and the highest walls as shown in Fig. 3.

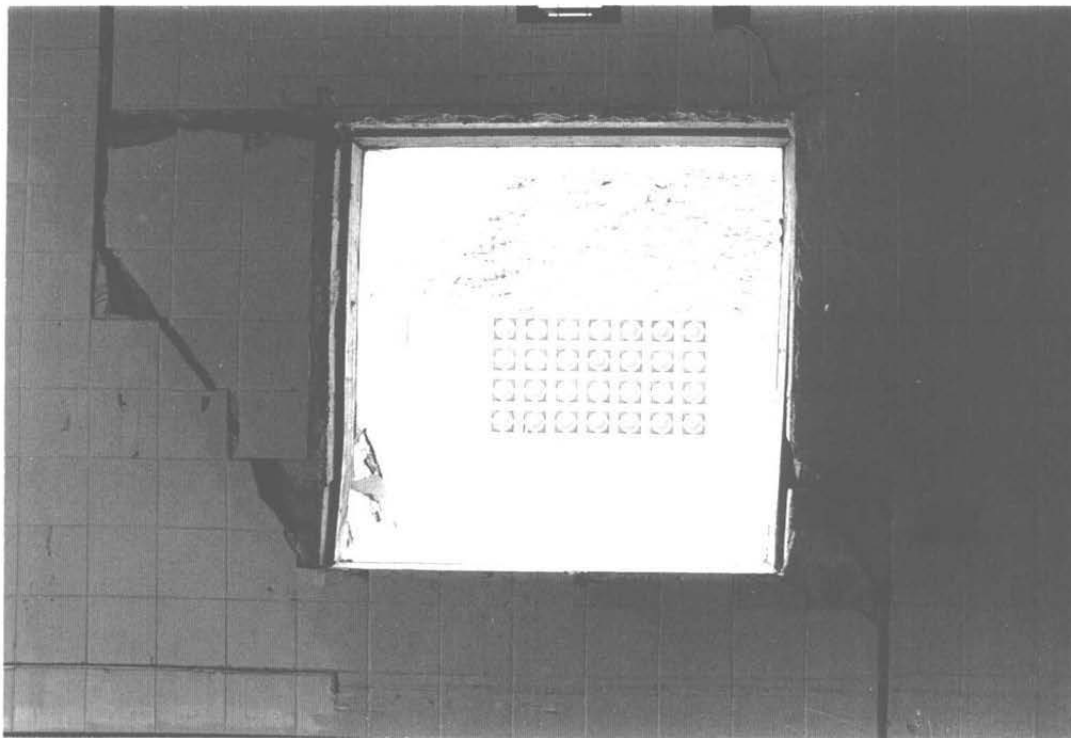
Very severe cracks have developed to the walls of the kitchen (on the ground floor) and of the W.C and bath room (on the first floor above the kitchen) as shown by Figures 4 to 6. It is very surprising to note from Fig. 4 that the width of the same cracks of the wall located at the first floor vary from 30 to 50 mm. Figure 4 shows that the window frame has loosened and moved slightly away from the wall due to severe cracking around the window opening. Generally, width of most of the cracks lie within a range of 20 to 30 mm.

Fig. 4 Very severe cracks in the kitchen wall.

1. Surface drainage must be provided all around the building and the ground surface should be graded.
2. Horizontal moisture barriers should be constructed around the building preferably in the form of concrete and/or asphalt apron to prevent excessive intake of the surface moisture.
3. The interior plumbing including sewer and water supply lines should be checked for leakage periodically.
4. All house gardens should be paved, to prevent the effects of over-irrigation.
5. No shrubs or ground coverplants should be retained or introduced in future within 3 m of house structure gable ends and no trees planted within 5 m of house foundation pads.
6. Prompt investigation of any reported structural damage which if found to be associated with expansive strata must include identification and removal of any water sources.

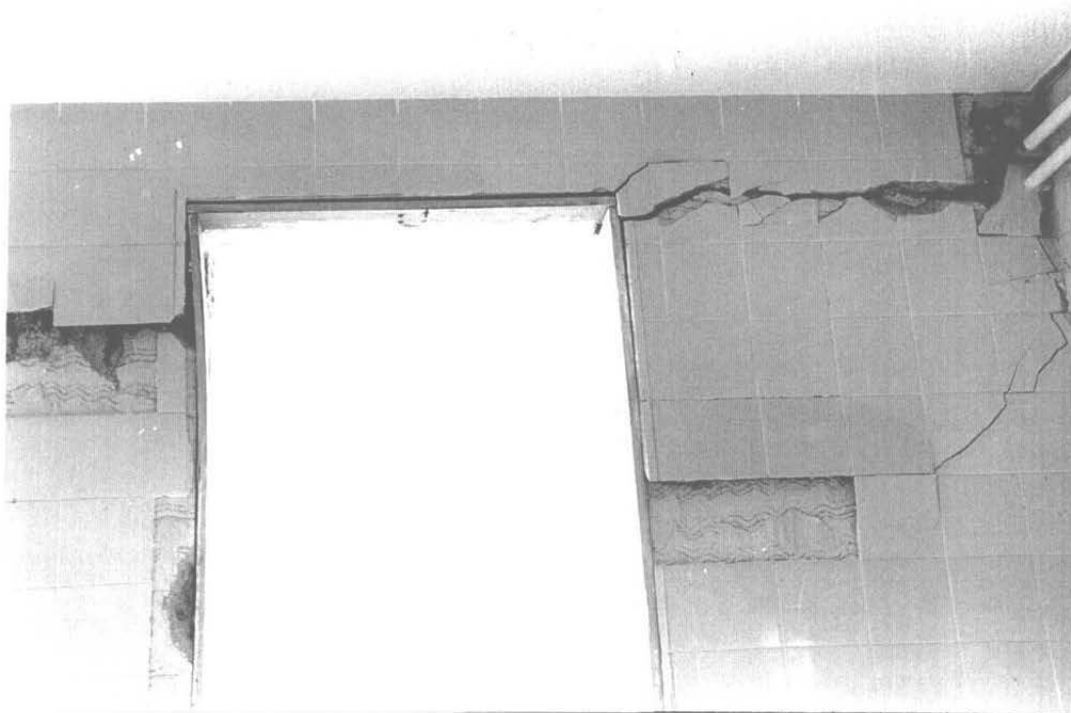
Figure 5 shows a combination of the horizontal, predominantly diagonal and vertical cracks. Generally, the width of the cracks measured is between 10 to 30 mm. The kitchen walls show the worst damage in comparison with the damages to the majority of the walls of the building. It is most likely that the problem has been aggravated by the defects in the water supply in the kitchen itself. The wall cracks are classified as very severe degree of visible damage in accordance with BRE (1981) classification. Very severe diagonal cracks are observed from the backyard face of the same wall (Fig. 6) varying between 30 to 75 mm.

Fig. 5 A close up view of the kitchen wall showing diagonal and horizontal cracks.

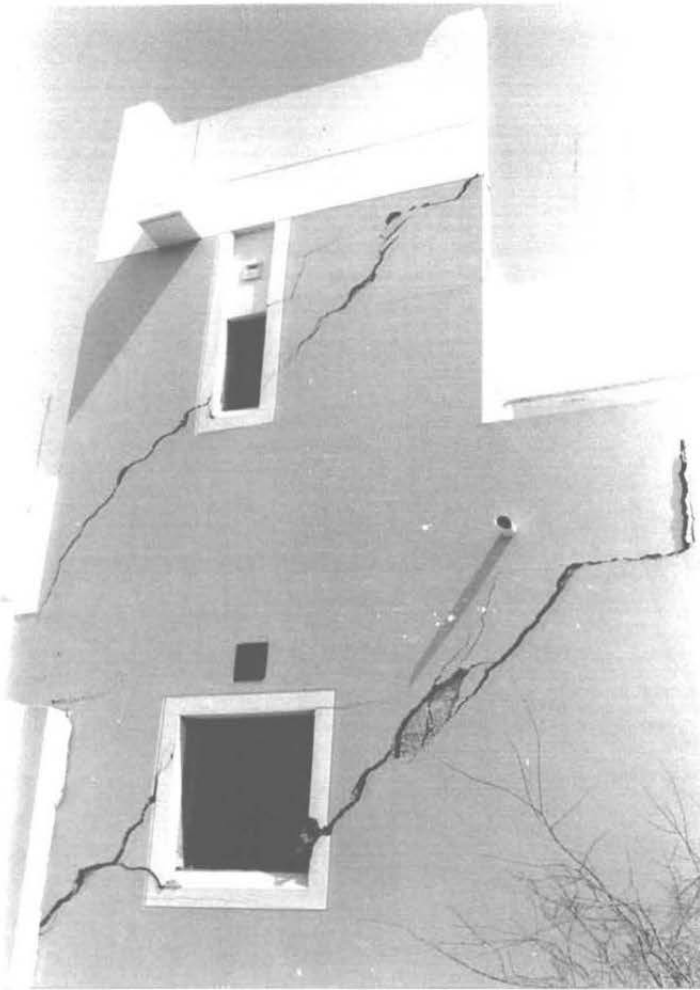
It turns out from the damage assessment of these walls that extensive damage has occurred to the walls facing the backyard. This sustained significant damage to the walls has occurred due to the differential foundation heave caused by non-uniform change in soil moisture content. The backyard has been subjected to considerable watering for shrubs and plants throughout the year. Since, the walls were not designed to resist the stresses developed by additional bending moment and shear force due to the interaction between the expansive foundation soil and the structure, consequently the distress has been relieved in the forms of cracks in the walls.

Fig. 6 Back elevation of house number 18 showing extensive damage to the wall.
