## Remedial Measures to Seepage and Instability Aspect of a Dam Near Bombay

**SYNOPSIS:** The paper describes the distress caused to a minor earth dam constructed at a high elevation in a mountainous area to conserve water. The distress related to instability of the dam and also due to high percolation underneath the dam coupled with formation of piping. The remedial measures taken to rectify instability and reduce percolation are described in this paper.

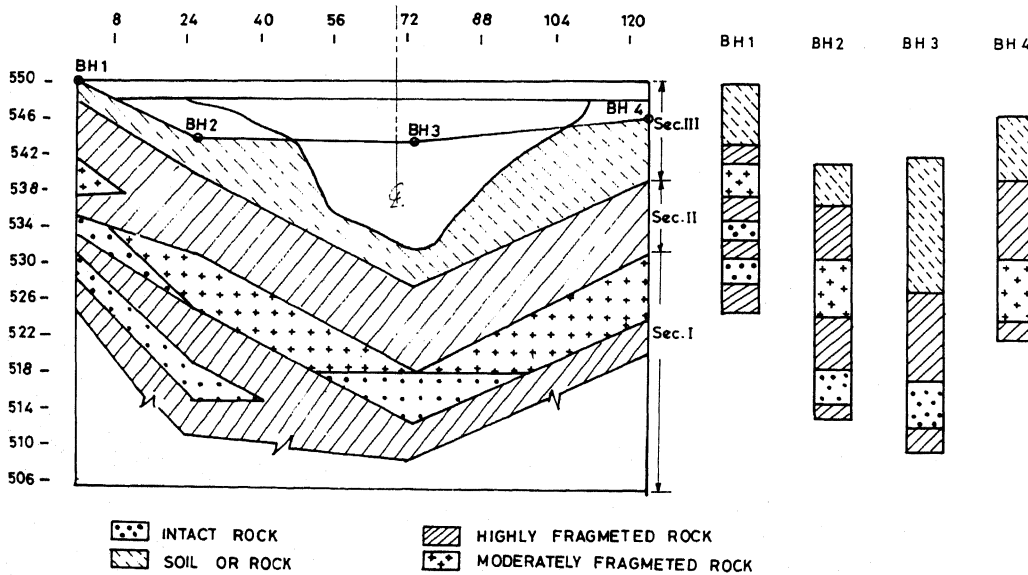
Fig. 2 Subsurface Section Along the Dam Axis

The whole area consisted of highly weathered soil mass followed by highly fractured and jointed basalt. See Fig.2. Such a condition of reservoir may give rise to high degree of subsurface percolation. It was also observed that a big piping had appeared close to the waste weir and was cutting across underneath the dam and was opening up down stream at RL 536. Further examination revealed that 2 to 3 streams which are passing through the reservoir area converge into goose neck and join the main valley. The location of the piping coincides with the course of the stream. It is presumed that the cut off trenches are above the bed of the streams which are filled up with sand and gravel. See Fig.5. It is also observed that considerable distress has taken place on the right flank due to blasting operation during the construction of waste weir. This can lead to heavy percolation through the right flank when the dam would be full.

To understand the causes of heavy seepage it was considered necessary to take around 4 boreholes along the dam axis. See Fig.2. With the help of 4 borehole logs a subsurface profile is developed to indicate the strata containing murrum, highly crushed fragmented rock and intact rock etc. It can be seen from the section that on the right flank murrum deposit is encountered upto RL 536 and at the centre of the dam it is upto RL 527.5. Near borehole 4 the murrum zone ends at RL 539. Below the murrum zone around 8 m. to 10 m. of thick fragmented crushed rock zone is encountered. On the left flank the rock strata encountered is moderately fragmented rock as shown in Fig.2. On the basis of subsurface section coupled with surface observations in the storage area it can be concluded that even after the dam is constructed almost all the water can percolate out at a high rate through the subsurface underneath the dam. The average thickness of crushed rock and murrum overburden would be around 18 m. Approximate computations show that the coefficient permeability K value would be  $2.2 \times 10^{-2}$  cm/sec. for average strata. However, the coefficient of permeability for fractured zone would be  $4 \times 10^{-1}$  cm/sec.

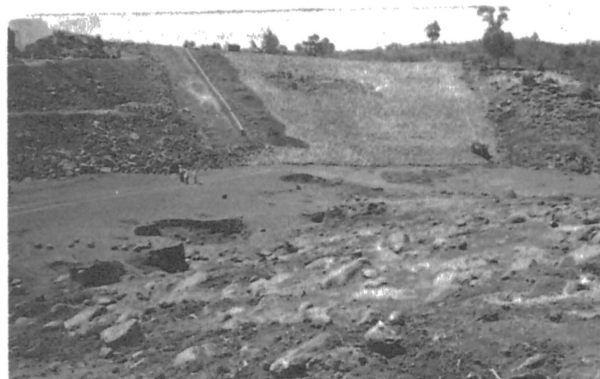
Fig. 4 Nature of Basin.

Inadequate embedment of right and left flanks of earth dam into the original natural ground has added to further seepage losses and also to instability of the dam itself. Weakening of the right flank due to construction activities in the waste weir has further contributed to high seepage and to instability to flanks and the dam. See Fig.4.

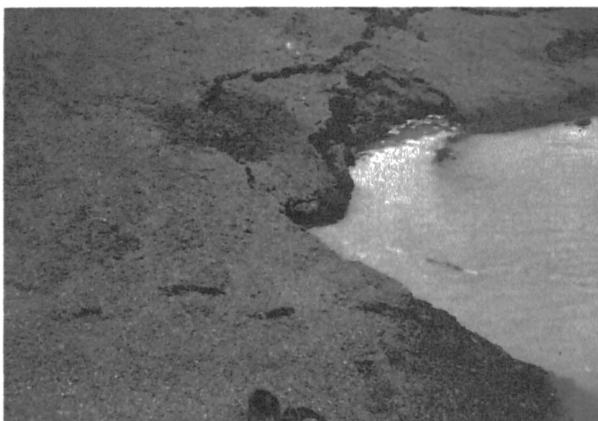
Fig.6 Piping

In adequate cut off, untreated subsurface, and followed by storing of tank has resulted into high internal subsurface erosion and formation of pipes. See Fig.6.

The amount of grout consumption in terms of cement bags turned out to be more than 90 bags per hole between the waste weir and chainage 50 as compared to 2 to 5 bags per grout hole on the left flank. The above procedure was implemented only after the reservoir got emptied. The piping portion was plugged with cement concrete.

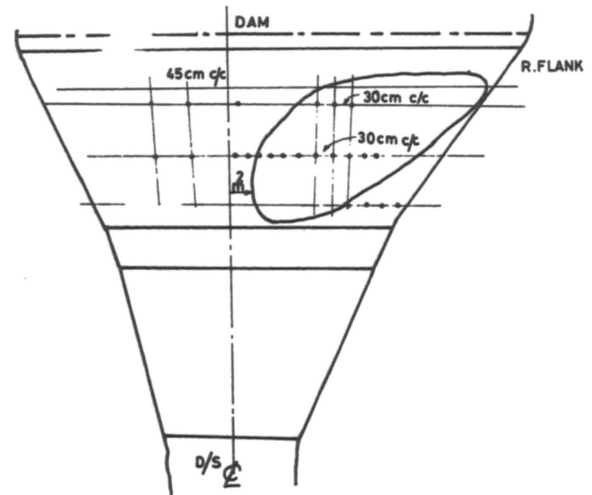
Fig. 7 d/s Face

The portion on the down stream of the dam enclosed between RL 538 and RL 542 and between chainage 40 and 68 showed subsidence and heave indicating potential possibility of slide. In addition a subsidence of around 30 cms was observed on the top of the dam towards d/s side between chainage 45 and 55.

on the d/s side, there was a need to take immediate rectification measures. The measures taken with respect to stability are described below. With the help of zone of subsidence and heave a probable circular potential plane of failure was adopted for analysis. The computed value of the activating force turns out to be 4 tonns/m. width. It was considered prudent to provide shear connectors to take the whole activating force (4T/m. width) as the portion was already in the process of sliding. The method adopted consisted of providing 3 rows of shear connectors with the spacing as shown in Fig.7 and Fig.8.

Minimum number of rip rap stones were removed at the location where the shear reinforcement were to be inserted. Pnumatic drill was used to drill a 2.5 cm. diameter hole upto a depth of 1.5 m. into the original ground through the body of the dam. Care was taken to see that the surrounding rocks are not disturbed. After the drilling was completed 16 mm. diameter steel bars were inserted into the hole upto the desired depth. The remaining cavity of the whole was filled with cement slurry of 1 in 15 consistancy. The 3 rows of bars were inter connected with 6 mm. diameter bars at the surface of the soil layer. Immediately after these rods are placed in position the rip rap

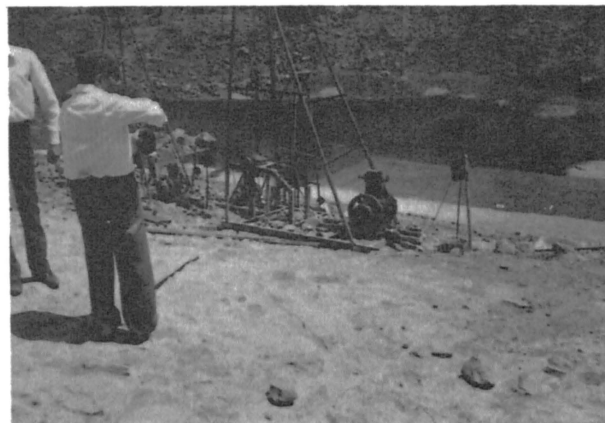
Fig. 10 View Showing Basin Asphaltic Treatment and Grouting.

considerably in reducing the percolation as observed during the filling of the dam. See Fig.10. When the dam was completely filled suddenly a pipe appeared increasing the percolation. Subsequently it was observed that the pipe got started on the upper reaches of one of the streams. See Fig.10. With the help of asphaltic treatment and grouting the percolation was reduced to the extent of  $10^{-4}$  to  $10^{-5} \text{ cm/sec}$ . However, as the basin is small and the demand of water is high it was decided to adopt gunniting and sodium silicate treatment to treat the basin to prevent percolation. The streams were treated by gunniting to a considerable distance from the reservoir area.

Asphaltic treatment was adopted to prevent seepage of water. The method consisted of scraping the area, placing 2 cm. to 3 cm. thick graded metal and lightly compacting it. 70-80 penetration asphalt was spread at the rate of 5% of the weight of the aggregate. Choke stone was spread and was lightly rolled. Subsequently a thin layer of asphalt was spread on the top and was covered with stone dust. Only some critical part of the basin could be treated before the rains during 1984. This helped

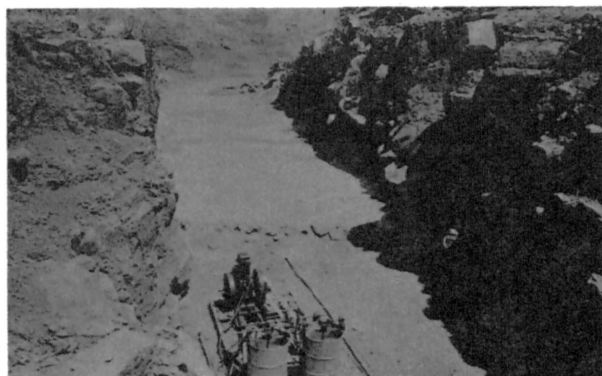
Fig. 11 Waste Weir Prior to Lining.

The major portion of the waste weir pass through rocky strata. For construction in rocky strata blasting methods were adopted. The waste weir was left without lining and sides and bottom are highly jointed. The distance between the waste weir and the dam is around 5 m. to 7 m. The bottom of the waste weir is 10 m. wide corresponds to FSL (RL 544).

Waste weir was lined with bricks and was properly plastered. Polythene sheets were used below and around the brick lining to prevent water from percolating. The gap between the brick lining and undulated surface of the blasted waste weir wall was filled up with soil. See Fig. 11, Fig.12, Fig.13 and Fig.14.

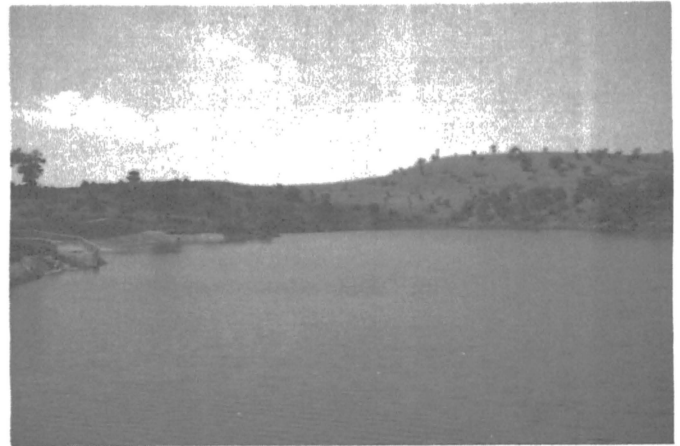
Fig. 15 Reservoir - Filledup

During the last 2 fillings the dam has not shown

any distress and is stable. See Fig.15.
