## **CASE HISTORIES OF DAMAGE OF FOUNDATIONS NEAR SLIDING SLOPES**

**Constantine A. Stamatopoulos**

### **ABSTRACT**

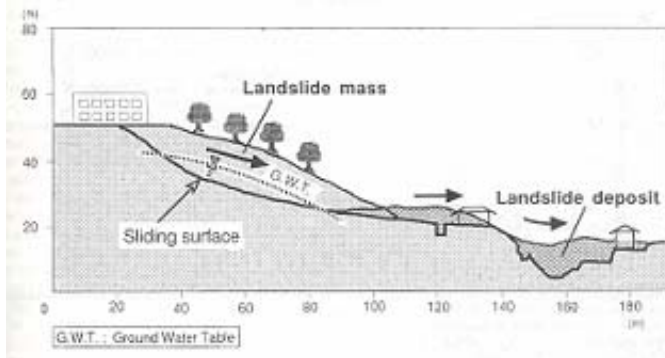
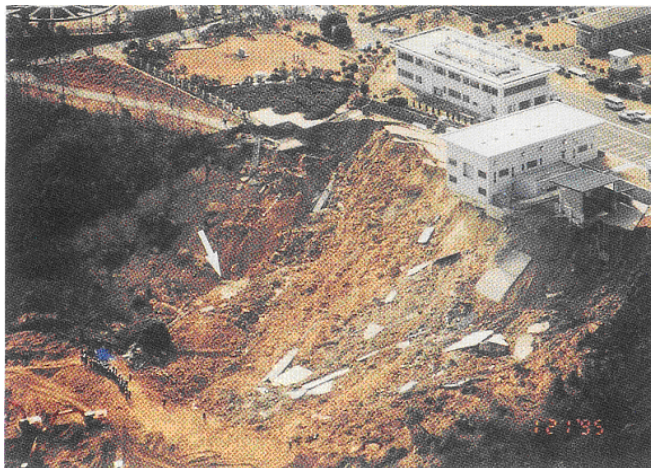
Fig. 1a gives the cross-section of the Nikawa slide (Sassa at al, 1995, Sassa et al., 1996). The slide width was about 100m. The landslide volume was 110.000 to 120.000  $m^3$ . Estimated displacements are 50 m. The slide was very rapid.

With a landslide volume in the order of  $110,000 \text{ m}^3$ , moving rapidly over a distance of about 100 m, the slide destroyed 11 residential buildings causing 34 fatalities (Sassa et al., 1996). It is of interest to observe that a building at the top and near the edge of the slope did not collapse (Fig. 1b), presumably because (a) the foundation of the building was rigid and (b) the width of the slide below the building was small (about 5m) compared to the width of the building (about 20m).

Fig. 1. (a) Cross-section and (b) figure showing the damage of a building n of the Nikawa slide (Sassa at al, 1996).

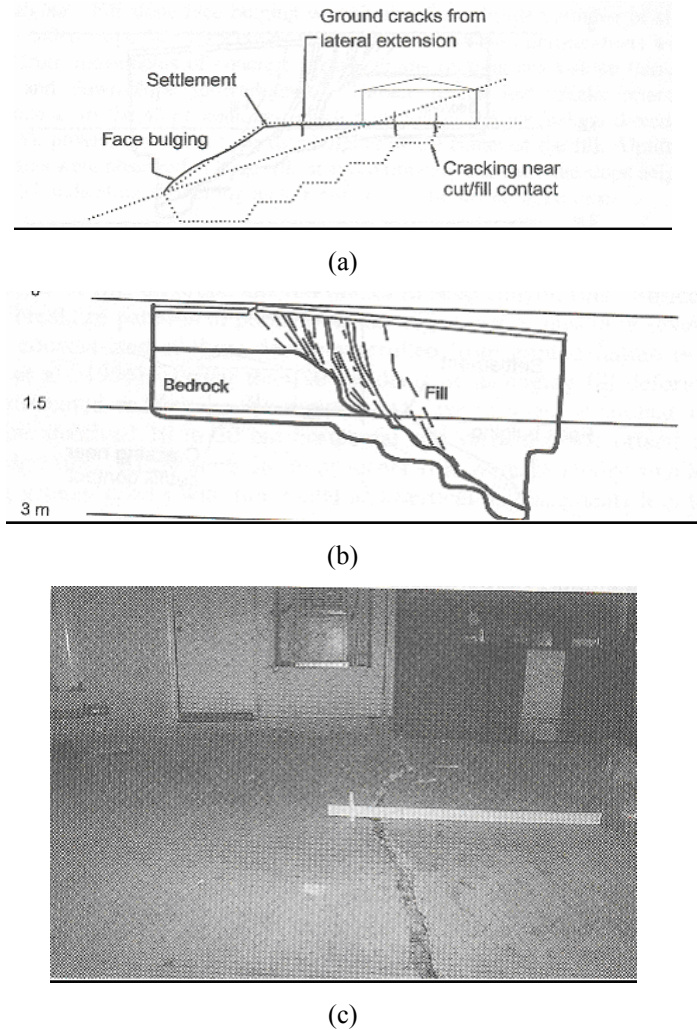
Table 1 gives the ground settlements in all cases. It can be observed that relatively small ground settlements (0.1-0.01m) occurred. A schematic illustration of ground displacement is given in Fig. 2a.

Stewart et al. (1995) studied structures that were damaged as a result of the above settlements. A schematic diagram and typical photo of building damage are given in Fig. 2. It can be observed that settlement extended about 10m from the edge of the slope and affected about 60% of the width of the houses. As a result of the settlement of the fill, the foundation slab collapsed and moved towards the slope. Table 1 gives characteristics of the damage of the houses in terms of the settlement. Characteristics of the houses are not given. It is believed that the buildings did not have rigid foundation.

Fig. 2. Damage of buildings as a result of the Northridge (USA) earthquake: (a) and (b) schematic illustration and (c) typical photograph of the ground displacement and damage of buildings (Stewart et al., 1995).

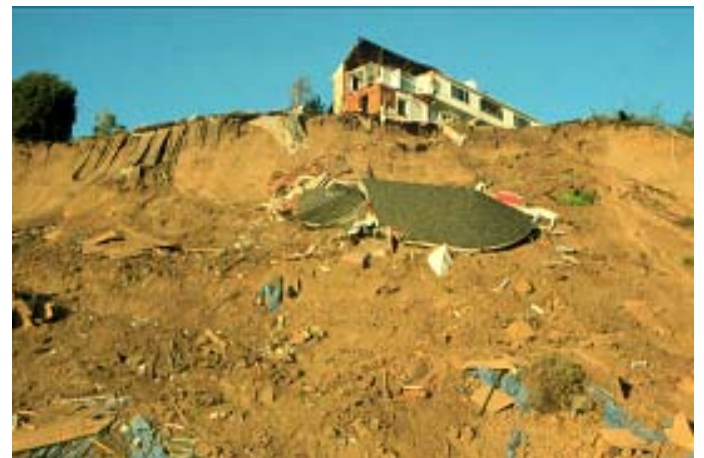
The slide was shallow (Fig. 3) having 2-5m depth. It occurred in heterogeneous soil consisting mainly of sands and silts with small cohesion. Estimated slide displacement is 7m.

The slide caused partial collapse of a house very near the edge of the slope (Fig 3). The house was wooden and had one floor. The house partly collapsed, presumably because the foundation slab failed. The width of the foundation that was affected by the slide was about 3m out of the about 10m of the total width.

Fig. 3. Photograph of a house that was destroyed as a result of a slide at Pacific Palisades, by the Northridge, 1994, earthquake. (<http://pubs.usgs.gov/of/1996/ofr-96-0263>, 2006)

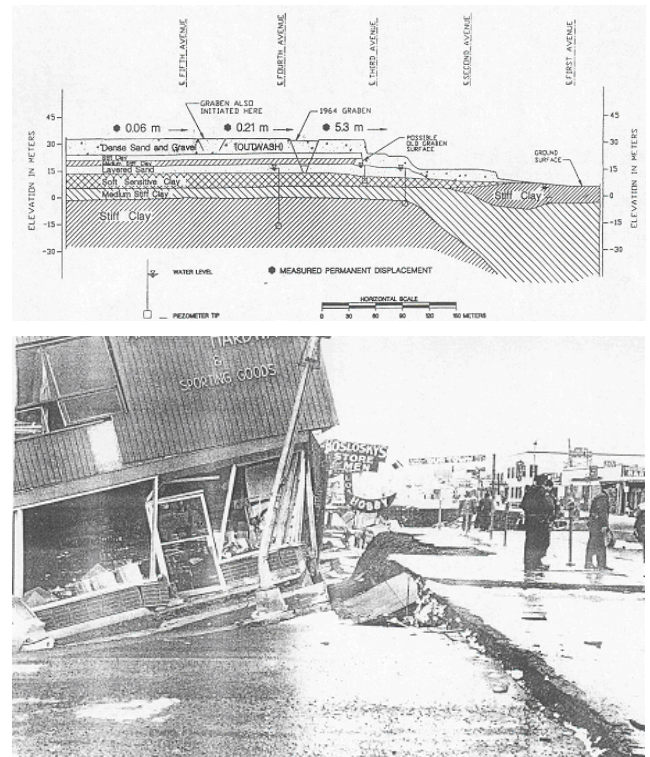
Fig. 4 gives a cross-section of the slide (Stark et al., 1998). The landslide mechanism was horizontal translation characterized by graben development. Slide horizontal translation was about 5m. Graben inclination is about 40°.

As illustrated in Fig 4, the large seismic displacement caused large settlement and rotation of a building, that made it uninhabitable. Yet, the buildings did not collapse.

Fig. 4. Cross-section and figure showing the damage of the a building near the edge of the slope of the 4th Avenue Anchorage slide of the Alaska, 1964, earthquake. (Stark et al., 1998, Bolt, 1978).

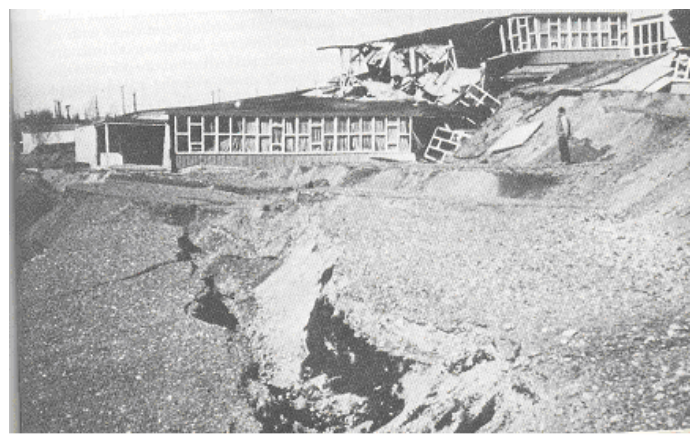
Soil conditions at the Government Hill slope are similar to those described in the previous section. The cause of failure appears to be the undrained failure of the soft sensitive bootlegger cove clay, described in the previous section. Both the horizontal displacement and the settlement in the vicinity of the slide are about 5m (Fig. 5).

A school was located near the slope that slid (Bolt, 1978). As illustrated in Fig. 4, about 8m of a 20m wide school was in the air, without foundation soil below it, as a result of the slide. The building partially collapsed, presumably because the foundation was not rigid enough.

Fig. 5. School building that collapsed as a result of a landslide at Government Hill, Anchorage, as a result of the Alaska, 1964 earthquake (Bolt, 1978).

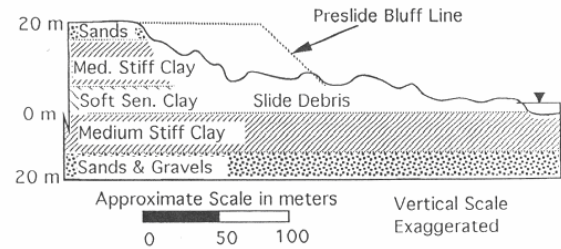
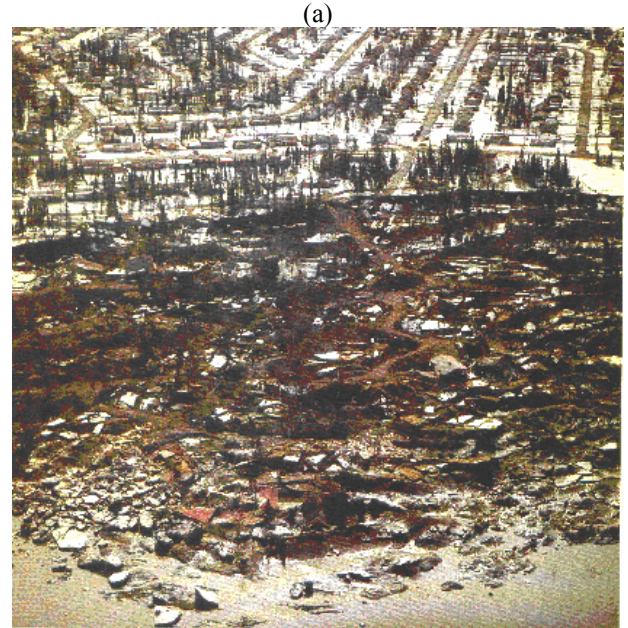
A cross-section of the slope is given in Fig. 6a. The slope had inclination about  $20^\circ$ . The northern portion of Anchorage is built on a sand and gravel outwash deposit overlying a thick stratum of bootlegger cove clay. The upper and lower zones of this clay deposit are fairly stiff and competent, but the central portion is weak and sensitive. This portion lost its strength and this caused the slide.

The houses on the slope moved downwards many centimeters or meters (Figs. 6b, 7a, 7b). The houses were wooden, one-story and two-story, with rigid foundation. The houses in the upper part of the slope moved horizontally less than 2m and did not collapse. The houses in the lower part of the slope moved more (about 10 to 120m) and some of them practically collapsed.

(a)  
(b)  
Fig. 6. The slide at Turnagain Heights as a result of the the Alaska earthquake of 1964. (a) cross-section of the slide, (b) photo of the slide.

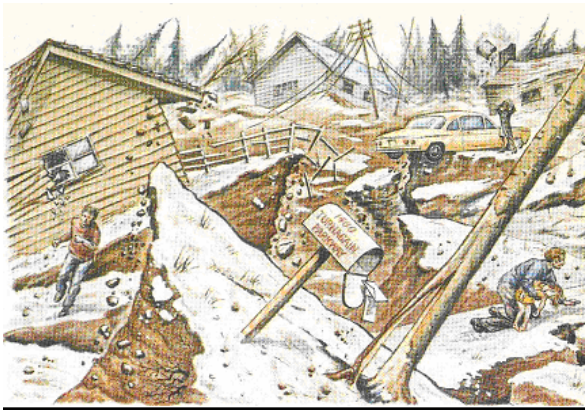
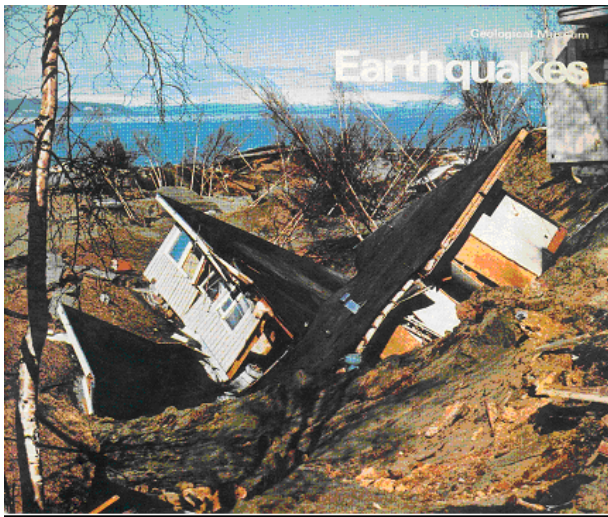
Fig. 7. The slide at Tanagain Heights as a result of the the Alaska earthquake of 1964. (a) schematic illustration of damage to buildings and (b) photos of damage to buildings (Bolt, 1978).

The historic case studies also illustrated that the soil mass adjacent to the slope moves downslope usually with displacement that decreases as the distance from the free side of the slope increases (Fig. 6b). Yet, often the displacement is random, as a result of many small failures and slides (Fig. 7a, Fig. 7b).

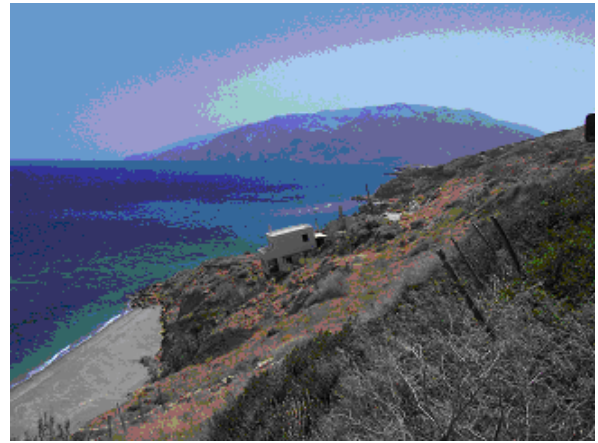
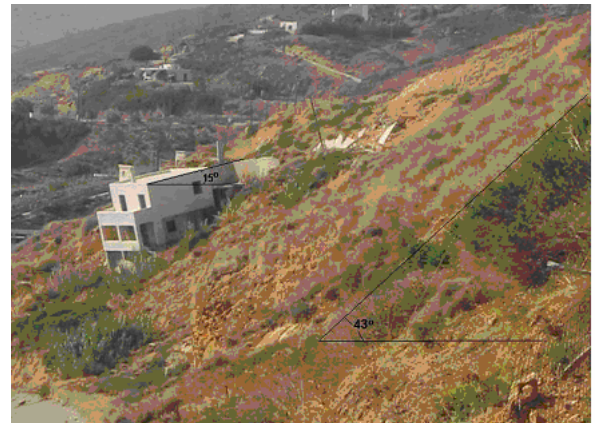
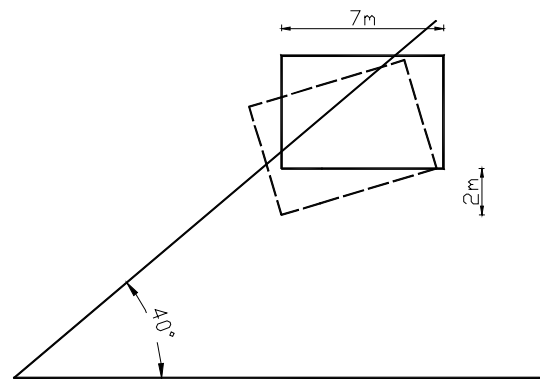
The slope that slid has height about 30m from the sea level, inclination about  $40^\circ$  and its toe is in the sea (Figs. 8a, 8b). Laboratory tests on the laboratory of the author revealed that the soil of the slope is a low-plasticity clay (classified as CL) with Liquid Limit 37%, Plastic Limit 23%, Plasticity Index 14% and percent of fines 57%. The slope slid by 5m at a region of about 30m. The slide had considerable depth, about 5m.

A two-floor building was on the slope. The building, of reinforced concrete, was recently constructed. The building was constructed by excavating the side of the hill and constructing a side retaining wall. As a result of the slide, the building was separated from a wall by settling by about 1.5m and rotating by about  $15^\circ$  (Figs. 8a, 8b, 8c). The wall practically did not move (Fig. 9a). Even though the displacement and rotation of the building was considerable, the building did not collapse. Yet, it suffered severe cracks and wall movements (Fig. 9b).

Fig. 8. Slide as a result of heavy rain in 2003 near Chora in Skyros: (a) the slide, (b) the rotation of the building, (c) Schematic diagram of the effect of the slide on the building (Stamatopoulos C. and Stamatopoulos A., 2005).

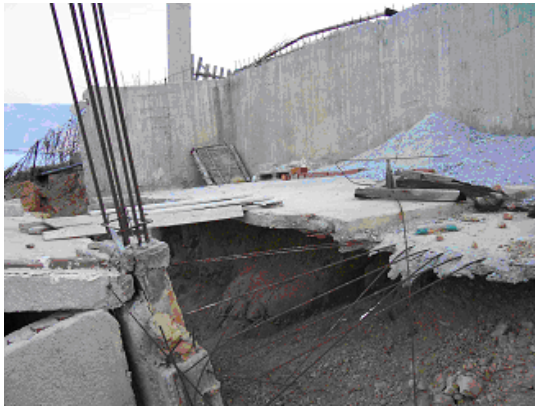
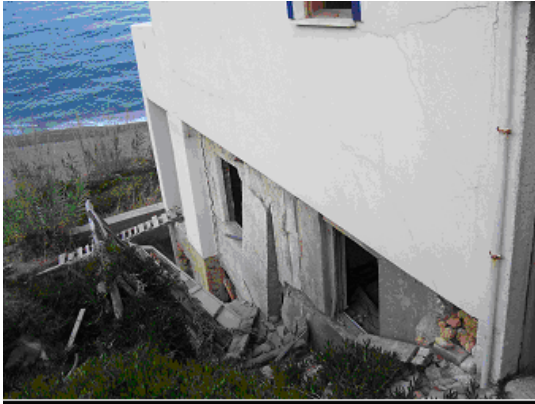
Fig. 9. Slide as a result of heavy rain in 2003 near Chora in Skyros: (a) separation of the building from the lateral wall and (b) damage of the building.

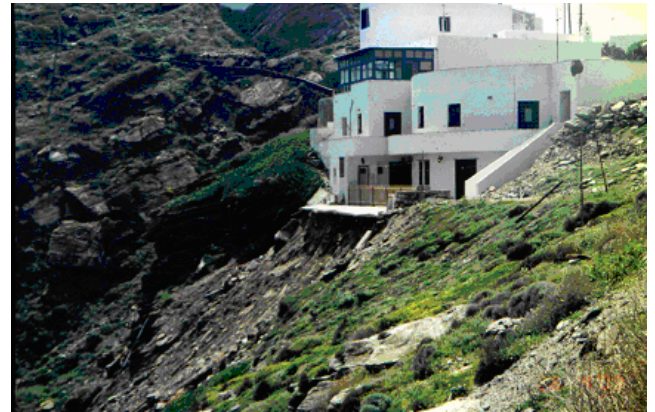
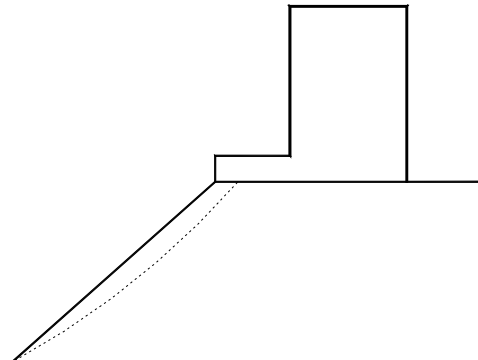
The sliding surface was approximately parallel to the slope and at a small depth from the surface, about 2 m. Ground displacement was about 5m (Fig. 10a).

A two-storey small house was near the edge of the slope. The building was recently constructed, of reinforced concrete. As illustrated schematically in Fig. 10b, the sea side of the structure formed a veranda slab that was left in the air for about 1m. The width of the building is about 10m and of the veranda is about 3m. The small loads in the veranda slab that was left "in the air", as well as the strength of the concrete may explain why the slab was not destroyed as a result of the "undercutting" of the soil.

Fig. 10. Structure on slide as a result of heavy rain in 2003 at Kastro, Sifnos (a) Photo (Stamatopoulos and Stamatopoulos, 2003) and (b) Schematic diagram of the effect of the slide on the building.

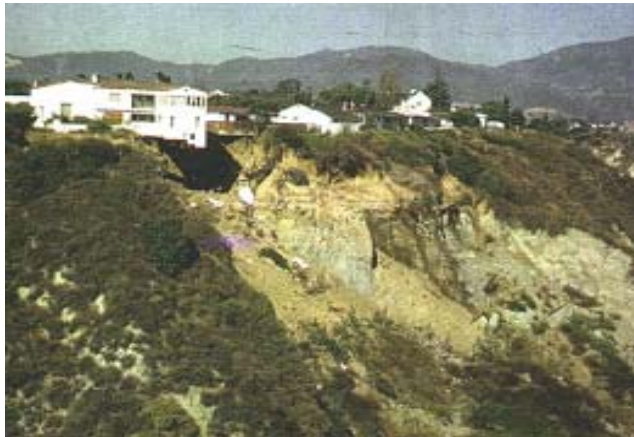
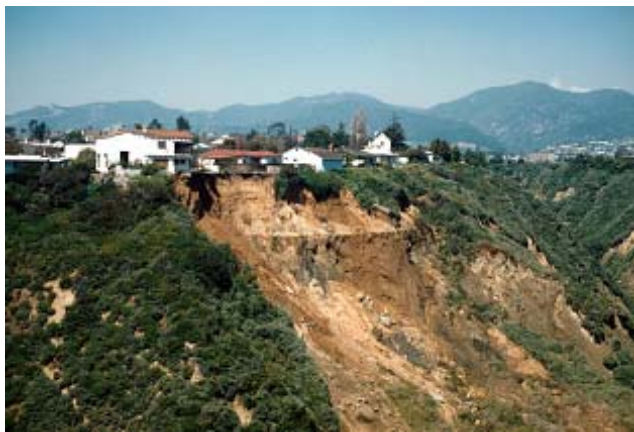
The slide was shallow. It had a depth of 3 - 5m. Ground displacement was about 7m (Fig. 11).

A two-storey building was at the surface, near the edge of the slope. As illustrated in Fig. 11, the edge of the building, over about 3m, out of total width of 15m, was left "in the air". The building did not collapse and was not severely damaged.

Furthermore, a one-storey building was at the surface, near the edge of the slope. As illustrated in Fig. 11, the edge of the building, over about 1.5m, out of the total width of about 8m, after the slide was left "in the air". The building did not collapse and was not severely damaged.

Fig. 11. Structures affected from a slide as a result of heavy rain in 1956 at Pacific Palisades –Potrero Canyon - De Pauw Street, California ([http:// geology.wr.usgs.gov/wgmt/elnino/scampen/examples.htm](http://geology.wr.usgs.gov/wgmt/elnino/scampen/examples.htm), 2006, <http://www.glifff.org/usgs/listing/8692>, 2006).

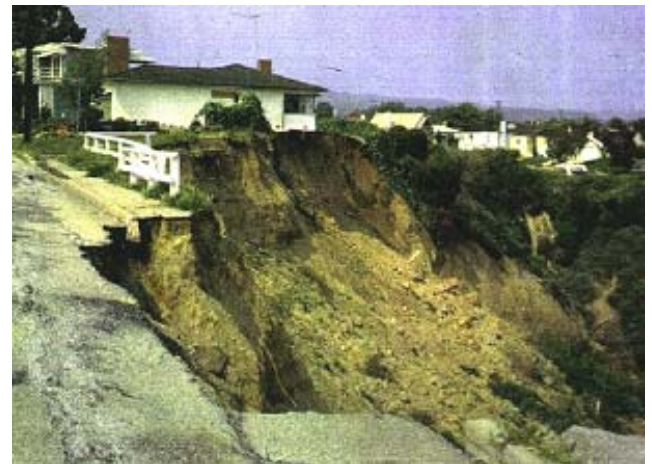
The slide was shallow. It had a depth of 3 - 5m. Ground displacement was about 6m (Fig. 12).

A one-storey building was at the surface, near the edge of the slope that slid. As illustrated in Fig. 12, the edge of the

building, over about 1m, out of the total width of about 5m, was left "in the air". The building did not collapse and was not severely damaged.

Fig. 12. Structure affected by a slide as a result of heavy rain in 1969 at Palisades –Potrero Canyon - Friends Street, California ([http:// geology.wr.usgs.gov/wgmt/elnino/scampen/examples.html](http://geology.wr.usgs.gov/wgmt/elnino/scampen/examples.html), 2006)
