Bloomfield Road Stormwater Storage Tanks Grouting Works, Blackpool, UK

Seventh
International Conference on
**Case Histories in
Geotechnical Engineering**

**BLOOMFIELD ROAD STORMWATER STORAGE TANKS GROUTING WORKS,
BLACKPOOL, UK**

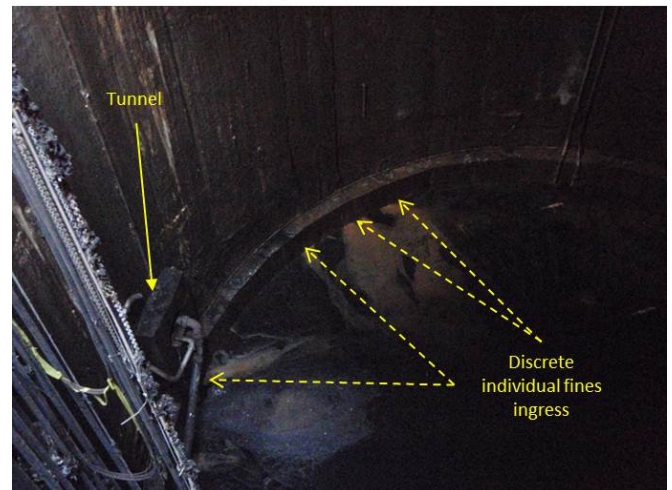
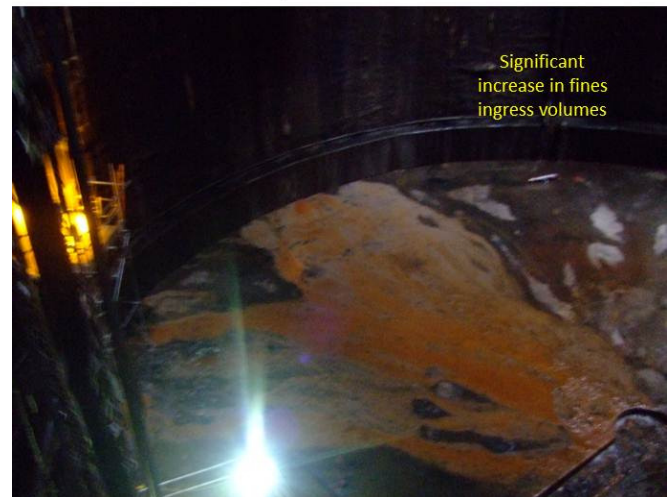
Since 2001 groundwater has been reported flowing into one of the tanks, Tank 2, around the joint between the base and a corbel ring beam which transfers groundwater uplift loads from the base to the diaphragm walls. Groundwater ingress with minor fines, dissolved mineral content and turbidity has increased since 2001. Inflows in 2010 were observed between 4l/s and 48l/s and averaging 18l/s. Between 2008 and 2010 an increase of fines ingress was also observed (Fig. 3).

Fig. 3 – Notable increase in fines ingress volume between March 2008(a) and March 2009 (b)

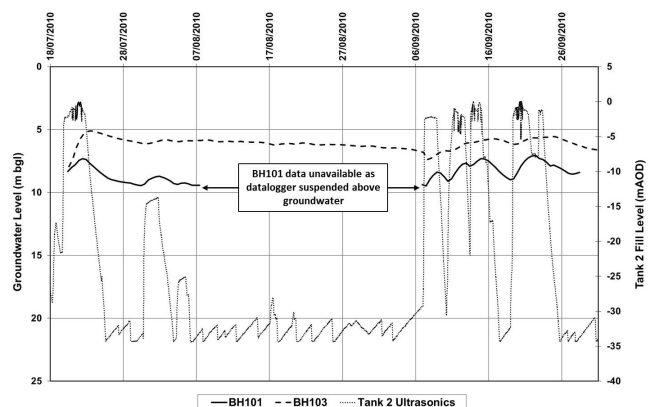
Fig. 7 – Groundwater Monitoring within Boreholes BH101 and BH102

Groundwater monitoring indicated a lower level to that previously recorded during pre-construction investigations. It was also established that groundwater levels increased rapidly during storm events (indicated in Fig. 7 by the rapid increase in tank fill levels). There was a discernible difference in the rate of groundwater level reduction between the two boreholes following storm events; groundwater levels falling more rapidly in BH101 compared to BH103. BH101 was constructed close to the greatest point of observed ingress and as such it was considered that the increased rate of groundwater level reduction was attributable to inflows within the tank.

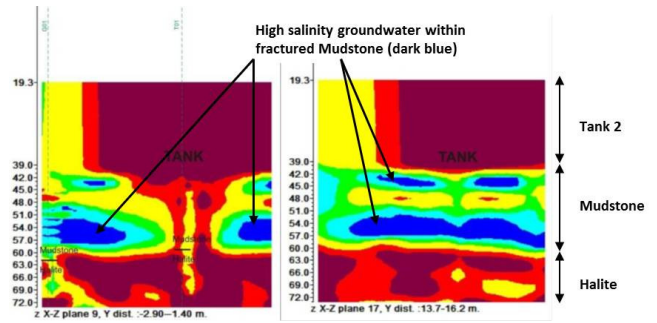
Fig.9 - Example of CHT interpretation indicating high salinity flows through fractured/fissured Mudstone

Results from the CHT survey indicated high chloride groundwater flow through the mudstone. It was concluded that significant halite voiding was not present (Fig. 9).

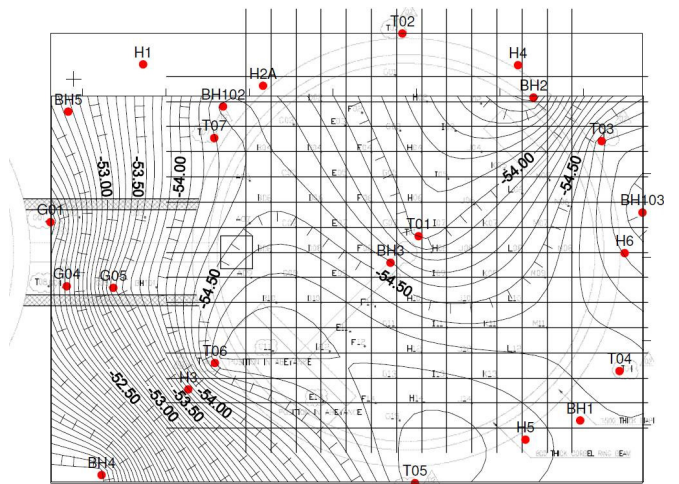
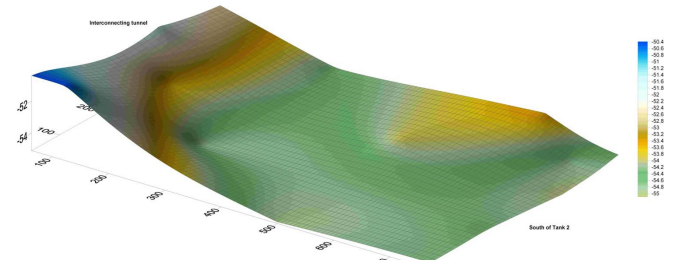
CHT and physical borehole data was interpreted to map the Mudstone Halite interface within the footprint of the tank (Fig. 10). In turn this data was used to schedule final depths for grouting boreholes within the Mudstone and avoid unnecessary penetration of the Halite.

Fig. 10 – Mapped Mudstone Halite interface (above, contour plot to mAOD; below 3D visualisation)

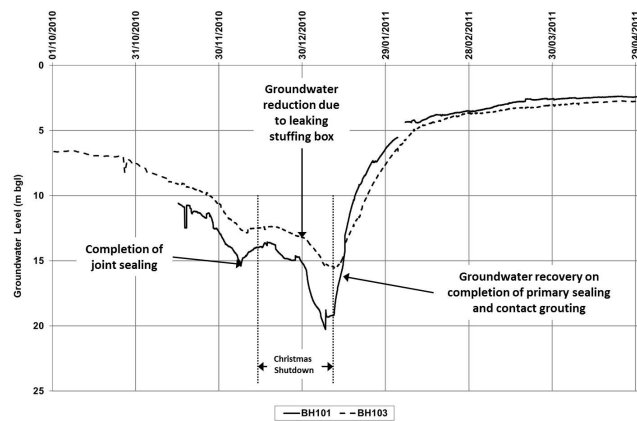
During these drilling operations an initial rapid reduction in external groundwater levels was observed (Fig. 11) due to the resultant temporary increase in inflow in to the tank. The injected resin grout resulted in an effective temporary seal against groundwater inflow. On completion of these sealing operations, combined with initial contact grouting beneath the base slab (see below), a rapid recovery of external groundwater levels was observed (Fig. 11).

Fig.11 – Rapid External Groundwater Recovery on Completion of Primary Sealing

Primary base joint sealing works were undertaken to seal the joint between the base slab, diaphragm wall and corbel ring beam to stem the observed groundwater inflows. These works commenced with the drilling of inclined small diameter

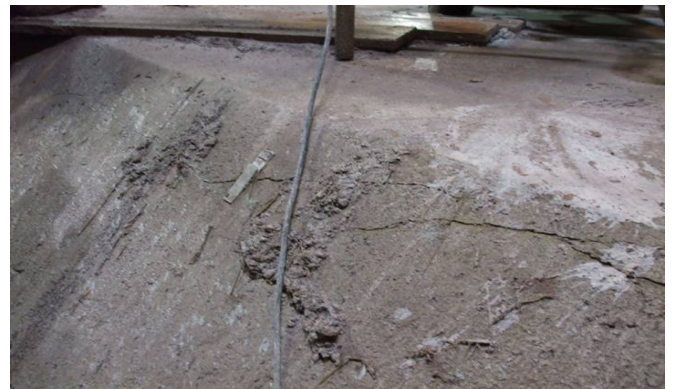
initial construction as per the original design. During grouting operations surface concrete cracking was observed around the sump (Fig. 15) within the limits of imposed displacement. On observing this cracking grouting works were temporarily suspended pending review. The engineering team concluded that the observed distress, to a relatively inflexible area of the base slab, had been induced as a result of the observed rapid recovery of external groundwater uplift pressures. It was suspected that the base slab had never realised full uplift pressures that might have contributed to the distress observed. With continued grouting operations monitoring indicated no further progression of the observed distress confirming adequate initial base slab design. Concrete repairs were undertaken to make good the slab.

Fig. 15 – Cracking to tank base slab in vicinity of the sump.

Post treatment internal inspections demonstrated the successful stemming of observed groundwater ingress. Also, no further progression or deterioration of concrete cracks to the base slab was recorded.

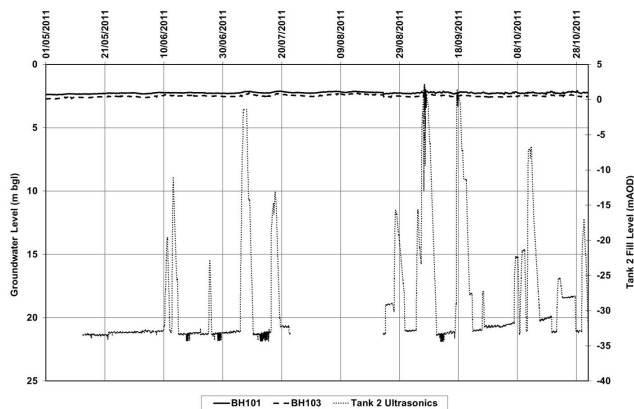
Continued groundwater monitoring following completion of site works indicated continued recovery to levels comparable with those demonstrated during pre-construction investigations (Fig. 16).

Fig. 16 – Post Construction Groundwater monitoring
