International Conference on Case Histories in Geotechnical Engineering (2008) - Sixth International Conference on Case Histories in Geotechnical Engineering

Repair of a Failed Slope Using Geogrid Reinforcement

Bureau of Road Research and Development, Department of Highways, Thailand

REPAIR OF A FAILED SLOPE USING GEOGRID REINFORCEMENT

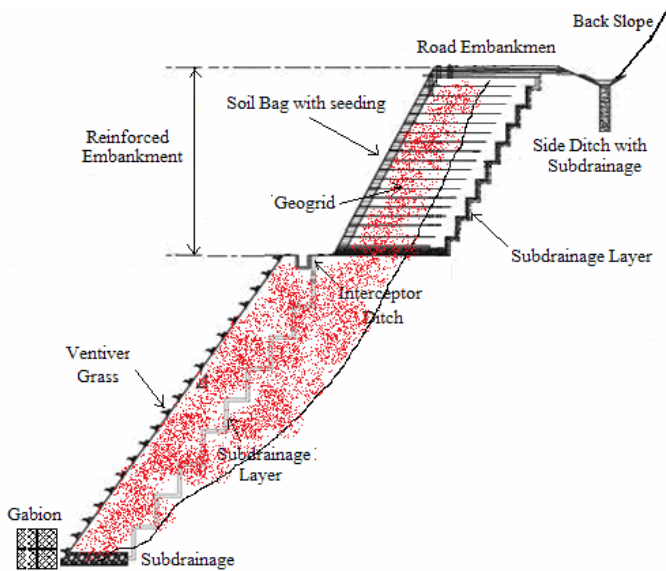
A test site with sloped embankment failure was selected and the failure characteristic is shown in Figure 1 and Figure 2. The failure occurred on December 2005 after the big raining. The failure occurred from the side slope in which the toe slope started to move. Then everything above including the road embankment was collapsed. One traffic lane disappeared causing difficulty and danger to road users. Thailand Department of Highways had the budget for the repair work and the reconstruction had begun.

Figure 1: Cross Section of the Sloped Embankment Failure

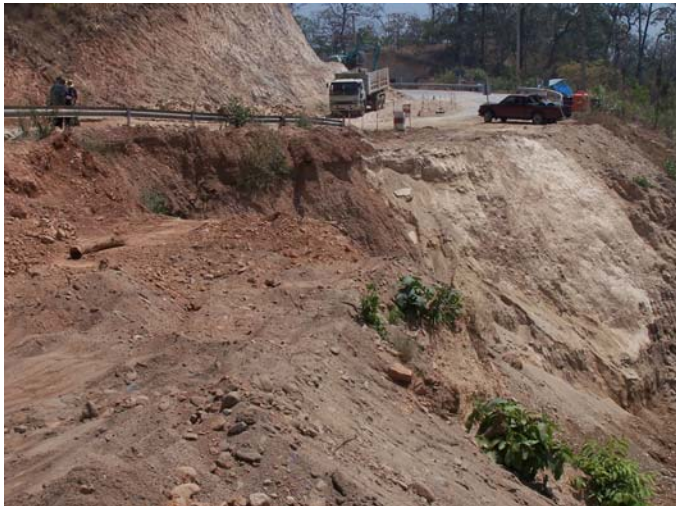
Figure 2: Site with Sloped Embankment Failure

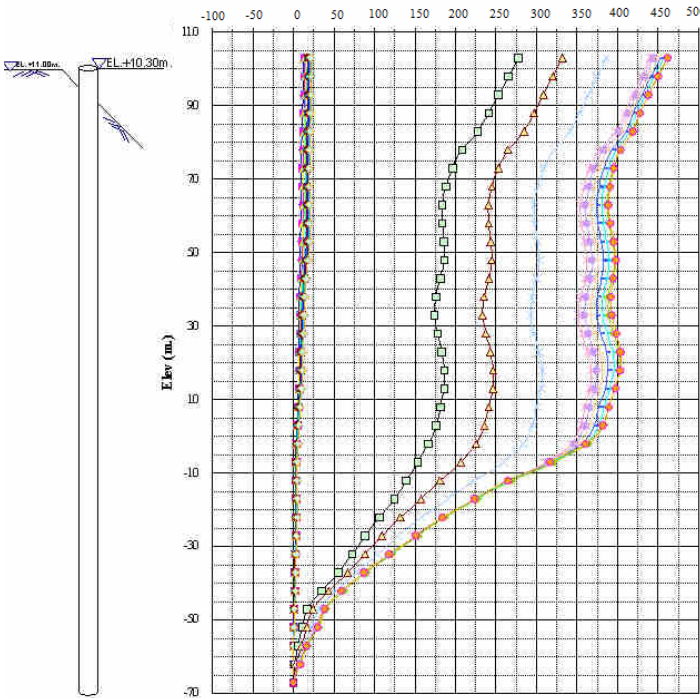
The horizontal displacements from inclinometer INC-02 and INC-03 are shown in Figure 4 and Figure 5.

Figure 4: Horizontal Displacement of INC-02 in millimeter

At 9 months after the reconstruction, the maximum horizontal displacement of the top berm was about 470mm, which it was quite similar for the bottom berm. When considering the

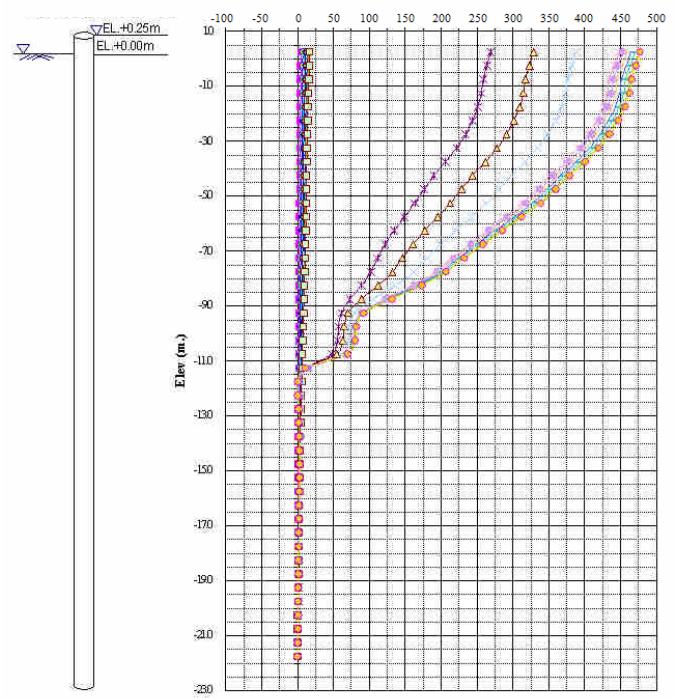
Figure 5: Horizontal Displacement of INC-03 in millimeter

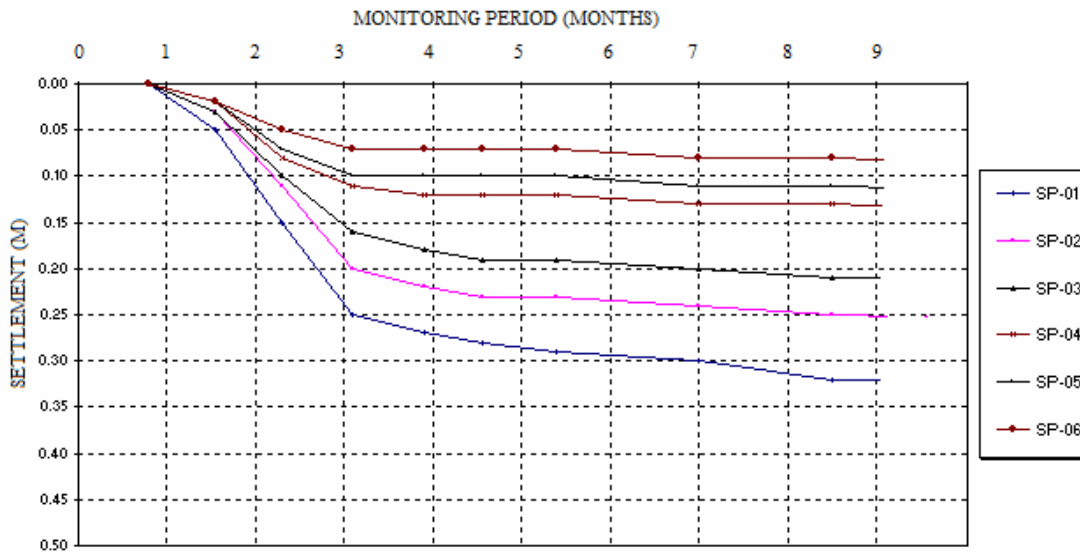
vertical settlement at the top of embankment, the reading from SP1-5 showed the maximum of 32cm settlement as shown in Figure 6.

The large horizontal movement and vertical settlement were expected to be due to the underground water, which lessened the soil strength. This was confirmed by the reading of the

Figure 6: The Settlement at the top of Embankment (SP1-5)

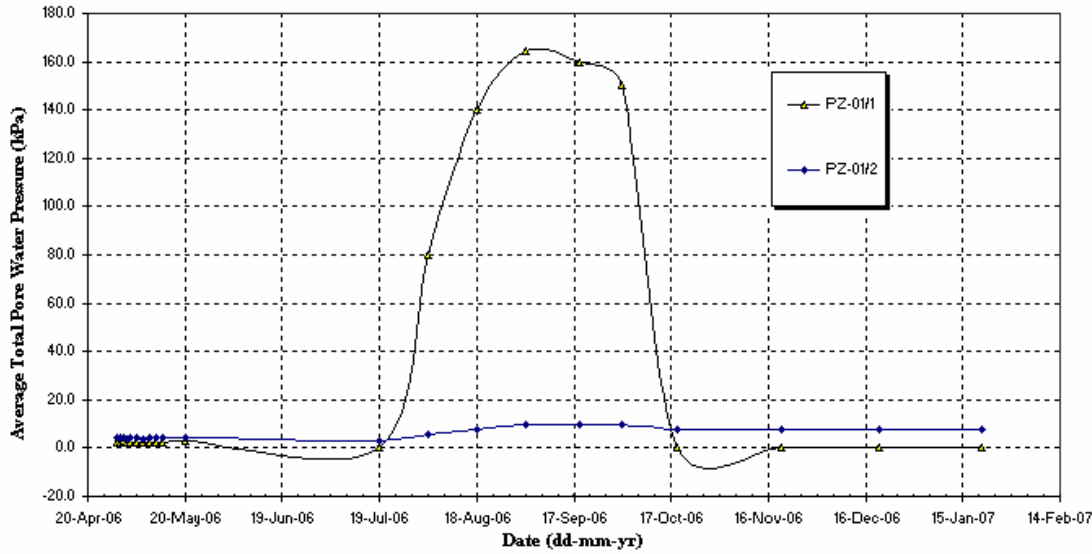
piezometers PZ-01 and PZ-02 as shown in Figure 7 and Figure 8.

Figure 7: The Water Pressure in kPa from PZ-01/1 and PZ-01/2
