International Conference on Case Histories in Geotechnical Engineering (2008) - Sixth International Conference on Case Histories in Geotechnical Engineering

Need for Prior Geotechnical Engineering Studies for Foundation Design: Cases of Collapsed Buildings in Port Harcourt and Environs, Nigeria

NEED FOR PRIOR GEOTECHNICAL ENGINEERING STUDIES FOR FOUNDATION DESIGN: CASES OF COLLAPSED BUILDINGS IN PORT HARCOURT AND ENVIRONS, NIGERIA

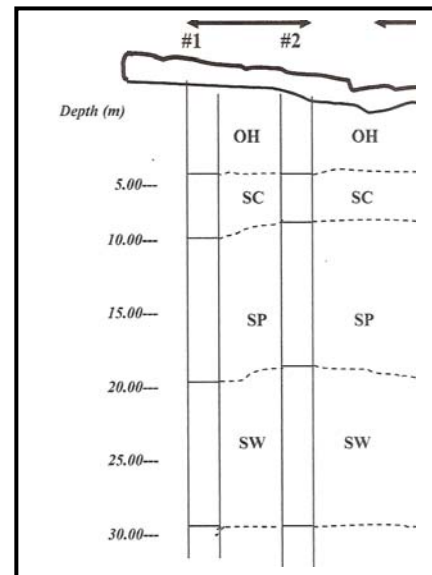
Fig. 5. Soil profile near the building site at Opobo.
