Foundation Failure of the St. Thomas Church, New Delhi

Devendra Sharma

Central Building Research Institute, Roorkee, India

SYNOPSIS - The St. Thomas Church was built in 1933 in New Delhi. By oversight it was founded on a graveyard having graves at two levels. The comparatively heavy rains of 1958 and 1964 showed wide spread damage by differential settlement and tilting of tower. During the investigations in 1959 by the Central Building Research Institute, Roorkee, the earlier history of the site and church was examined. It was found that excessive damage had occurred in 1943 also and underpinning of foundations and butressing of walls was done to arrest it. Collapse of graves below the foundations was the reason for damage which reoccurred, mainly in the portions which were not underpinned or partially underpinned. Effectiveness and feasibility of remedial measures vis-a-vis the soil investigations are discussed.

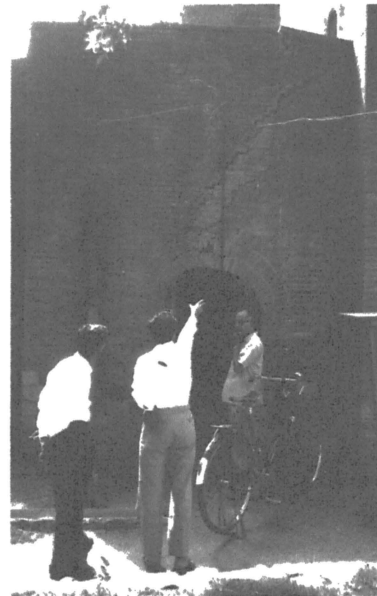
FIG.3 CLERGY VESTRY

Widespread cracking and sinking occurred after the heavy rains in 1958. The problem aggravated and in early 1959 the Central Building Research Institute was approached for investigations. It was observed that the tower had settled 4in to 6in (10cm to 15cm) showing cracks, wider at top and upto ground, at its junction with longitudinal and transverse walls of the church. The tower tilted away from the building towards the West corner. There was severe cracking of walls of the Clergy Vestry, Fig.3. Floor sills of stone and arches over doors and window also showed cracks. The entire portion comprising of the Choir Vestry, the Sanctuary and the Clergy Vestry separated from the Nave by tilting backward and showing through crack in the roof arch. Majority of cracks were slant along the diagonals. Differential settlements of floors showing sinking along the walls and heaved up centre were conspicuous.

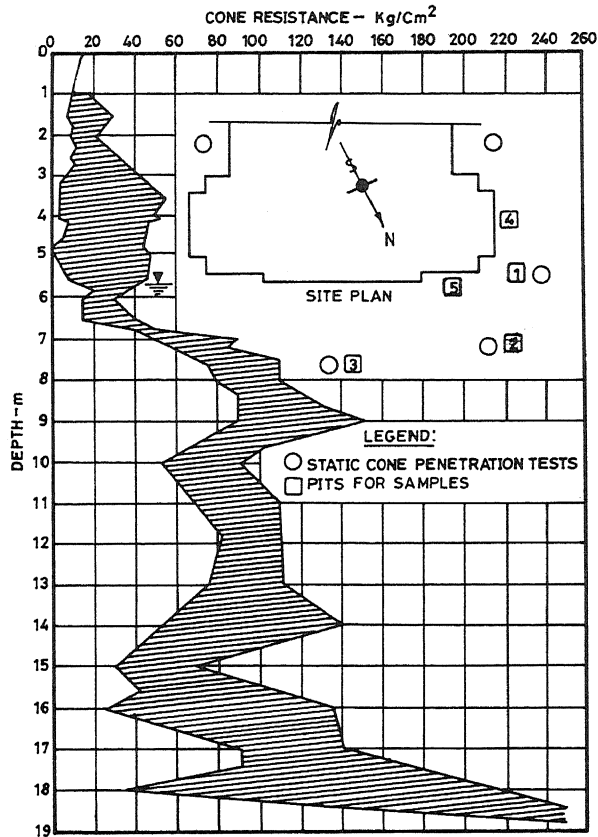
FIG.4 TEST LOCATIONS & STATIC CONE RESISTANCE

The Choir Vestry, the Sanctuary and the Clergy Vestry were the most cracked portions. The soil investigations were carried out near these portions. For undisturbed sampling three open pits were dug and five static cone penetration tests were carried out (Fig.4) in March-April 1959. The soil test data are summarised in Fig.5. Undisturbed samples were used for oedometer tests. Additional two pits close to the tower faces were dug for ascertaining the actual depth of the foundations and the examination of the strata. The depth of the foundation below the tower was confirmed at 4ft 6in (1.37m) below ground level. There was a clear evidence of filled up soil. In pit No.4 graves were encountered at 6ft 6in (2m) and 8ft 6in (2.6m) and in pit No.5, these were at 7ft (2.1m) and 8ft 6in (2.6m) depths below ground level.

collapse of hollows which were indicated by the penetration test showing little or no resistance at certain elevations and confirmed by open excavations. The scatter of curves indicate variability of a filled up ground (Fig.4).

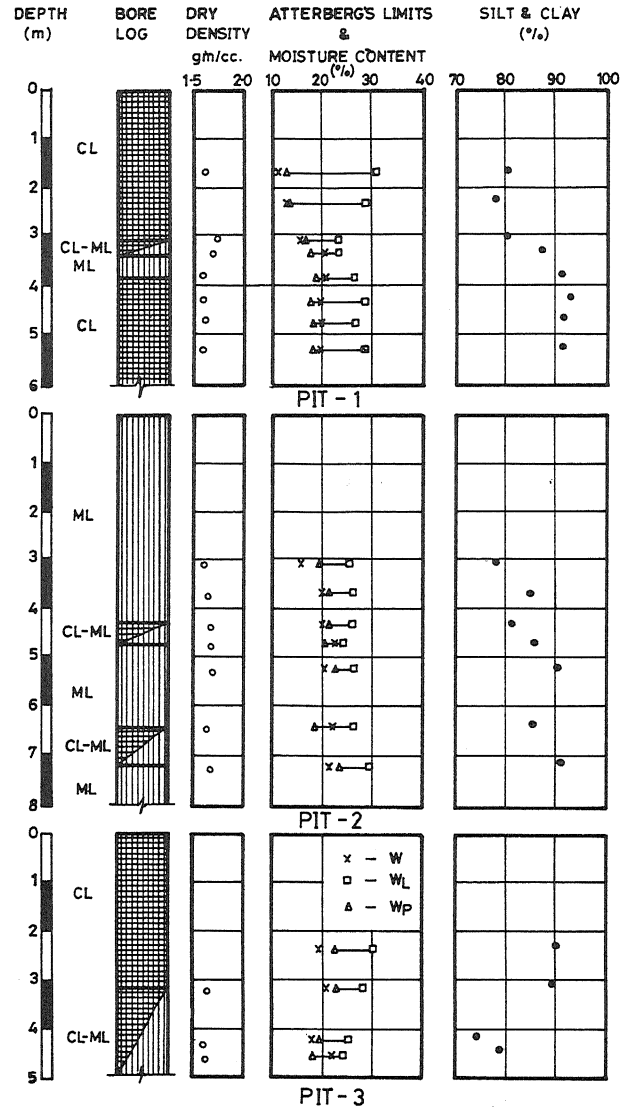
FIG.5 BORELOGS & SOIL TEST DATA

During the course of excavation a number of graves were encountered as indicated in two typical sections (Figs.5 & 6). Barring a few cases, there are two levels of burials at about 2m and 2.6m. It was on record that a pit dug at the Clergy Vestry near the West face revealed a burial at 11ft 3in (3.4m) alongwith an earthen pot containing an egg and two coins of 1835 and 1838, East India Company. The typical orientation, head towards West (direction of the holy 'Kaba') was clearly suggestive of the Muslim burials.

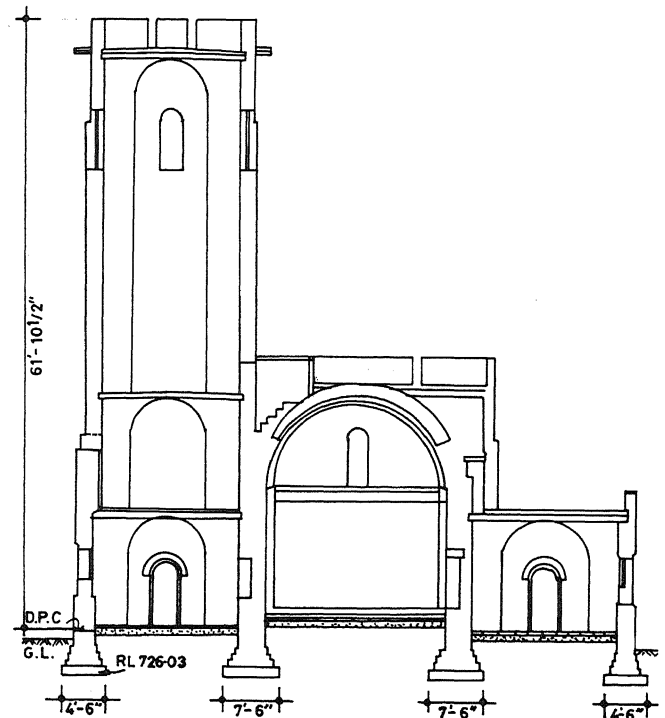
FIG. 8 SECTION ON CC

It is worth noting that more damage of sinking and cracking was noticed in 1958-59 in the tower and sanctuary portions which were not on foundations strengthened by underpinning (Fig.8). The Clergy Vestry was partially underpinned at the corner and this resulted in substantial damage. The underpinned corner remained in position while the adjacent portions showed sinking along with the backside wall of the sanctuary.

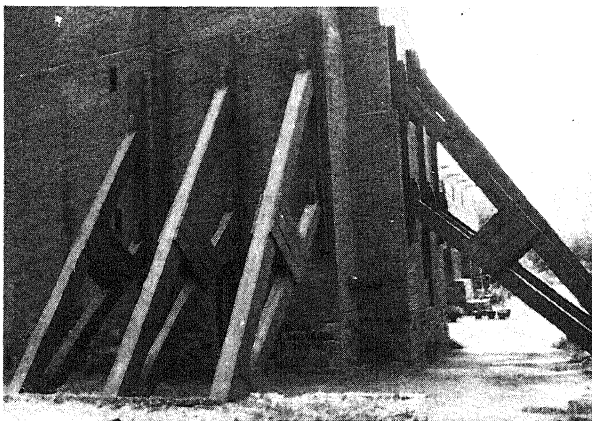
FIG.9 SHORING AT TOWER

In 1959-60 shoring in Fig.9 was done at the two outer sides of the tower and similarly at the Clergy Vestry walls. The support for shoring at the ground is derived from shallow concrete filled trenches. This shoring has outlived its useful life and as seen in 1986 it is partially rotten and now a relic from the past.
