Slope Stability Evaluation for an Existing Steep Cut in Weathered Volcanics, Hong Kong

SYNOPSIS : This case study concerns an investigation of a major existing soil slope. It is a 60m (197 ft) high cutting slope, at 40 degrees to 60 degrees to the horizontal, exhibiting a considerably greater degree of stability than was obtained by a series of geotechnical investigations and analyses.

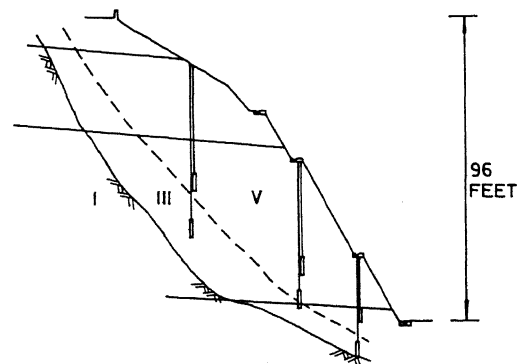
Fig. 1 Lower Slope Section Showing Horizontal Drains and Piezometers

The deeper zones of weathering also exhibited permanent ground water. Horizontal drains installed along the deeper zones of weathering, and the drains which intercept these zones at depth were found to yield a permanent flow of

ground water during dry seasons. The presence of these deeper zones of weathering and fracturing and their inferred attitudes indicates that they serve as preferred paths where ground water from both regional and local sources could be concentrated. In areas associated with these zones, a seasonal rise of ground water is evident from both piezometer monitoring and from seepage stains beneath horizontal drains.

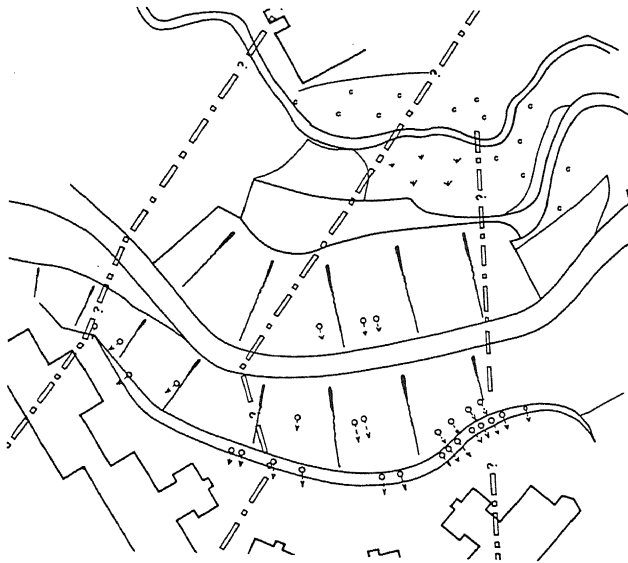
Fig. 2 Site Plan Showing Zones of Deep Weathering

The unusually large number of borings already drilled prior to this study facilitated to the early development of a geological model of the complex subsurface conditions. From the interpretation of aerial photographs, geological site surface mapping, and review of existing borehole data and ground water level monitoring, three major zones of deep weathering were considered to extend across this area (Figure 2). Correlation of field mapping and borehole data suggested that these zones of deeper weathering were probably shear or fracture zones in the rock mass.

The thickness of the materials in the weathering profile varies across the study area. The transitional zone is thickest in the area of deep weathering associated with closely spaced fracturing and shearing of the rock mass.

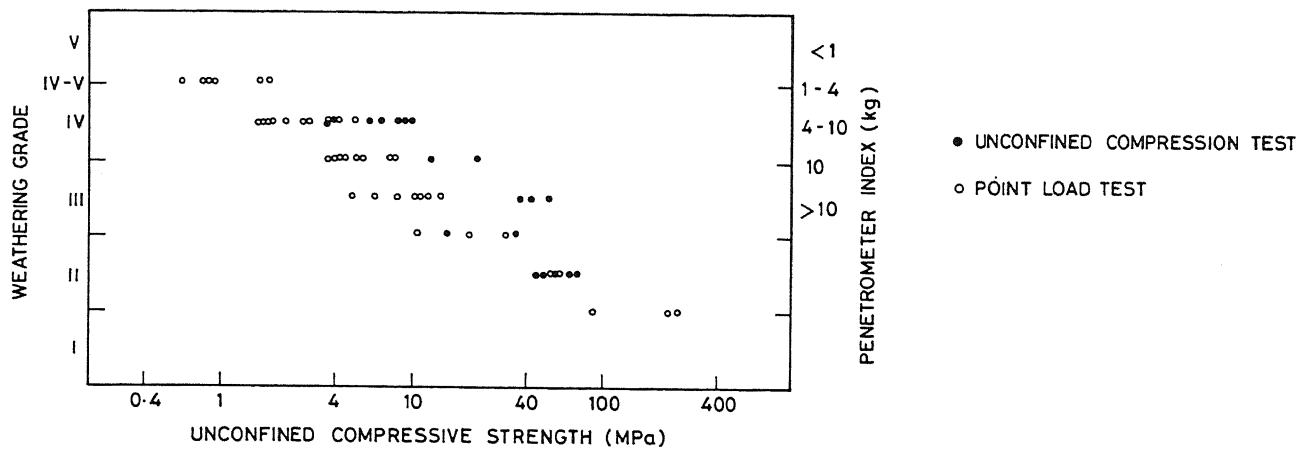
Fig. 3 Index Strength Test Results (After Kwong 1985)

Additional fieldwork was carried out for this study. 12 vertical and 4 horizontal drillholes were each selected for a specific purpose such that the geological features of the site can be defined. During the course of the field exploration, the locations of some of the later holes and test pits were revised as a result of the information obtained from the first few holes and test pits. Core samples of soil, transitional material and rock were obtained using a Mazier retractable triple tube core barrel. Block samples of weathered rocks were collected from trial pits and exposed areas on the existing cut slope. Grades of weathering were classified by visual examination and a pocket penetrometer modified for testing strong materials was used to provide a quantitative index strengths of materials which had undergone different degrees of weathering (Figure 3), (Kwong et al., 1984).

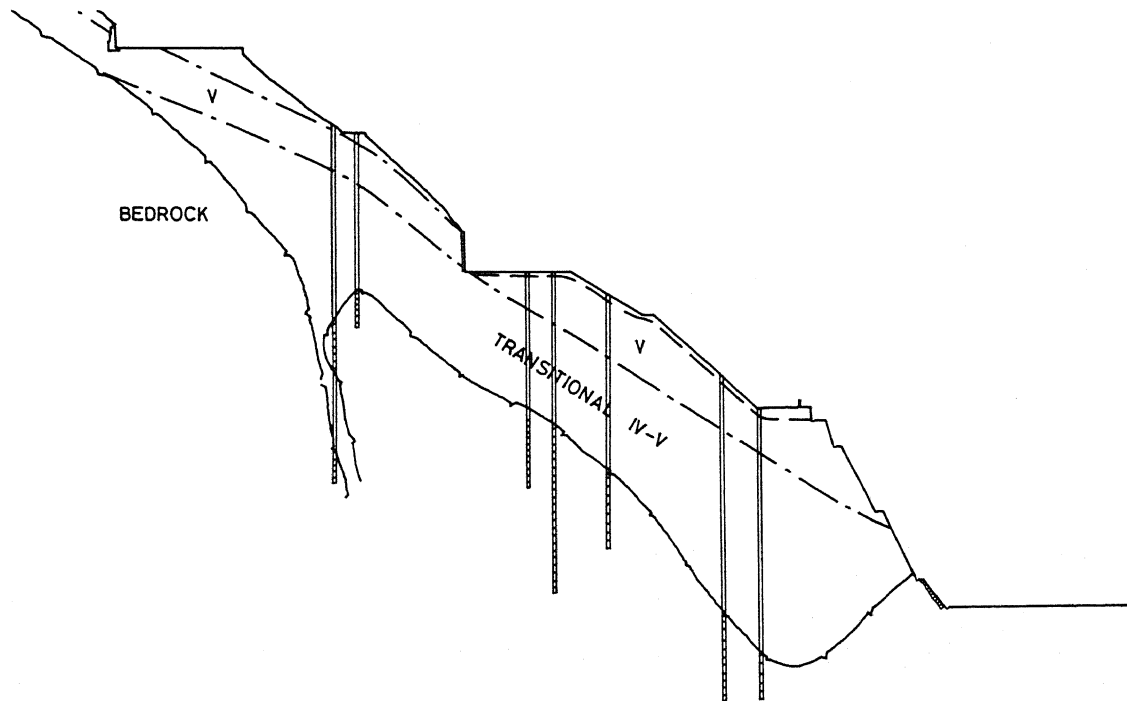
Fig. 4 Cross Section of Slope

The volcanic and granite rock mass at depth is generally grade III. Except along major stream courses, to either side of the site, a weathering mantle capped by thin colluvium covers the study area. In most areas, where a soil to rock interface exists, the rock is grade III to IV. The soil to rock interface is a transitional zone comprised of grade IV to V material. The transitional materials usually have high SPT "N" values (N=80 to >200) and when soaked in water, only the disturbed part of the sample disintegrates. A layer of grade V volcanic soil generally overlies this transitional zone (Figure 4).

The zones of the slope classified previously as soil were found to consist primarily of grade IV, transitional, and grade V weathered volcanic rock. The deeper weathering profile is believed to be controlled by a very complex geological condition. Detailed logging of recovered rock cores and petrographic examination of thin sections prepared from rock samples indicated that the welded tuff was

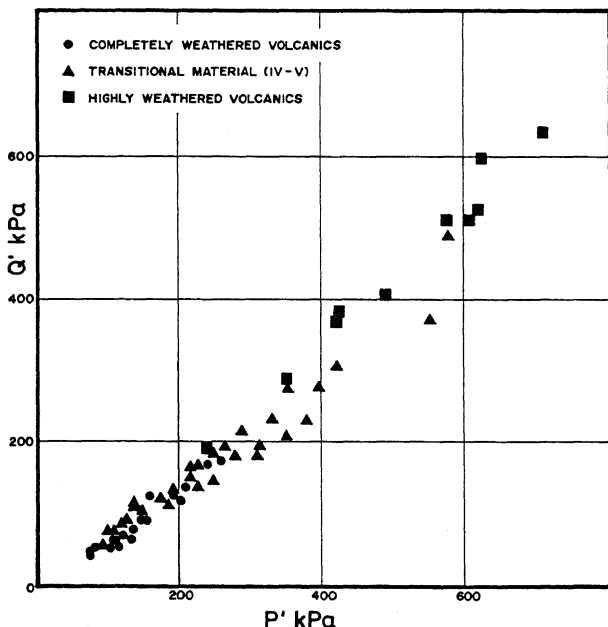
Fig. 5 Triaxial Strength Test Results

The strength parameters for grade V, transitional, and grade IV materials were obtained by performing consolidated drained triaxial tests on Mazier samples (Figure 5), Table 2. Point load strength tests and unconfined compression tests were carried out using NX size cores, (Figure 3).

Type	c' (kPa)	ϕ' (deg.)
Grade V	9	37
Transitional	18	39
Grade IV	34	42.5
