Foundation Strengthening and Protective Measures for Sri Sangameshwar Temple at Kudal Sangam, Karnataka

Devendra Sharma
Central Building Research Institute, Roorkee, India

SYNOPSIS : Sri Sangameshwara temple situated at the confluence of two rivers developed noticeable tilt. Also the temple site be inundated by the back waters of the dam during floods. An elaborate plan of dismantling the temple and reconstructing it by the same stone pieces and statuary could be carried through partially only and the sanctum sanctorum portion housing the 'Lingam' had to be retained. Now the entire temple is to be reconstructed as and where it was. The temple was founded on a boulder plateform with heterogeneous river deposits below it. Honouring the constraints of uninterrupted daily worship rituals in the temple and the underside of the pedestal supporting 'Lingam' not to be disturbed, strengthening by providing a double row of piles around the existing structure and a protective wall around the site were recommended. The choice and design aspects of these measures are discussed.

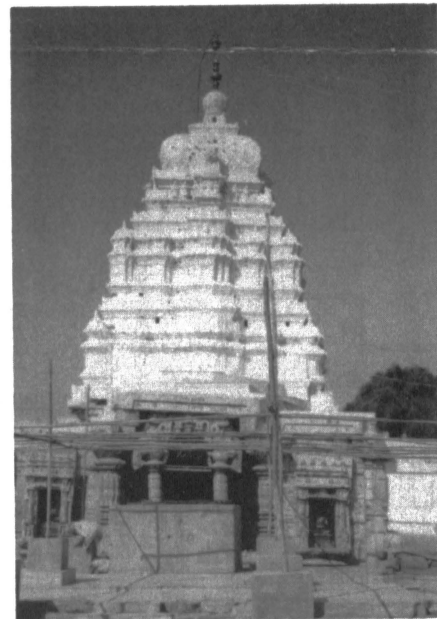
FIG.2 Front view of the temple

The differential settlement at the base and tilt towards north of the temple are noticeable (Fig.2) on viewing from east and west. The

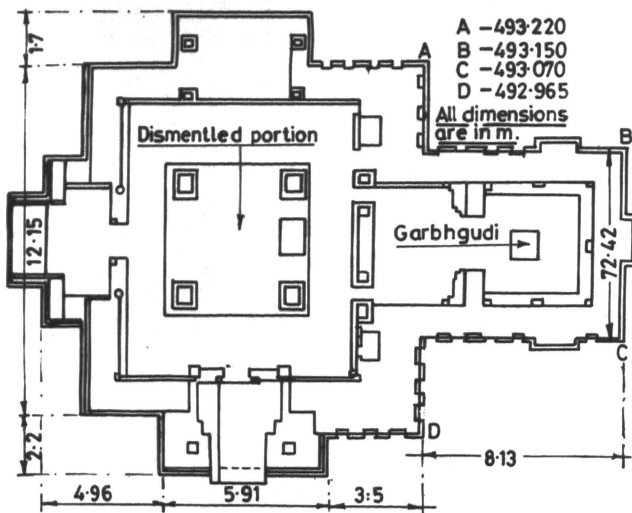
FIG.4 Temple plan

levels on the four corners of the existing structure taken in 1987 (Report, 1987) are shown in fig.4 and these showed no change during the period of three years upto 1990. The tilt of the back side between B and C towards north is 1 in 84 and between A and D is 1 in 51. The tilts show that there is tilt towards east also. The difference of levels between points B and C is 0.08m. As the temple is with massive walls with tapering top with a series of corbels, the entire structure may be considered to tilt by the same amount as its base. The overall tilt and general ground slope are in the same direction i.e. the north/north east.

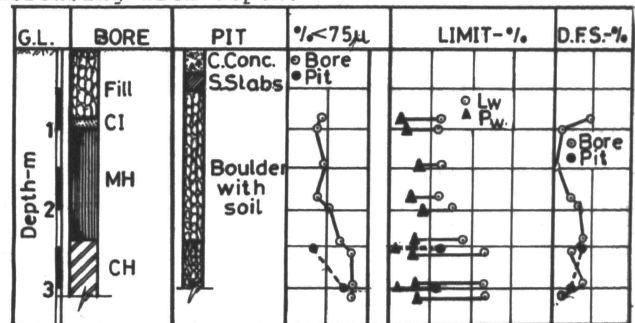
FIG.5 Bore log and pit data

The borehole made by augering and a pit dug at the site (Fig.1) showed strata as given in Fig.5. There is a trend of increasing finer fractions, higher liquid limits and swelling with depth. The lower strata soils in borehole and the soil in the interspaces of the boulders below the temple are of compressibility increasing with depth.

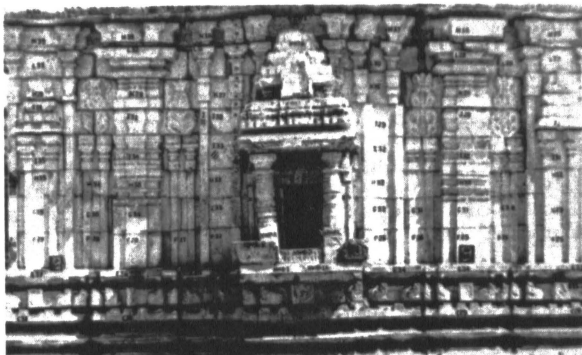
FIG.7 A view of back wall

The temple is several centuries old and no documented details except an original temple plan carved on a rock outcrop (Fig.6) at a place few kilometers away from the temple could be available. This plan is at the temple plinth level and if it is the complete layout, the original temple had only a smaller structure leading to the entrance of the sanctum sanctorum. Now diementled front portion within a square of about 16m sides (Fig.4) must be a later addition. A part of the originally constructed front is still retained (Fig.2). The sanctum sanctorum structure at its base is within 7.5m x 7.5m (Fig.4) and with a total height of 16m upto temple top above the present floor level. The granite stone masonry with exquisite carvings Fig.7 has a wall thickness of about 1m and is 5.6m high. The remaining tapering top structure is plastered brick work with moulding (Fig.2 and Fig.3). The estimated weight of the superstructure is 1130t. The masonry on outside showed signs of weathering, obliteration of stone carvings, opening of joints and dislocation of stones (Fig.7). The brick top was also reported to have cracks in the past and repaired.
