Hydrostatic Pressure at a Soil-Structure Interface

R. Craig Findlay

Senior Geotechnical Engineer, E.C. Jordan Co., Portland, Maine

SYNOPSIS: A case history of hydrostatic pressure development along the soil-structure interfaces of a water retaining structure is discussed in this paper to illustrate the use of instrumentation to verify expected performance during construction. For the project described, the development of hydrostatic pressure along the soil-structure interface during and after head pond watering was monitored using pneumatic piezometers. Monitoring of the piezometers detected a high hydrostatic pressure caused by a leaky contraction joint seal. Subsequent repair of the seal reduced water levels along the interface to expected levels, resulting in successful operation of the facility.

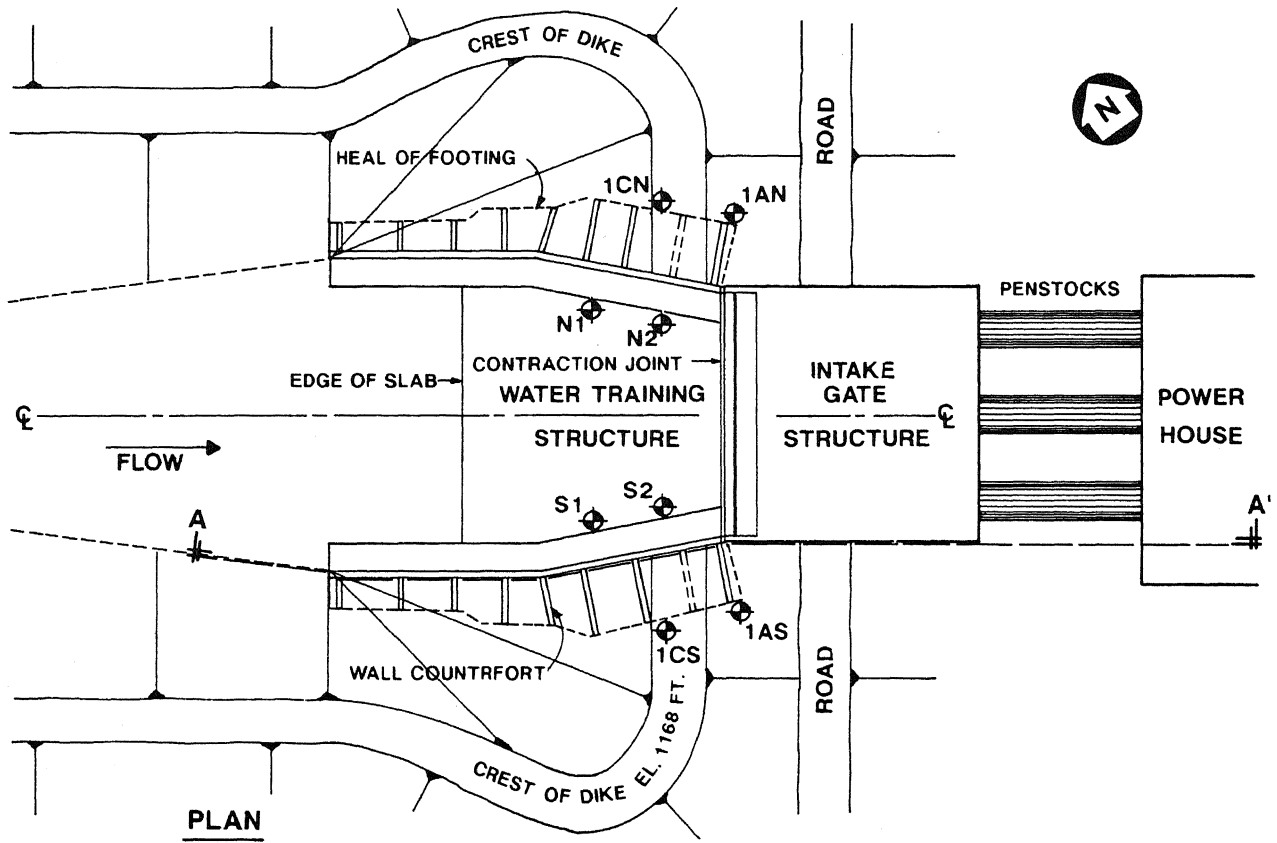
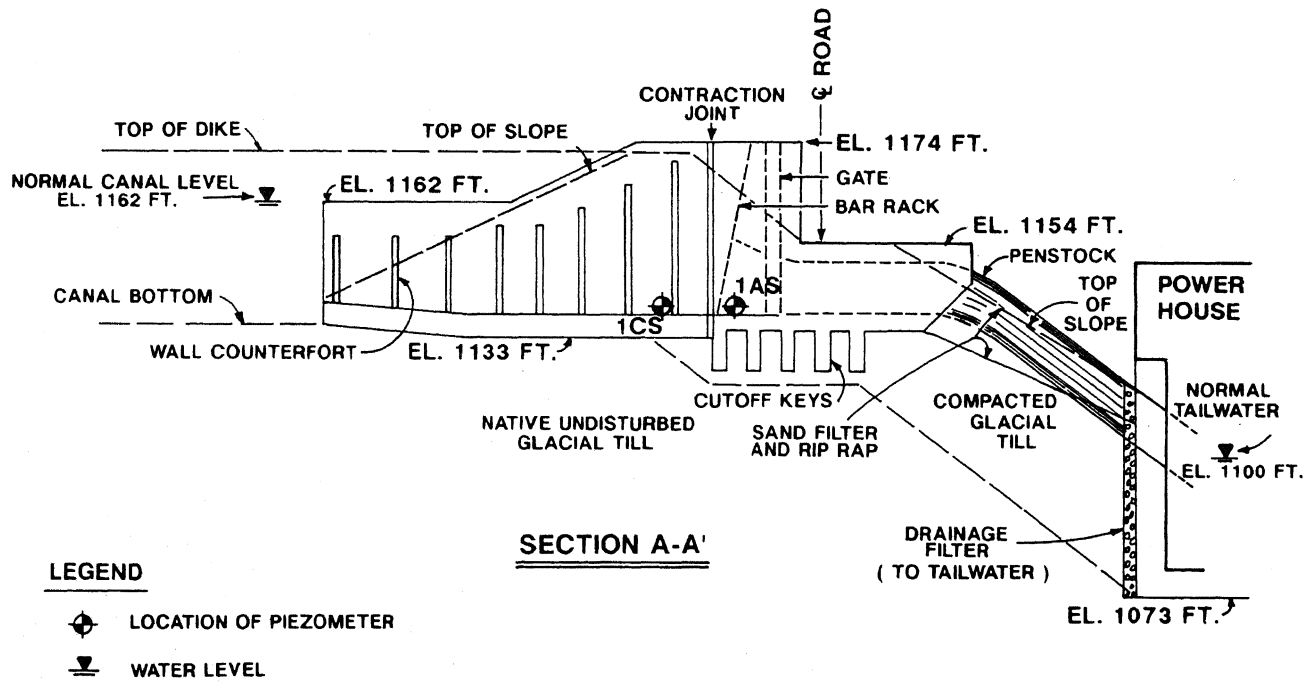
Fig. 1 Plan and Section of Penstock Intake Structure

This article focuses on the development of the hydrostatic pressure along the soil-structure interface between the canal dikes and the penstock intake structure. A schematic plan and sectional view depicting the configuration of the soil-structure interface along the penstock intake structure are presented as Figure 1.

The penstock intake structure was constructed on undisturbed and recompacted glacial till as shown on Figure 1. The canal dikes were constructed of recompacted glacial till excavated from the cut areas of the 6,000 foot (1829 m) long canal which channels water to the penstock intake. These dikes directly abut the penstock intake forming a soil-structure interface. The penstock intake was designed to have piping resistance by counterforting the structure side walls and provision of cut off keys along the base of the structure (see Figure 1), thus providing a serrated interface with the dike and base soils and effectively increasing the seepage path. Because of concern for piping potential along the soil-structure interface and the large head drop (62 feet or 19 meters) between the canal and tailwater, four pneumatic piezometers (two on each side of the intake structure, as located on Figure 1, denoted as 1CN, 1AN, 1CS, and 1AS) were installed to monitor the development of the hydrostatic pressure across the soil-structure interface during and after initial canal watering. The piezometers were the double tube type, with a pressure range of 0 to 60 pounds per square inch (0 to 4.2 Kg/cm²), actuated and monitored using dry nitrogen gas from a portable indicator box.

structure, were not adequately sealed. Dye was injected on the soil side of the seal in an effort to see if the zones of leakage could be positively identified. The dye came through the seal in numerous locations indicating an inadequate seal. Prior to identifying the leaky seal, there was concern that underseepage below the structure may have occurred, contributing to the high measured pore pressures. Down stream drains and ditches located at the toes of the canal dikes were inspected to see if and observable piping had taken place. No evidence of such piping was noted. Further investigation of underseepage was done utilizing pump tests. These tests were conducted by digging sump pits at the upstream edge of the water training structure base slab, followed by continuous pumping of the pits. The piezometers were monitored before, during and after the pumping to see if a response of the piezometers could be observed, which would indicate that underseepage might have occurred. The tests indicated no response. Based on all the observations, it was concluded that the cause of the high measured pore pressure adjacent to the contraction joints was leakage of the contraction joint.

The retrofitted seal was redesigned and repaired to accommodate the difficult sealing conditions. The revised seal was essentially identical to the original retrofit seal except that a 1/4-inch (0.6 cm) thick hydrophylic membrane material was placed behind the steel plate strips. This material swelled to almost double its original size in the presence of water, forming a positive seal between the concrete, Hyplon and the metal strips. To monitor potential development of hydraulic pressure which could be an indication that underseepage below the structure may have developed, four additional piezometers (numbered N1, N2, S1, and S2) were installed through the base slab of the training structure, located as shown on Figure 1, to measure hydrostatic pressure below the structure.

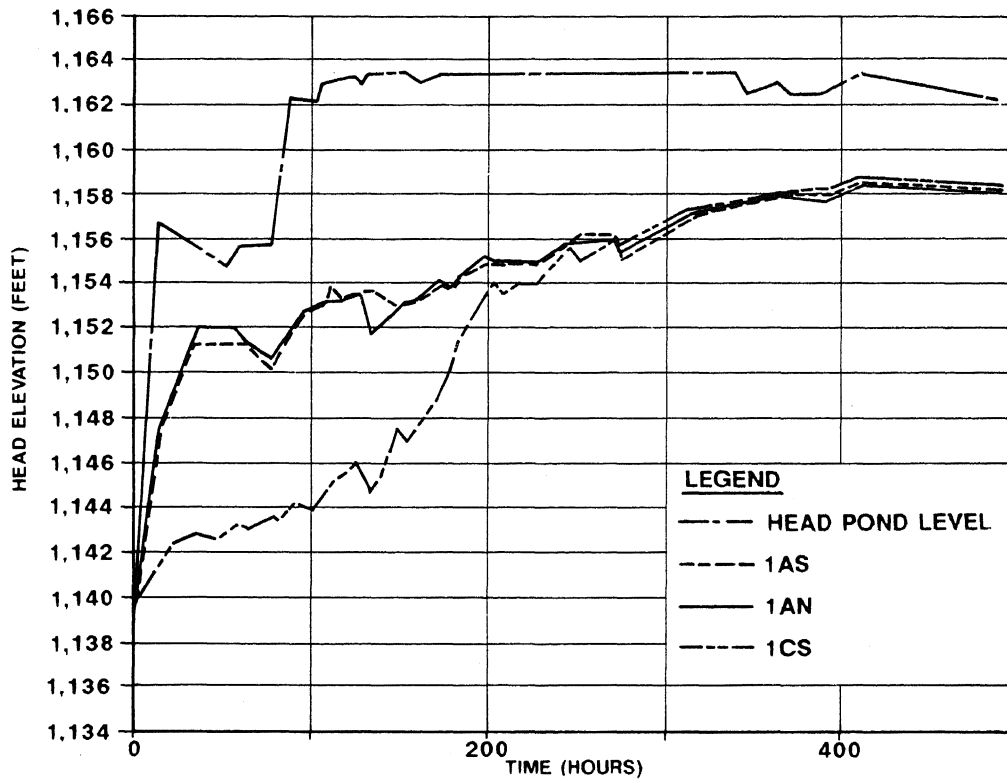
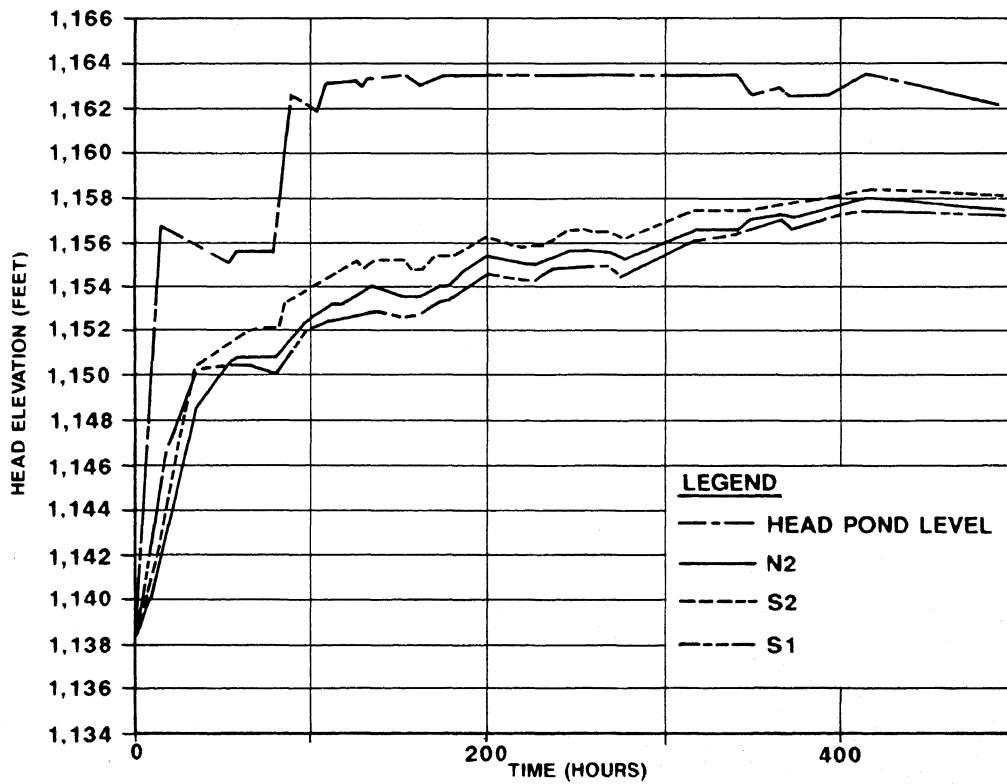
Fig. 2 Piezometer Response vs Head Pond Level After Final Seal Repair

After the modifications to the retrofit seal were made, the canal was refilled at an average rate of about 1.5 feet per hour (0.5 m/hr) to an elevation of about 1156 feet. During this refilling, the piezometers readings were monitored about once per hour, however, piezometers 1CN and N1 were malfunctioning and did not provide usable data. Readings of the functioning piezometers during the first 500 hours are presented on Figure 2. During the refilling, hydrostatic pressures as indicated by the piezometers remained below headpond level. Piezometer 1CS registered a head unexpectedly less than 1AS and 1AN, probably due to its somewhat more isolated location within the glacial till beside the structure and away from the flow path of least resistance which is likely to be along the bottom of the water training structure and then along the sides of the gate structure. After filling the confined headpond to elevation 1156 feet, refilling was terminated and the

elevation of the headpond was monitored with time over a 40 hour period. During this hold period, the piezometers initially indicated continued increase in the hydrostatic pressure at the soil-structure interface, generally followed by a leveling off or decrease in pressure. Also during the hold period, the headpond level decreased by 1.8 feet (0.5 m). The volume of water lost as indicated by the headpond level reduction was of the same magnitude as would be expected by the estimated normal gate leakage, so it appeared that leakage through the contraction joint had been substantially eliminated, reducing the previous concern that underseepage and piping may have developed during initial filling. After the hold period, head pond filling continued to about elevation 1162 feet, which was achieved about 100 hours after refilling of the headpond began. At this time, the cofferdam across the canal was removed.

The piezometers were closely monitored until it became apparent that steady state conditions had been achieved and that the contraction joint was not leaking. The hydrostatic pressure along the soil-structure interface, as indicated by the piezometers, appeared to come into equilibrium (indicating steady state flow) about 400 hours (17 days) after the headpond was filled, except for piezometer 1CS, which continued to rise for about 1100 hours, finally equilibrating about a foot or so in hydrostatic head above 1AN and 1AS. The final equilibrium levels of the hydrostatic pressure were at the approximate elevations predicted by steady-state seepage through an earthen embankment of similar profile to the soil-structure interface, however, this equilibrium occurred many magnitudes faster than would be indicated by the measured laboratory permeability (about 10^{-8} centimeters per second), indicating the permeability along the soil-structure interface is likely about 10^{-3} to 10^{-4} centimeters per second (2×10^{-3} to 2×10^{-4} ft/min). The piezometer readings were monitored frequently for a six month period to assure the steady state conditions remained constant, and that seal leakage did not restart. Currently monitoring is done on a seasonal basis by the station operators with no change from the expected steady state conditions as yet observed.
