## EXPERIENCES IN LARGE SLOPE STABILITY PROBLEMS UNDER COMPLEX GEOLOGY

**Camilo Marulanda**  
INGETEC S.A.  
Bogotá, Colombia

**Alberto Marulanda and Camilo Phillips**  
INGETEC S.A.  
Bogotá, Colombia

## CASE HISTORIES

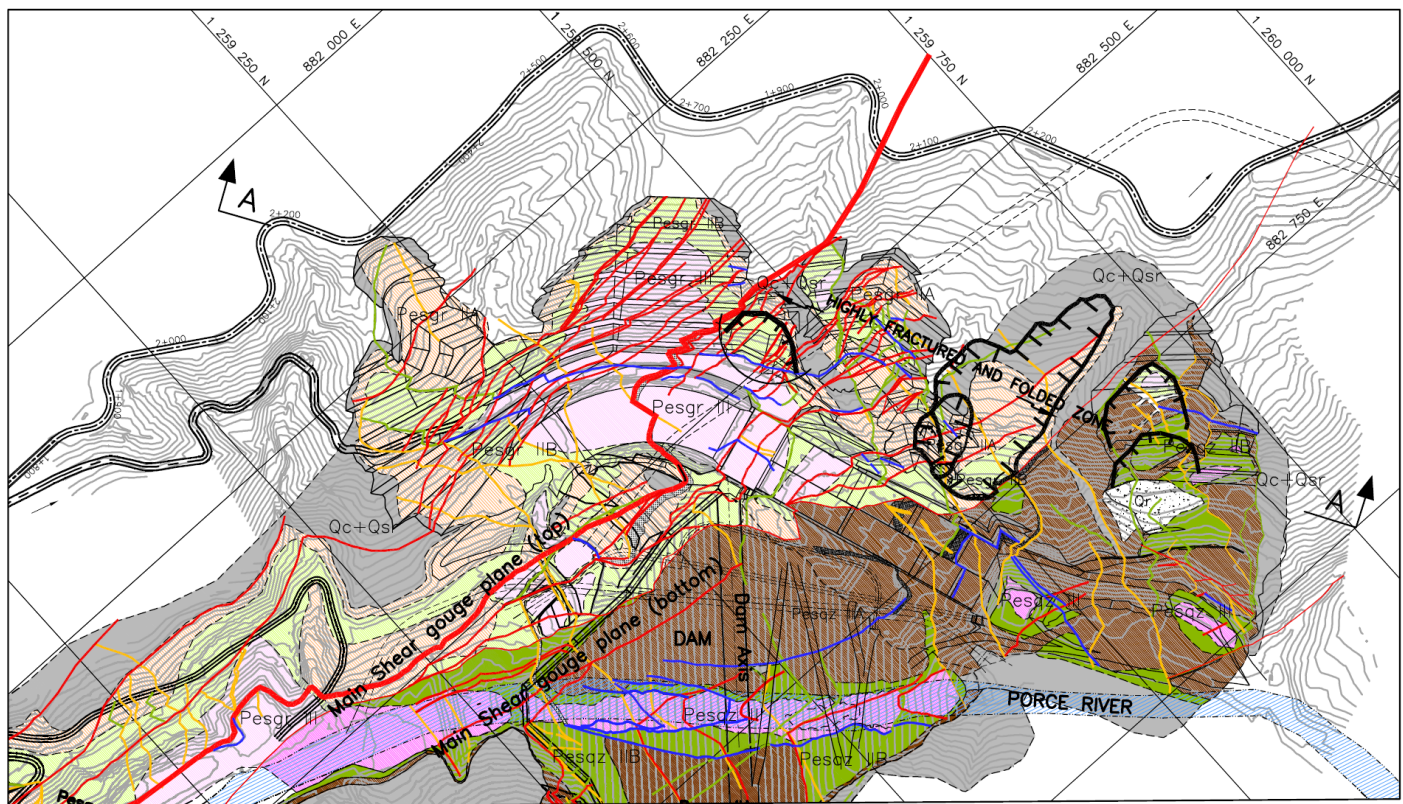
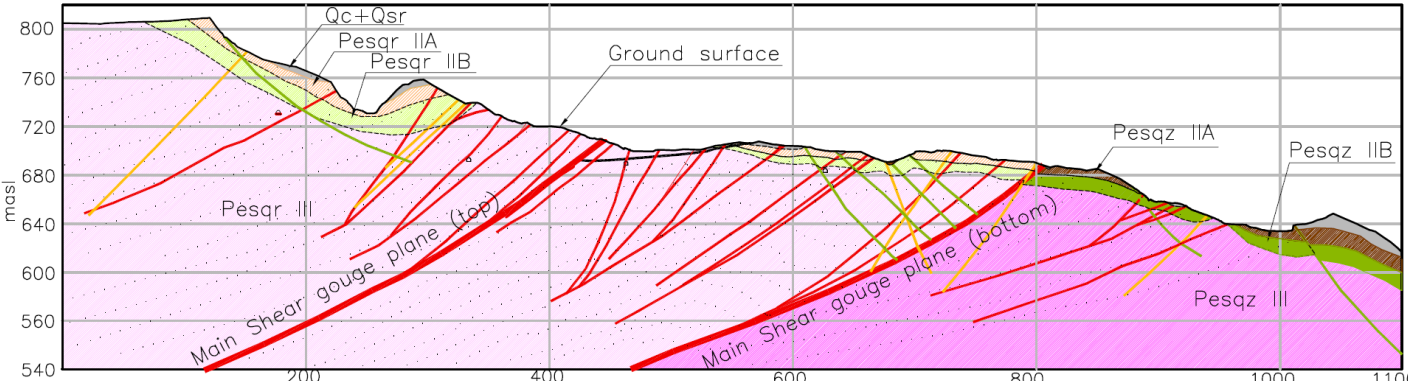
unpredictable way in the rock mass and are responsible for the stability problems encountered during the excavations. Figure 2 presents a geologic plan view and a cross section showing the differences found and the great dispersion of the discontinuities and the shear zones registered in various exploration galleries completed as part of the investigation of the dam abutments.

Fig. 2. Geologic plan view and cross section Porce III project

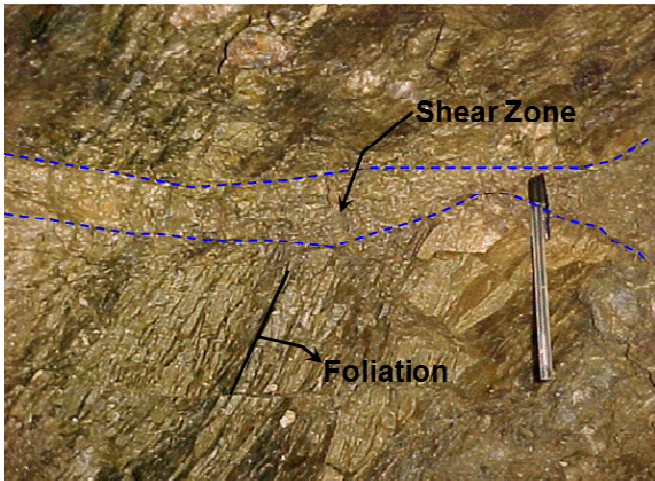
During the geotechnical investigations completed for this project, several shear and shear gouge zones were identified, with variable thickness ranging from 0.05 to 2 m parallel and across foliation planes in the area of the dam and in the tunnels. The material in the shear zone was pulverized rock with plastic soft fined-grained material accompanied by highly folded and fractured quartz veins. The shear zones that follow the foliation planes consisted of thin layers of weathered micaceous material (See Figure 3).

Fig. 3. Shear zone intersecting a foliation

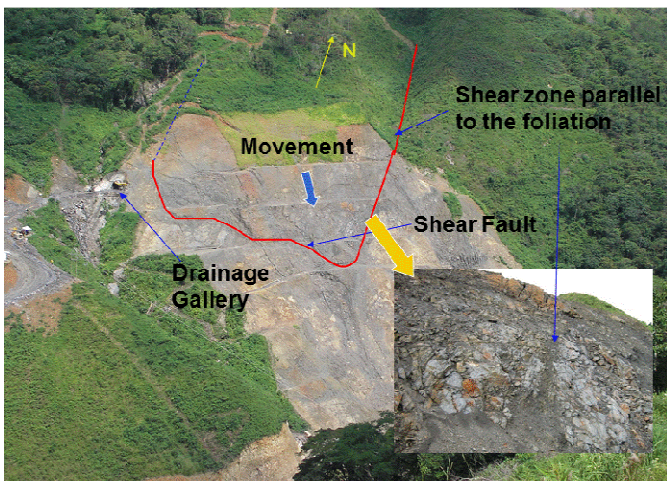
Other example of the problems related with shear zones included the excavations over the diversion tunnel performed for the upper side of the spillway. In this zone, instability resulted from a shear gouge plane inside the schist bedrock. The shear plane had as spoon type of shape, with a dip angle of 26° SW towards the slope. In addition, the unstable block was delimited by the foliation planes and a lateral shear gouge zone associated with the foliation (See Figure 4 and 5). The mechanism analyzed had a three dimensional geometry and was affected by the presence of underground water accumulated behind and over the failure surface.

Fig. 4. Failure surface at the spillway left slope

and back-analysis indicated that the residual shear strength was given by friction angle in the order of 25 to 28°. Laboratory tests of shear strength of undisturbed samples registered friction values of between 22° and 34°, with a cohesion that ranged from 0 to 80 kPa.

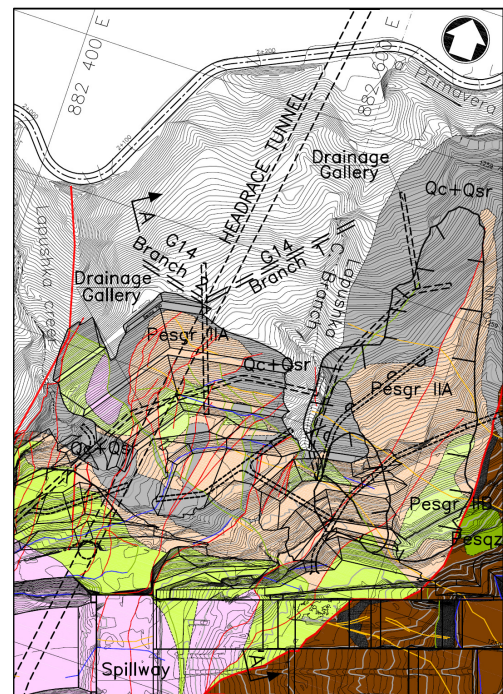
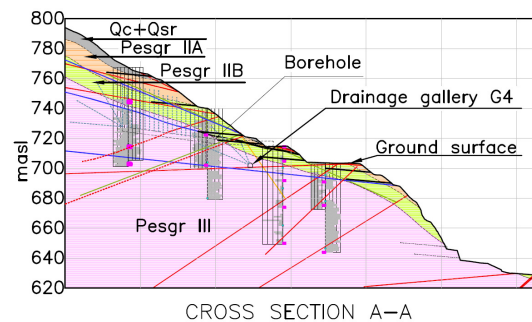
Fig. 5. Geologic plan view and cross section at the spillway.

The studies and the exploration demonstrated the presence of a high water table, affecting the stability conditions of this unstable zone. From the stability analysis, it was established the need to build drainage galleries and a superficial drainage system in order to lower the water pressures that were generating the instability problem. The model of analysis found feasible to increase the level of static safety using the drainage from around 1 to up to around 1.35. Additional measures including the installation of tendons of 72 tons where defined. Once the drainage measures were implemented, a drastic decrease in the movements was registered, therefore improving the stability conditions (Figure 6).

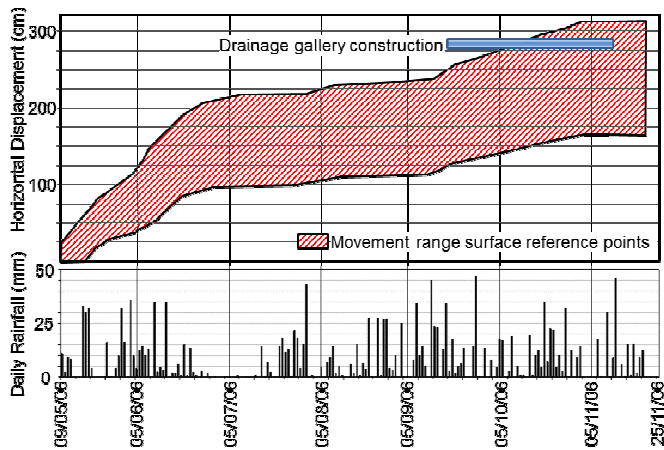
Fig. 6. Displacement rate reduction due to the excavation of the drainage galleries.

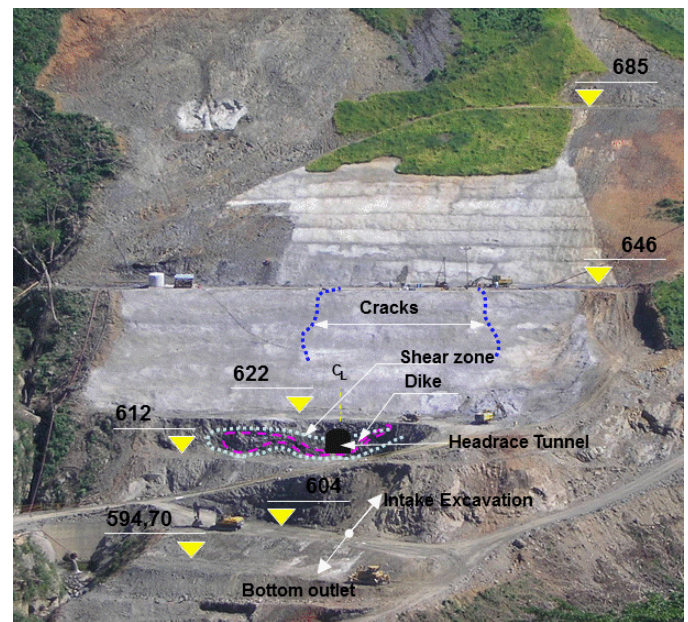
Another case related with the influence of shear zones in stability problems in the Porce III project was related with the excavations for the intake structure of the headrace tunnel. In this sector, a series of shear gouge planes with triturated and clayey material appeared and delimited the potentially unstable rock wedge illustrated in Figure 7. Towards the base of the triturated material a band of clay of 0.5 m of width was located. This shear zone had a totally irregular geometry forming a sort of laydown “S” where a great quantity of water accumulated.

During the parametric and sensibility analysis of the shear strength a value between 22° and 27° was established for the friction angle.

Fig. 7. Stability problems at the location of the intake structure.

dimensions and of the critical wedge considering the situation when the movements occurred as well was operation (with reservoir and rapid drawdown) indicated static safety factors of over 1.5 once the corrective measures were taken defined based on the analyses. These measures included the placement of a buttress behind the intake structure, reinforcement measures with tendons and a system of drainage holes. In addition, geotechnical instrumentation was implemented including inclinometers, surficial reference points and piezometers.

After the construction of the stabilization measures and the implementation of the instrumentation a considerable vertical cut was performed for the intake structures and no stability problems were observed, illustrating the effectiveness of the measures.

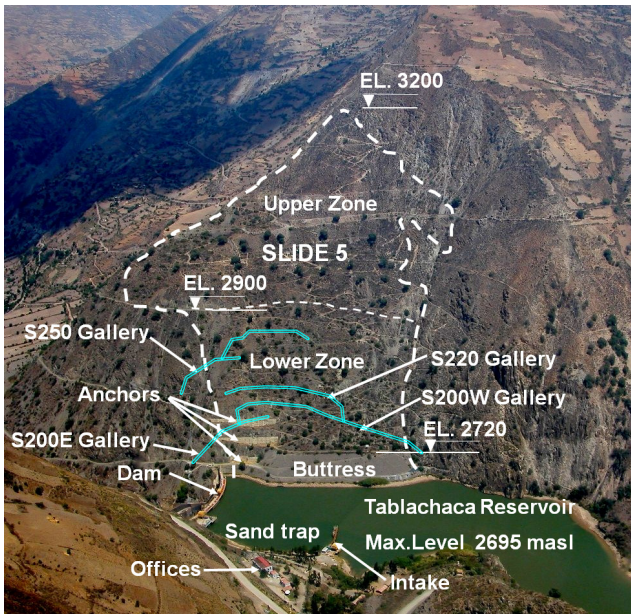
After the construction of the Tablachaca Dam, and shortly before the filling of the reservoir (September 1972), an important ancient slide, named Slide No.5, was identified in the right abutment, upstream of the dam (see Figure 8). Initial investigations indicated that the slide mass could be divided into an upper zone (initially inferred inactive) and a lower active zone. The active zone extends from elevation 2660 masl to elevation 2920 masl above the dam and reaches a maximum depth of 70 m measured from the surface. The active zone area is approximately 7.50 ha and its volume is estimated at 3 Hm<sup>3</sup>. The upper portion of the slide is comprised by an “inactive” zone that extends up to elev. 3200 masl, covering an area of 14 ha approximately and an active zone representing an additional 5 Hm<sup>3</sup>.

Fig. 8. General view of Slide No. 5.

In June 1982, the emergency works required to control the movements of Slide No. 5 were undertaken. The main contingency measures consisted of (1) construction of a free draining buttress at the foot of the slide, (2) installation of prestressed anchor up to 110 m long near the dam and at locations where the buttress could not be placed, (3) construction of two drainage galleries with radial drains within the rock mass and (4) drilling of horizontal drainage holes from the surface. Construction of the buttress fill included densification of existing sediments in its foundation by means of compacted gravel columns, as these sediments were determined to be susceptible to liquefaction under a seismic event.

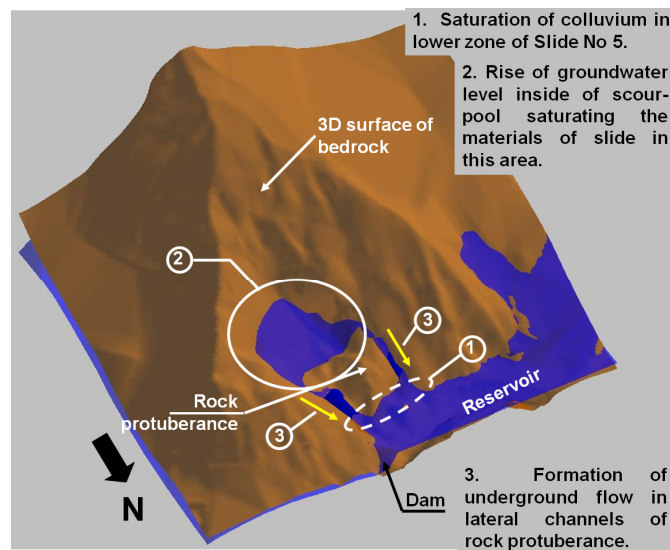
Figure 9 presents the presence of a scour-pool or cavity formed in the bedrock which is covered by the ancient landslide and the more recent colluvium deposits. In the area immediately upstream of the dam a channel or gorge exists that descends to elevation of approximately 2800 masl down to the riverbed. The gorge is oriented towards the reservoir and coincides with the movements that have occurred in this area. In the intermediate zone, the scour-pool does not reach the bottom of the river, but rather is bound by a rock protrusion composed of highly fractured and gouged slate. In the west sector of the slide, another type of gorge, of less depth and width than the one previously described is located (descends to an approximate elevation of 2800 masl).

Figure 9 also presents the phreatic surface prior to construction of the drainage galleries. This figure illustrates that prior to construction of the galleries; a buildup of water level developed in the scour-pool that forms the bedrock, thus saturating the slide material. At the same time, such a rise in water level, connected the scour-pool to the reservoir by means of two underground flow paths (gorges) located in each side of the landslide, developing seepage forces in the lower portion of the sliding masses and reducing the stability. Upon completion of the drainage galleries and under the current conditions, the water build up in the scour-pool continued to take place but its level decreased and the underground water flow disappeared. Based on piezometric data, it could be determined that the construction of the drainage galleries lowered the water table in around 30 m on the lower zone of the slide and up to 70 m in the area of the scour-pool formed by the bedrock, indicating the effectiveness of drainage works.

Fig. 9. Behavior of groundwater levels before construction of drainage works Superficial and Deep Movements.

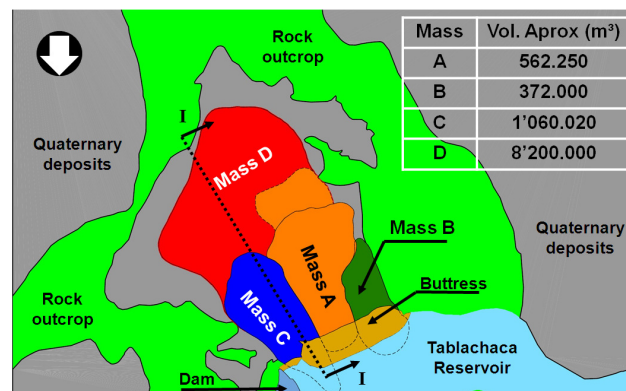
In the lower area of the slide, three potential masses were identified and are referred as A, B and C. Mass A is located in the intermediate zone, Mass B is located in west zone (the farthest from the dam), and Mass C is located in east zone, immediately upstream of the dam (see Figure 10).

Fig. 10. Plan view of potential slide masses in Slide No. 5.

In the upper area of the slide, Mass D was identified by means of the deep shear points registered on the inclinometers above elevation 2750 masl and below elevation 3115 masl. Based on these shear points the deeper slip surface was identified behind the slip surfaces A, B and C, which have less depth than Mass D (see Figure 10).

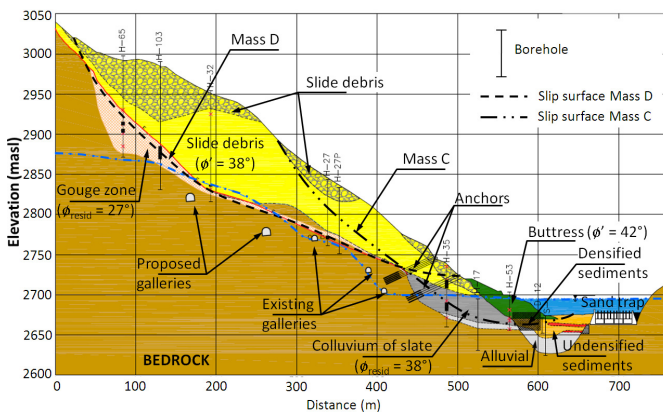
The strength parameters for the different materials that compose Slide No. 5, shown in Figure 11, were determined

Fig. 11. Cross Section I-I through Slide No. 5 (plan view presented in Figure 10)

would exhibit a precarious stability condition. This, due to the fact that the existing drainage galleries do not have the range to control the groundwater level at the base of mass D, and therefore a build-up of water level could occur under a severe event. Based on this assessment, two additional drainage galleries were recommended as shown in Figure 11.

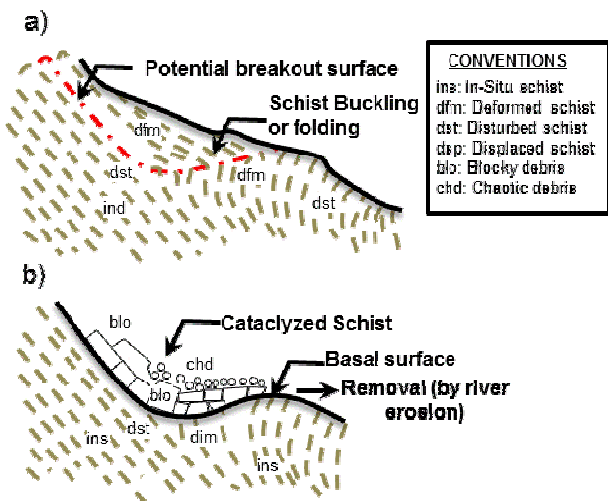
Most of the landslides were found in schists and are associated with translational creep and movement effects through unfavorable foliation planes, breccia zones, shears and joints. The origin of these old landslides has been associated with buckling effects of the weaker schists located in steep slopes and with river erosion as shown in Figure 13.

Fig. 13. Origin of some landslides at Cromwell. a) bedrock flow in sheared rock. b) development of landslide from bedrock flow [After: Gillon et al., (1991)]
