Natural Slope Failure on Weathered Andesitic Breccia in Samigaluh Area, Indonesia

NATURAL SLOPE FAILURE ON WEATHERED ANDESITIC BRECCIA IN SAMIGALUH AREA, INDONESIA

Paper No. 2.34

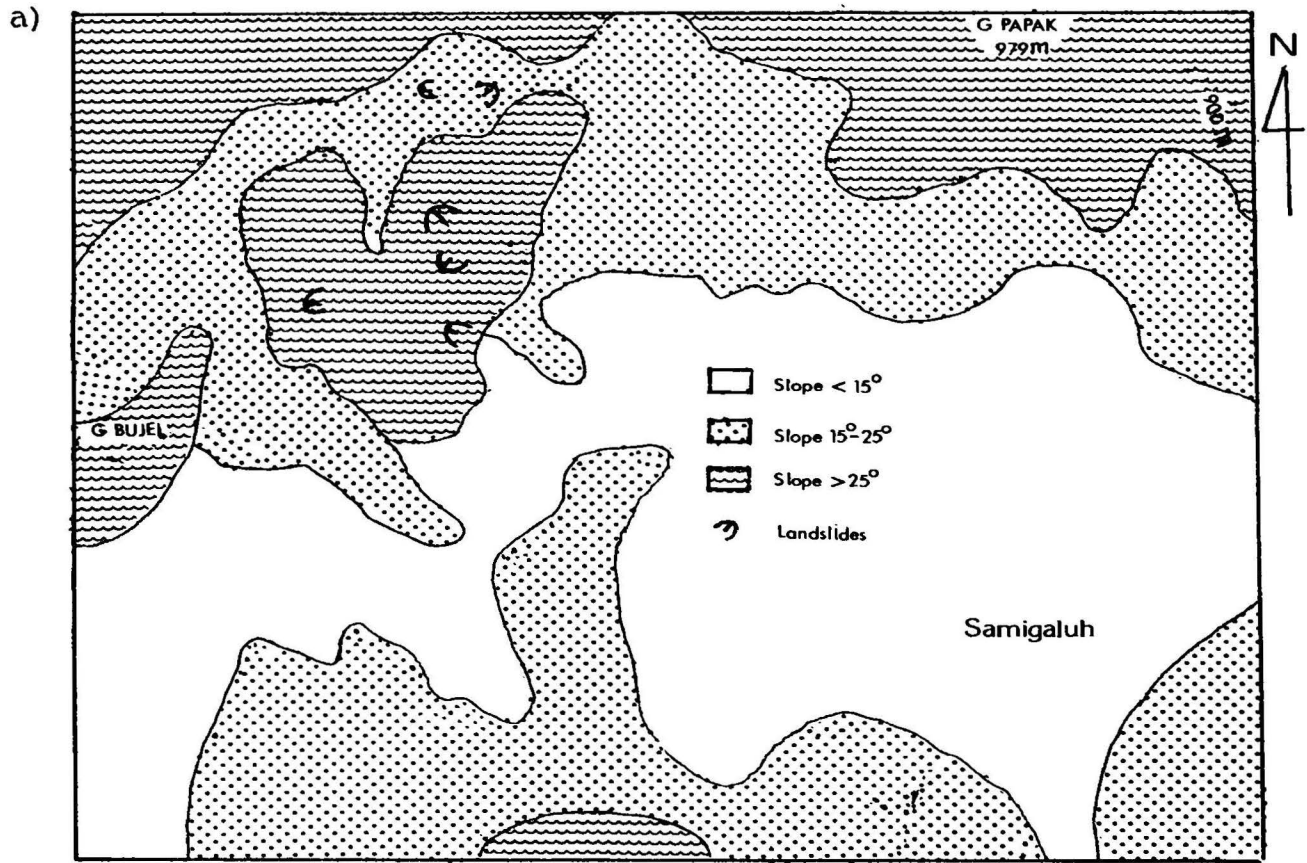
Figure 2. a) Slope Distribution Map and b) Soil Distribution Map in Samigaluh Area

All of the landslides (slope failures) occurred on the slopes with inclination of 25° to 35° .

Slope inclination. All of the landslides occurred on the area which was steeper than 25° . However, it was evident that some other slopes, which were steeper than 35° but covered by dark brown Sand-Clay and cultivated plants or forest, remained stable in response to the rainfall. Thus, it seems that the slope inclination exhibits less significant control on landslides than the soil type and vegetation.

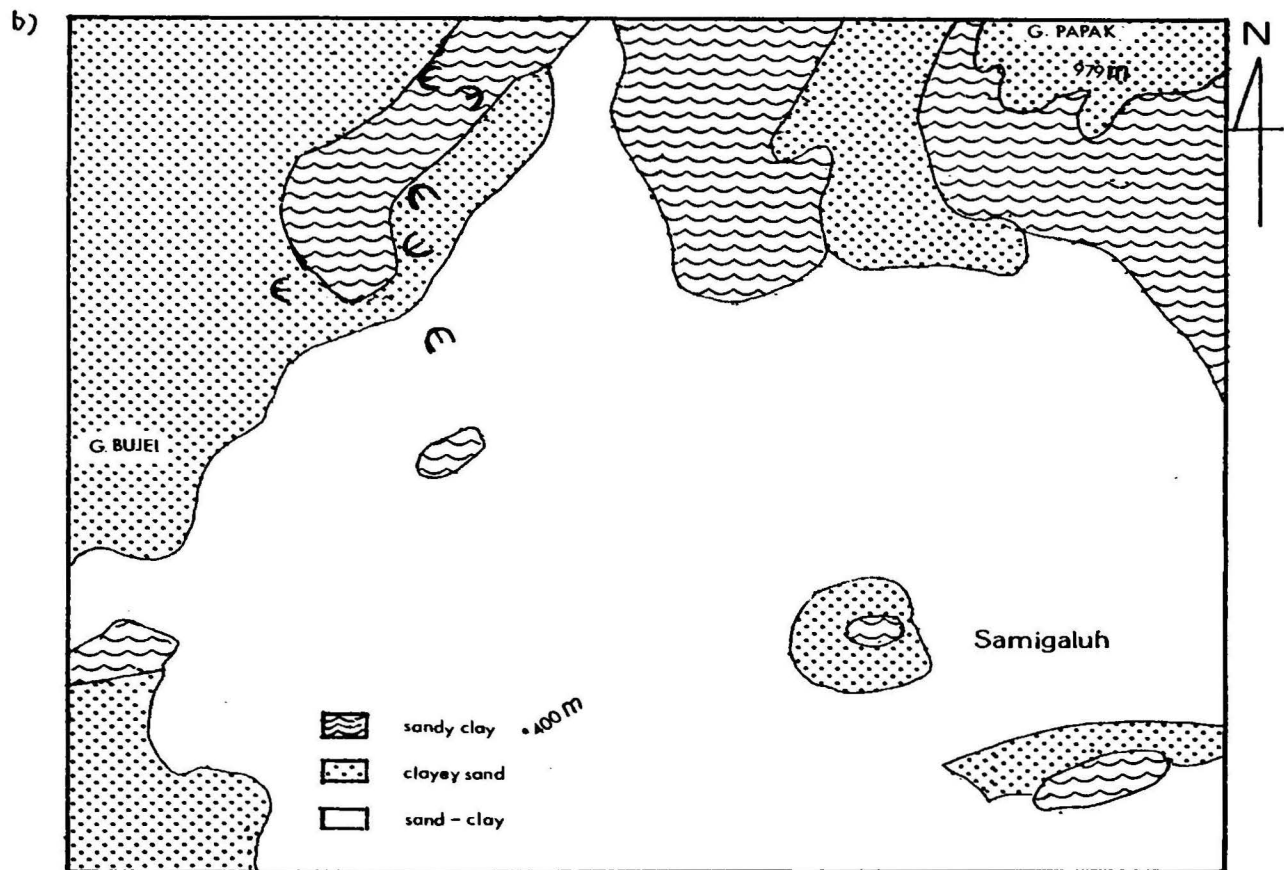
Bedrock underlying the study area is Andesit Breccia. Such Breccia consists of rock fragments (Andesit and Tuff) with various diameter size, i.e. 3 mm to 2 m. The matrix of Breccia comprises of Sandy Tuff. Most of the Breccia exposed is intensively weathered which results in various soil conditions as listed in Table 1. This bedrock is predominantly covered by those soils. Distribution of the soils in the study area is illustrated by Figure 2b.

Soil Types. It was found that three of the six landslides occurred on the slope covered by reddish brown Clayey Sand. According to the laboratory test results as illustrated in Table 1 this sand had the lowest shear strength, i.e. 1 to 8 kPa. That is why the slope that is covered by this soil type is the most sensitive one to fail.

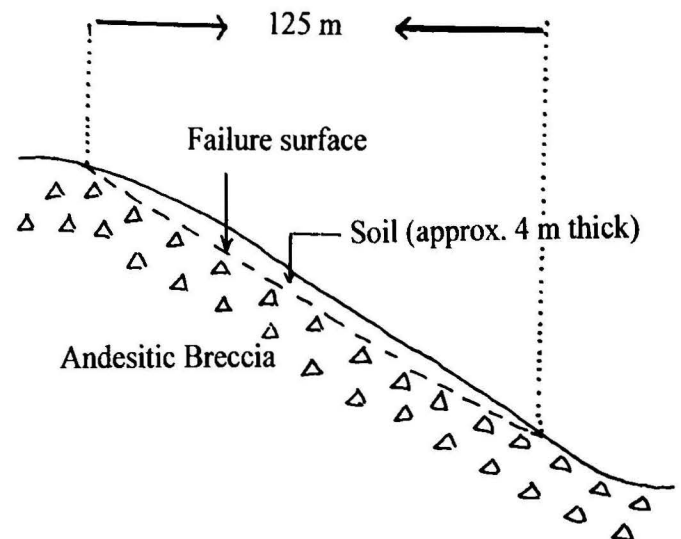
Figure 3. Landslide conditions

The geometry of the landslide is illustrated in Figure 3. From field inspection, it was recognized that only the soils, in particular Clayey Sand, were moved by the sliding. Meanwhile, the bedrock of Andesitic Breccia remained stable. Clearly, the contact between the soil and bedrock of Andesitic Breccia behaved as the failure (sliding) surface. Such surface was relatively parallel to the slope surface. In addition, the moving soils were very wet (muddy) and showed the flow pattern. This indicates that the landslide type was the earth flow as that was reported by the eyewitnesses.

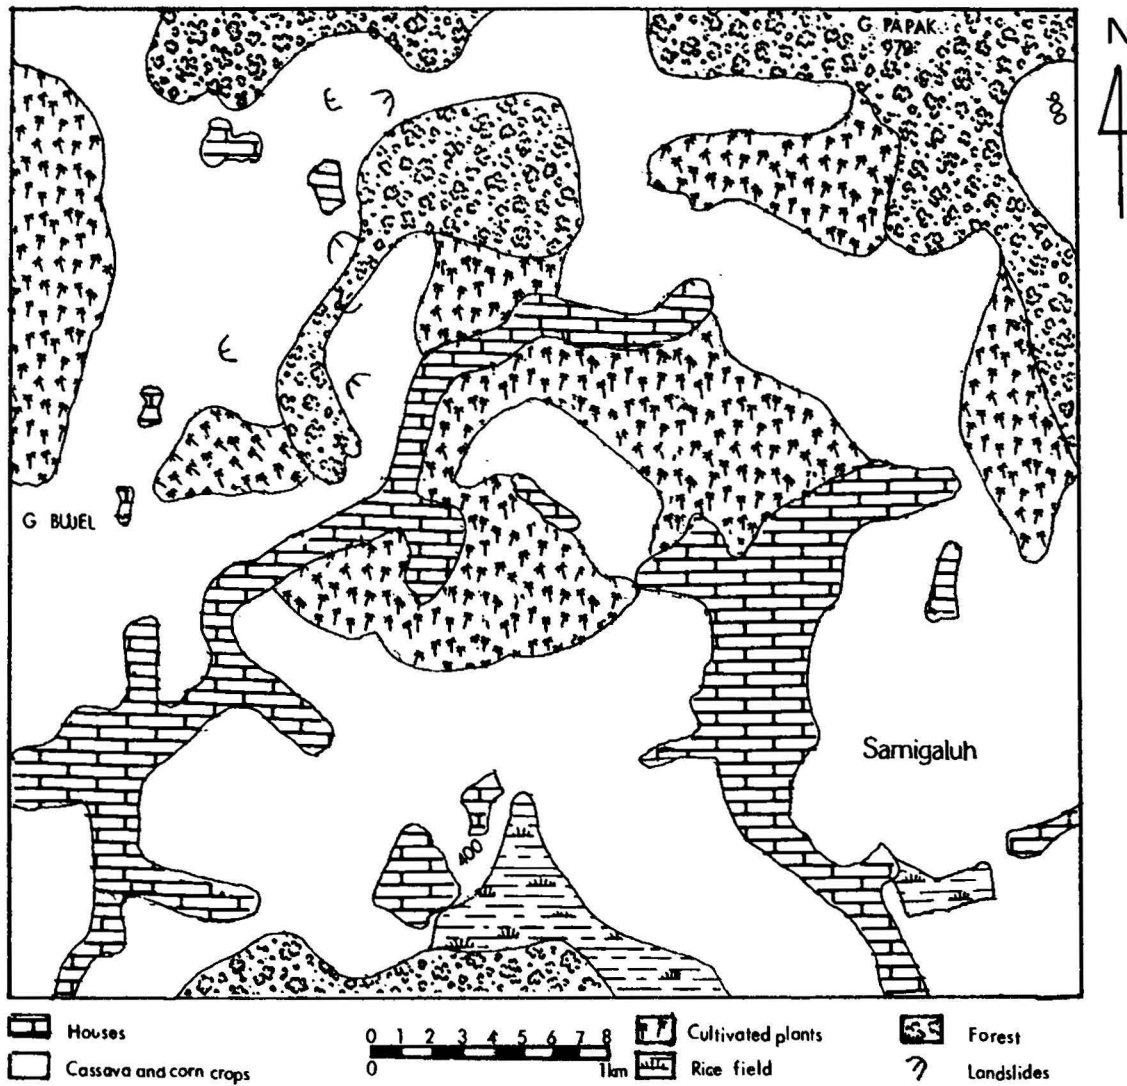
Figure 4. Landuse Map in Samigaluh Area

It was also recognized that all of the failed slope were covered by corn and cassava crops (Figure 4). Meanwhile, other slopes which had similar inclination to the failed ones and were covered by cultivated plant or forest, remained stable.

Vegetation. It is apparent that the root system of the corn and cassava crops tends to loose the interconnection of soil particle. This can increase the soil permeability at the root zone. Accordingly, the rate of rainwater infiltration was higher on the slope covered by these vegetation types. As a result, the rise of groundwater table proceeded in the higher rate as well, which then led to the more rapid shear strength reduction and thus the slope failure.

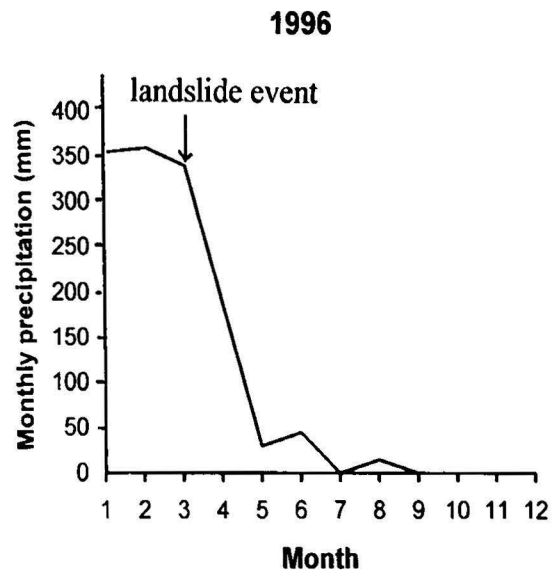
Figure 5. Monthly rainfall in 1996 (no data available in September to December)

The rainfall data was collected from the rain-gauge station located in Samigaluh at the elevation of 625 m above sea level. During 1986 to March 1995 the average annual and monthly precipitation were 2992 mm and 241 mm respectively. The highest annual precipitation was 3849 mm occurring in 1986, and the highest monthly precipitation in that year was 321 mm. However, there were no landslide events. On the other hand, landslide events occurred in March 1996 when the monthly rainfall was 340 mm (Figure 5). This is slightly higher than the average monthly precipitation since 1986.

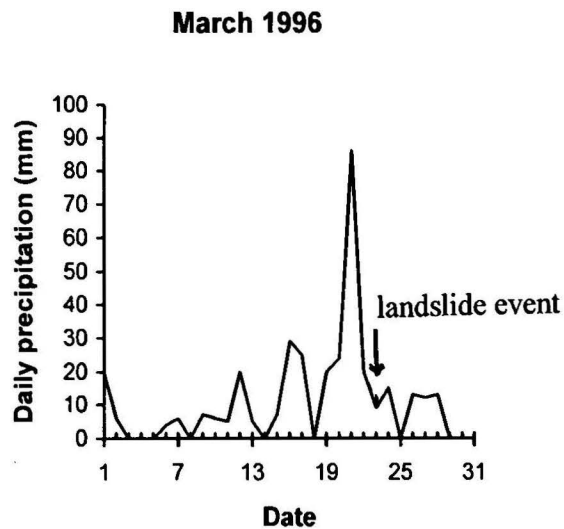
Figure 6. Daily rainfall in March 1996

Figure 6 illustrates the daily rainfall during March 1996. The landslide occurred on the 23rd when the daily rainfall was only 10 mm. It is interesting that these events did not coincide with the highest daily rainfall (i.e. 86 mm) which had occurred 2 days before.

Rainfall. Clearly, that the slope failures strongly related to the heavy rainfall. However, such failures did not immediately follow the heavy rainfall, but they were delayed for two days. This may be because the permeability of the soils which is relatively low. Thus, it took couple days for the rainwater to build up the pore pressure, so that the failure could be induced.

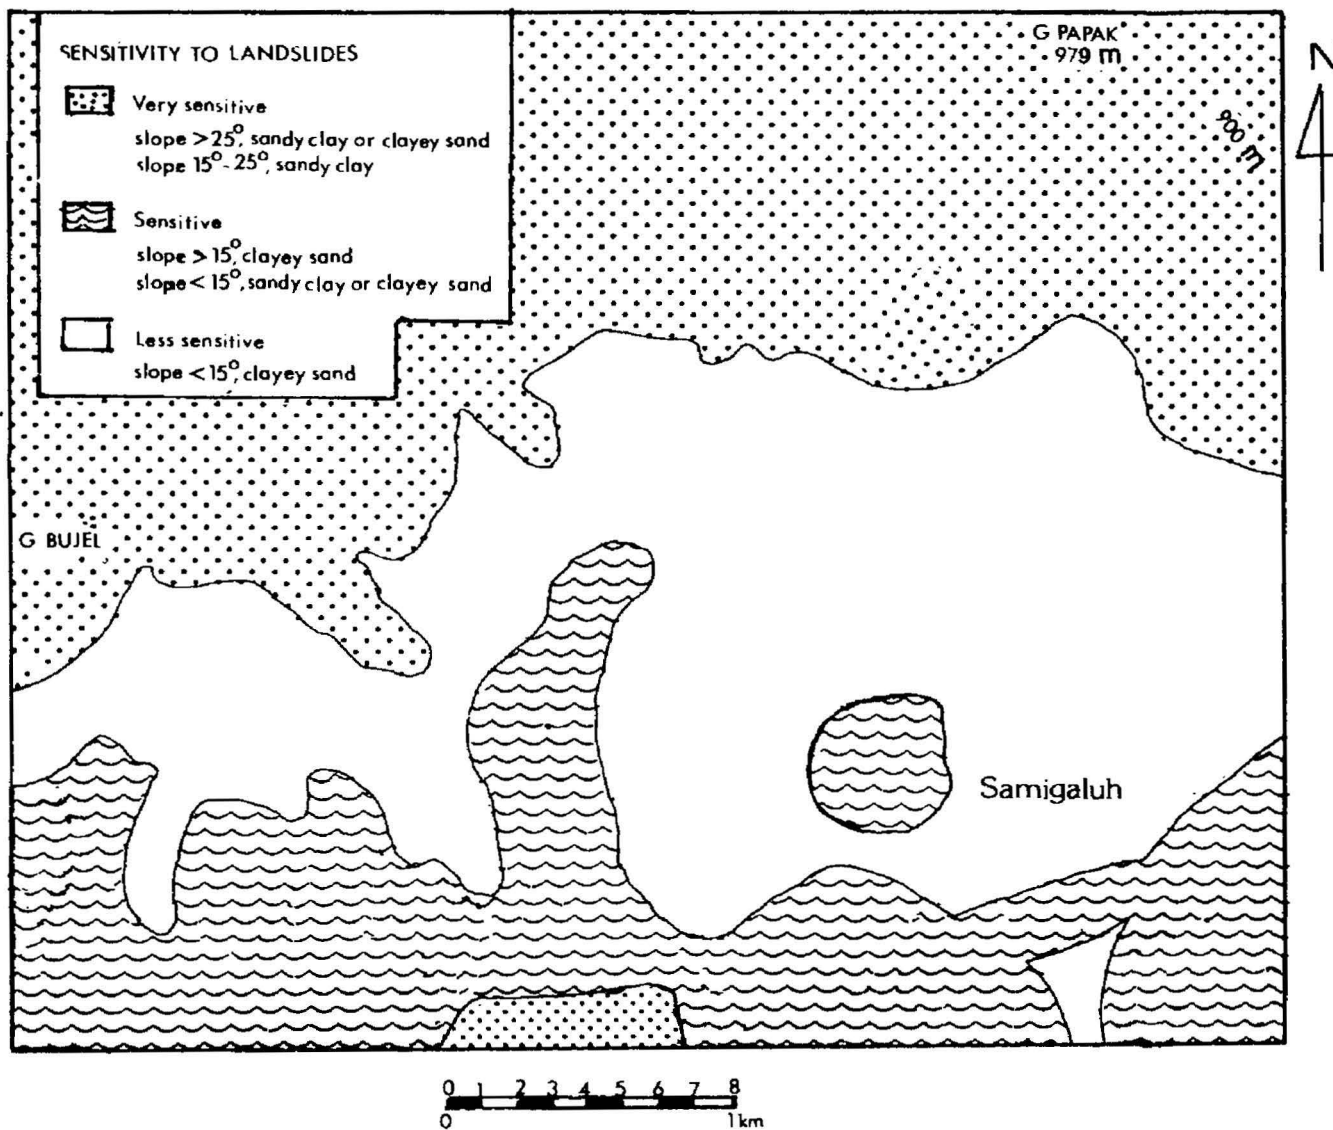
Figure 7. Landslide Susceptibility Map in Samigaluh Area

By considering all factors controlling the landslides as well as overlying several maps illustrating the distributions of slope classes, soil types and landuses (Figure 2a, 2b and 4 respectively), a map of landslide susceptibility could be established. The sensitivity of the area to the landslides is illustrated in such map (Figure 7). This will be useful to support the landslide prevention system in this area.
