An Investigation Into the Causes of Building Cracks on the Rear Scarp of a Major Landslip

AN INVESTIGATION INTO THE CAUSES OF BUILDING CRACKS ON THE REAR SCARP OF A MAJOR LANDSLIP

Paper 8.01

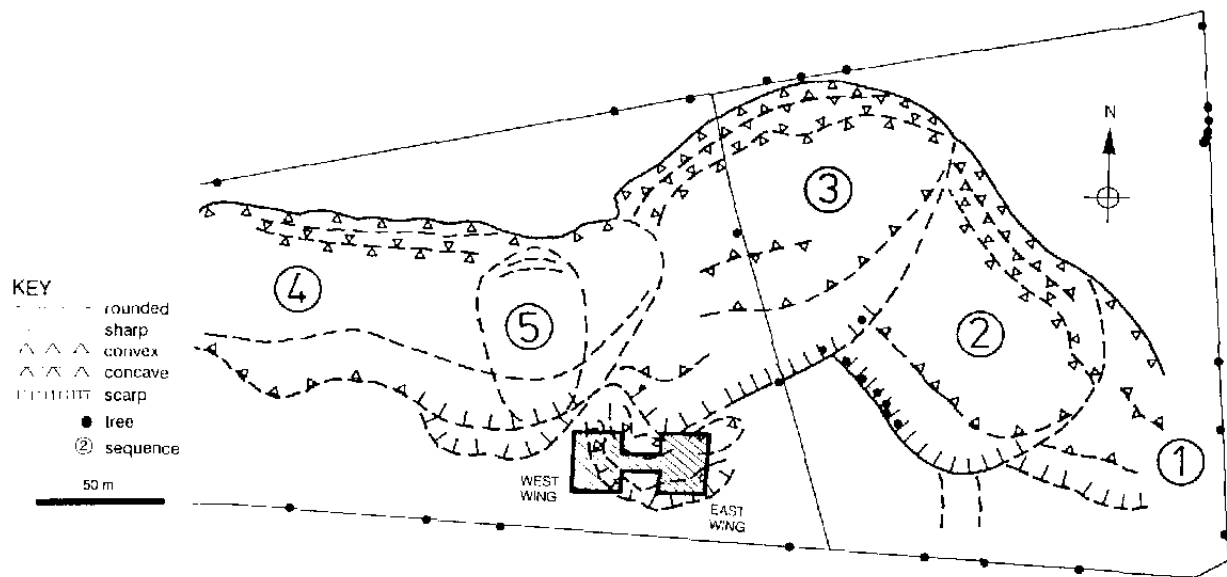
Fig. 1 Landslip complex, showing location of structure on rear scarp

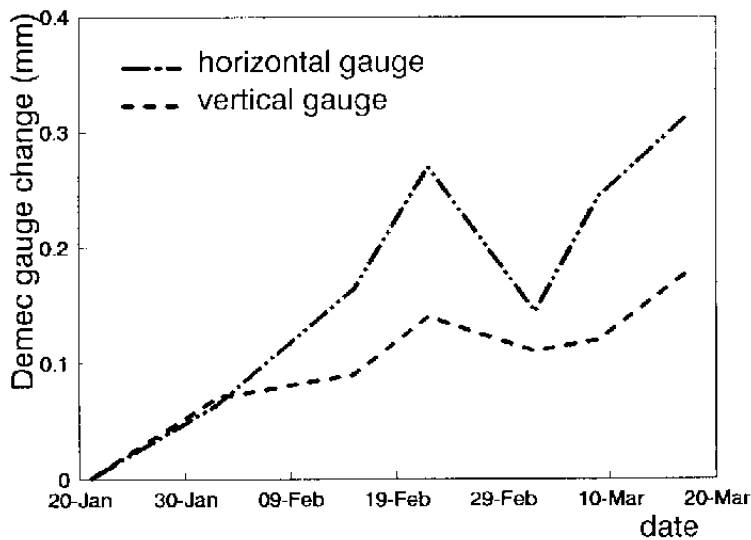
Fig. 2 Change in width of a crack, between January and March, from Demec measurements

The short-term and long-term movements derived from Demec gauges were revealing. In the late winter period from January to March, no significant foundation movements were detected by the precise levelling (which was carried out with a precision of better than 0.1 mm). However, during this time cracks in the building opened by, on average, 0.2 mm (that is, 100 divisions on a Demec gauge). For example, Fig. 2 presents data obtained from gauges located above the bridge (Fig. 3). In the absence of any other data, it would be difficult to decide whether this constitutes a progressive increase or a seasonal change from winter to spring. This ambiguity was resolved using data from the intensive monitoring carried out over a 24-hour period. The opening and closing of the cracks as they warmed and cooled through the day and night was evident (Figs. 3 and 4). This behaviour was repeated at all the East Wall measurement points (Fig. 5). Temperature effects were also observed through precise levelling of the roof parapets above the inter-connecting bridge on the west side: in summer the parapet lifted off the lower brickwork, as a result of arching action.

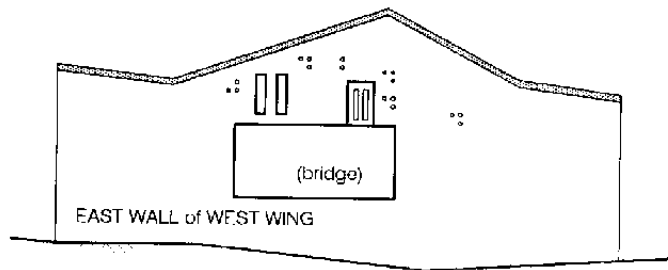
Fig. 3 Demec stud pairs on the East Wall (West Wing). Data given in Figs. 2 and 4 are for studs marked ●

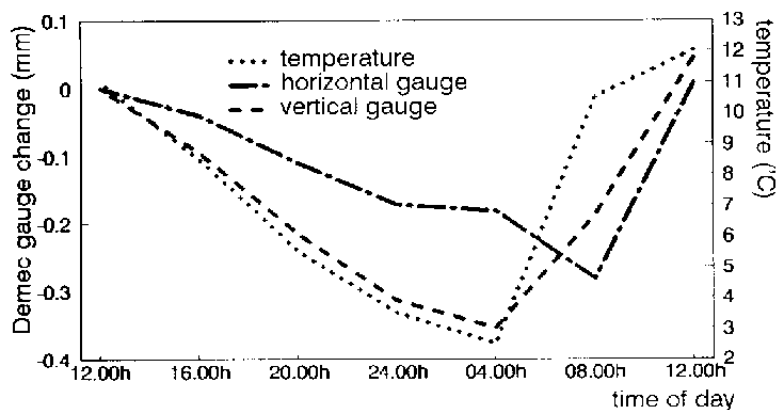
Fig. 4 Change in width of crack over 24 hour period

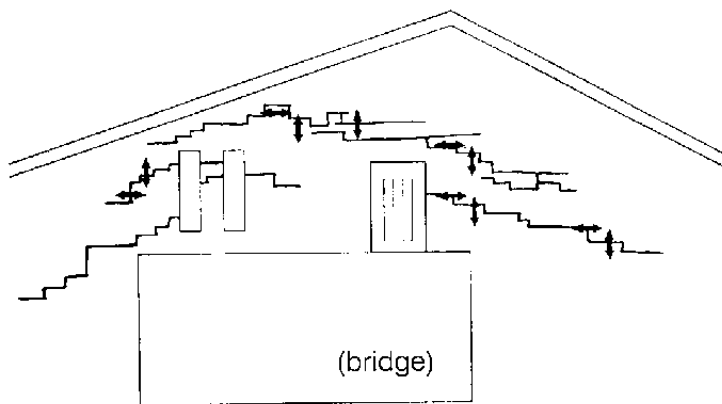
Fig. 5 Pattern of behaviour on East Wall (West Wing). Arrow indicates that crack widens with increasing temperature.

the progressive damage to the outer leaf arose largely from diurnal and seasonal thermal expansion and contraction acting in combination with the highly restraining nature of the structure. These cracks increased with time due to crack creep, which is associated with particles of debris falling into open cracks and preventing their closure upon cooling.

A significant conclusion from the fifth and sixth investigations was that the origins of the damage sustained by the building had changed since its construction. Initially, the observed cracking would have been due to drying shrinkage. Later, these effects lessened, and the subsequent cracking was a result of the construction details incorporated in the building. The combined use of fired-clay bricks and sand-lime bricks was identified as a key contributory factor. These materials have differing initial drying shrinkage and thermal expansion properties. When they are used together, movements should be permitted *via* butterfly ties and joints above the damp course. Also, beams, lintels and slabs should be isolated from the sand-lime bricks. The final investigations concluded that
