International Conference on Case Histories in Geotechnical Engineering (2008) - Sixth International Conference on Case Histories in Geotechnical Engineering

Back-Analyses of Landfill Slope Failures

BACK-ANALYSES OF LANDFILL SLOPE FAILURES

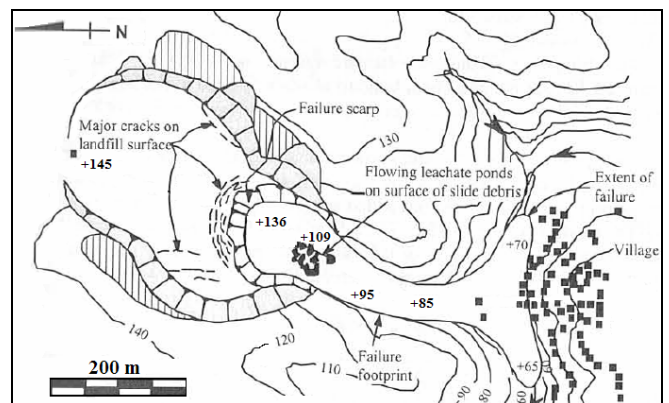
The catastrophic slope failure occurred on April 28, 1993 and resulted in 27 casualties and involved approximately 500,000 m³ to more than 1,000,000 m³ of waste (Fig. 2 shows a site plan view after the failure). Before the slide, 3 to 5 m of demolition debris and soil was placed on top of the uncompacted waste starting in mid-1992 to provide cover for the waste and to increase income obtained from the fees of dumping of demolition debris. Fires were known to be burning on the surface of the waste at several places during most of the year before the slide (Figs. 3 and Fig. 4 are photos from the landfill).

Fig. 2. Site plan view after slope failure (modified from Koerner and Soong 2000)

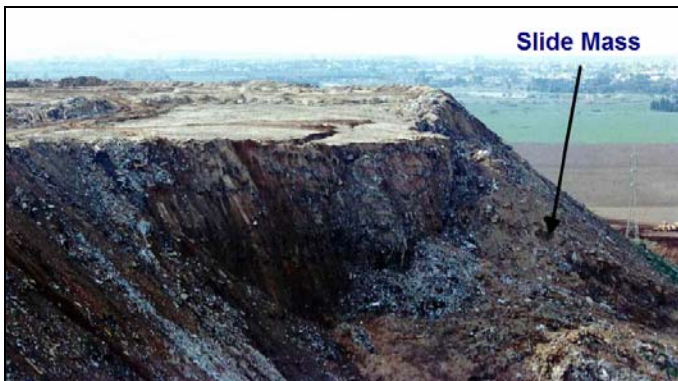
Side slopes of Hiriya landfill range from 1.3H:1V to 1.6H:1V with an average 1.44H:1V. The slopes are covered with a thin irregular soil cover, with waste exposed in some areas. Slope heights range from 43 to 64 meters, averaging 56 meters as measured above surrounding level terrain. As a result of the steep slopes, the lack of vegetation, drainage and erosion controls, the landfill has experienced small and large instability problems. In the winter of 1997-98 a major slope failure (Figures 6 and 7) occurred in the northern face of the dump, following a period of heavy rain, and the Ayalon River was blocked for some days.

Fig. 6. 1997 Hiriya landfill slope failure (Isenberg, 2003)

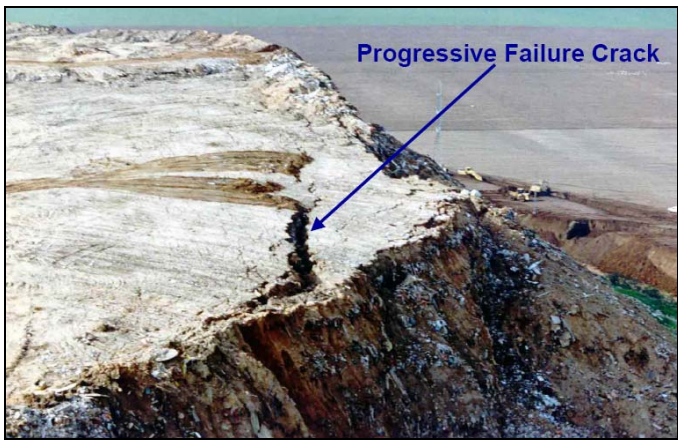
Fig.7. Top of Hiriya landfill after slope movement (Isenberg 2003)

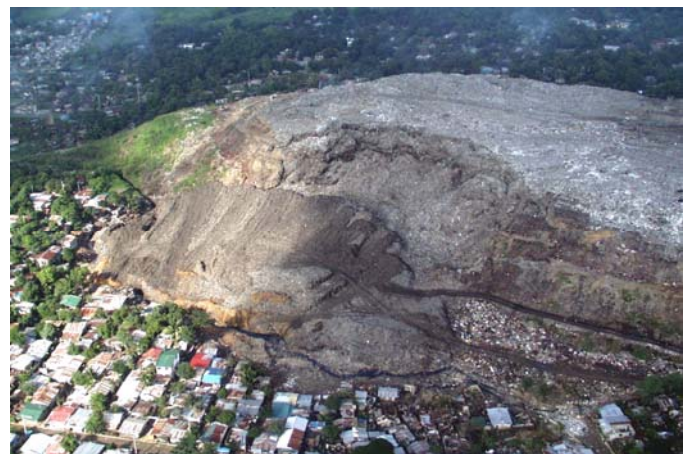
Fig. 9. Payatas landfill slope failure in 2000. (Kolsch and Ziehmman, 2004)

The picture of the observed failure in the field is shown in Fig. 9. Although the exact location of the failure surface is not

known, looking at the near vertical scarp, the thickness and movement of the displaced waste mass, and no sign of bulging at the toe to indicate a deeper seated failure surface through the underlying clay, the failure surface in the field seems to be shallower and mostly through the waste than failure surface A in Fig. 9. Therefore a critical circular failure surface was found using UTEXAS3 (shown as failure surface B in Fig. 11). This failure surface, together with unit weights of MSW from Merry et al. (2005), were used in a back-analysis. The weighted average effective normal stress along the failure surface is 45 kPa and the corresponding shear strength is 35 kPa.

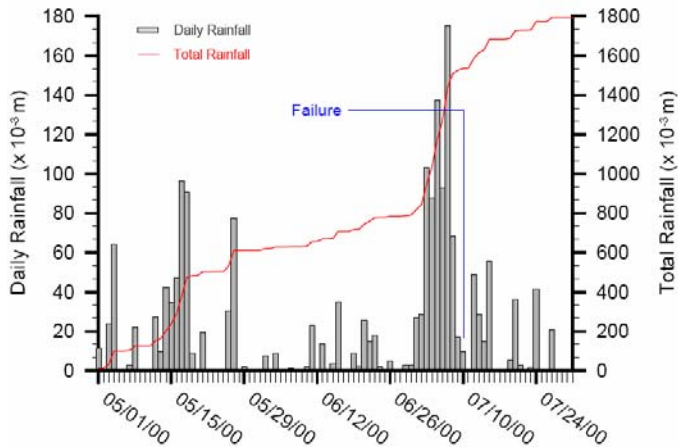
The exact mechanism of failure is not clear, but several factors probably contributed to the failure. These include heavy rains (68 cm rainfall caused by two typhoons that occurred in the area in the two weeks prior to the failure, see Fig.10) leading to the likely saturation of the entire waste mass; building up of waste that caused the side slopes to be steeper than recommended (1.5H:1V at the time of failure); ponding of water on the top of the slope; the construction of drainage trenches at the top of the slope to drain this ponding water; construction of a 2 to 3 m deep drainage ditch at the toe of the slope; and the potential build-up of landfill gas (Merry et al. 2005).

Fig.10. Precipitation record at Quezon City Weather Station in Philippines during May thru July 2000 (Merry et al. 2005).

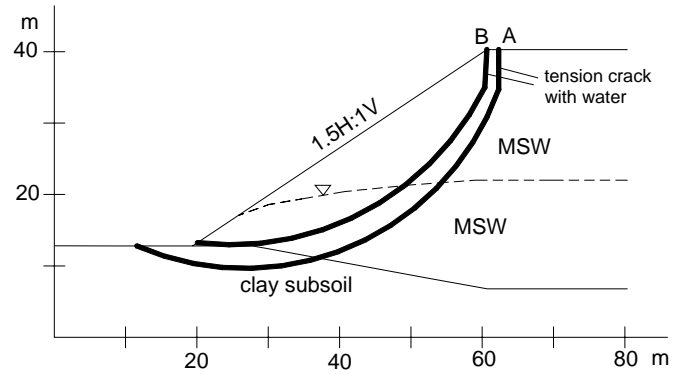
Merry et al. (2005) assume that the failure surface passes through the waste and the underlying natural clay (failure surface A in Fig. 11). In this study, using the failure surface A in Fig. 11, and using the unit weights of MSW and clay substrata, and shear strength of clay substrata given by Merry et al. (2005), a cohesion of 20 kPa, and a friction angle of 32 degrees are back-calculated for the MSW. The back-analysis is correct if the location of the failure surface used in the analysis represents the observed failure surface in the field, and the shear strength of the underlying clay strata is known. The weighted average effective normal stress along the portion of the failure surface that passes through the waste is 62 kPa and the corresponding shear strength is 59 kPa. Although Merry et al. (2005) did not back-calculate the shear strength of the MSW, they suggest using a cohesion of 19 kPa

and a friction angle of 28 degrees based on Geosyntec (1998) and Kavazanjian (2001). These parameters lead to an average effective normal stress along the failure surface through the MSW of 62 kPa and a shear stress of about 52 kPa, which is in agreement with the back-calculated shear strength parameters in this study.

Fig. 11 Cross section of Payatas landfill slope failure (modified from Merry et al. 2005)
