# Performance of Lightweight Waste-Impoundment Dikes

**SYNOPSIS:** The containment dikes of two sludge disposal lagoons were founded on low strength, highly compressible wetland soils in Madison, Wisconsin. These lagoons, constructed in 1942 and 1967 respectively, encompass 130 acres of digested sludge produced at the sewage treatment plant. The dikes have experienced two previous failures in 1970 and 1973. A dike rehabilitation program was initiated in 1976 to prevent additional failures. New dikes were built using wood chips as a lightweight fill. Non-woven synthetic filter fabric was used to prevent soil intrusion into the chips and to provide resistance to lateral spreading. An investigation was initiated in 1984 to assess the current and long term stability and settlement of the dikes, to determine the fate of the wood chip fill, and to develop recommendations for ways to stabilize the dikes, if necessary. This paper presents the results of the stability and settlement analyses, and the attendant interpretations. The investigation indicated better than marginal stability, predicted minor loss of freeboard between 1987 and the year 2000, and found only minor changes in the woo

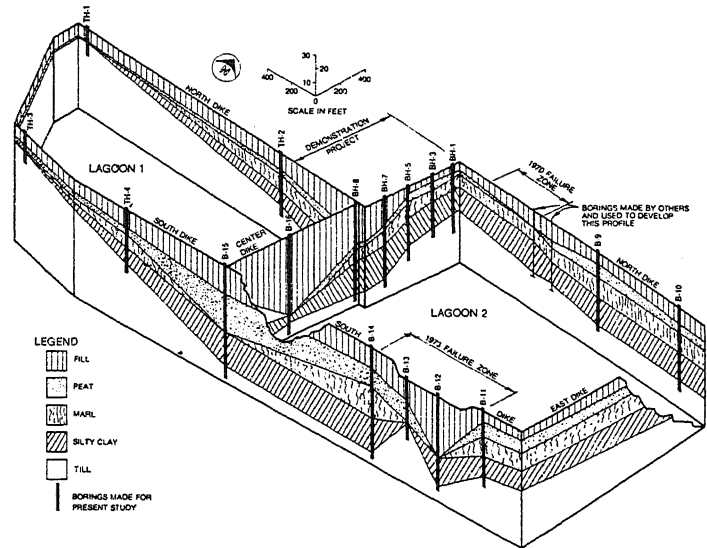
Figure 2. Subsurface Fence Diagram (from Schneider and Roth, 1976).

Twenty test borings were drilled at various locations around the lagoons by Schneider and Roth (1977) as shown in Figure 1. Based on results of those explorations, the general soil conditions at the sludge lagoons were determined to be as given in Figure 2. Three new boreholes and a number of cone penetrometer soundings were made initially as part of the current evaluation program. Another 8 boreholes were made later as part of the installation of instrumentation for the field monitoring program. The subsurface conditions revealed in these boreholes generally supported the subsurface conditions described in Figure 2.

Some of the boreholes were made very close to the boreholes made in the investigation of Schneider and Roth. For instance, a new borehole located near boring B-14 (see Figure 1) in the 1973 failure zone revealed the presence of 7 ft of new fill of gravel/wood chips combination underlain by 14 ft of old fill material consisting of gray-brown sandy-silty material. The native material below the fill is a high organic content (89%) peat with water contents of up to 400%. The thickness of the peat was 11.5 ft in the recent boring compared to 13 ft in boring made by Schneider and Roth. Under the peat, an organic material with lower water contents (about 200 to 300%) and a lower organic content (28%) was encountered. This 22.5 ft thick layer corresponds, perhaps, to the 24 ft thick deposit referred to as "silt, brownish-gray with occasional shell fragments" in B-14 of Schneider and Roth. This layer was underlain with another peat deposit of lower organic content (44%) compared to the upper fibrous peat. This is referred to as "amorphous peat" herein. This deposit is about 5 ft thick. At a depth of 55 ft there is a gray silty clay of lower water content (about 68%). This latter material is classified as a "highly plastic silt" according to the Unified Soil Classification System. It has a low organic content of about 5%. The thickness of the peat in the underlying organic material is about 1.5 ft less than the values given in the boring of 1975, perhaps indicating the amount of compression of the layers within the last 10 years.

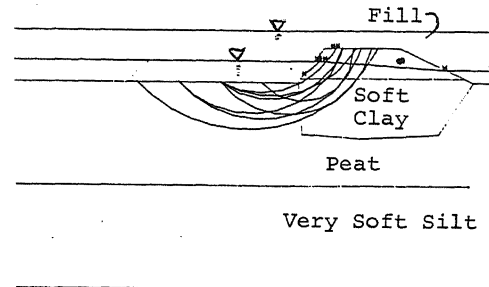
Figure 7. Stability Analysis Section and Critical Failure Surfaces

A series of stability analyses for a cross section (see Figure 7) through the south dike of Lagoon 2 near the west end of the 1973 failure zone was performed. This section was considered to be a critical section based on the thicknesses of the soft soil deposits and the geometry of the embankment. Furthermore, the most detailed account of soil properties and the stratigraphy was available at this location. Initially, it was assumed that all of the excess pore pressure in the peat underlying the fill had completely dissipated. In effect, the pore pressures in the underlying soils were set equal to the hydrostatic pressures produced by the lagoon and canal water elevations. Other analyses were made in which the pore pressures in the peat were higher than the hydrostatic pressure. There were also analyses performed in which the soil properties were varied within the perceived range of uncertainty. All of the analyses used an effective stress approach and were performed using the STABL computer program (Siegel, 1975) which is based on the limiting equilibrium method of slices for circular and non-circular failure surfaces. A summary of safety factors as a function of amount of excess pore water pressure assumed in the peat layer (0,100, and 200 lb/ft<sup>2</sup>) is given in Figure 8 for different assumptions about the soil properties and the choice of analysis. These analyses indicated the following (Edil and Bosscher, 1985):

1. Under the hydrostatic pore pressure regime, the cross section was quite stable.
2. The slope on the lagoon side was found to be more unstable than the slope on the canal side.
3. The presence of excess pore pressures in the underlying peat layer is very significant relative to stability.
4. All of the critical failure surfaces were confined basically to the upper peat layer.

10 MOST CRITICAL OF SURFACES GENERATED  
MINIMUM FACTOR OF SAFETY = 1.19572

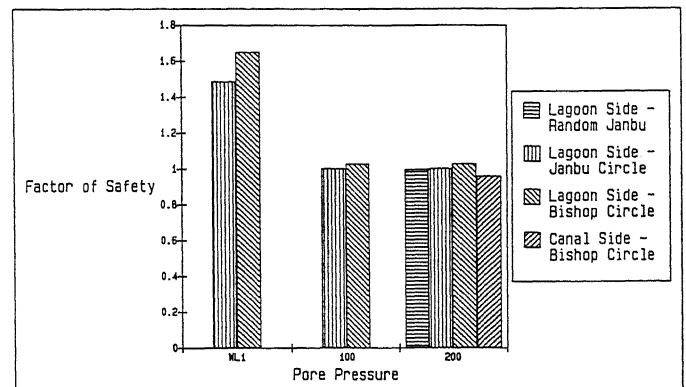
Figure 8. Safety Factors for Different Pore Pressures [WL1=Hydrostatic Pressure; 100,200=Excess Pore Pressure (lb/ft<sup>2</sup>)]

It is clear from this analysis that the presence of residual excess pore pressures induced by the weight of the fill (dike material) and additional pore pressures due to upward ground water discharge can reduce the stability of the dike slope to near critical levels. Since the lagoons lie within a groundwater discharge zone (as indicated in the previous studies), upward seepage should be investigated relative to stability.

Since it is clear that the dike stability is dependent on the magnitude of the excess pore water pressure in the underlying soils, it became imperative to make an assessment of the amount of excess pressure. For this purpose, a piezometer and a well were installed near boring B-14. The porous tip of piezometer was at a depth of 25 ft below the top of the dike and sealed in the underlying peat deposit. A cased open well was placed in the middle of the dike crest at the same location and extended 15 ft into the fill material. The water levels observed in the piezometer indicated that the peat deposit is not experiencing higher pore pressures than would be expected. It is, however, higher than the level indicated in the open well in the dike material. This may be due to the lag in water level response to the changes in the water levels of both the lagoon and the nearby stream channel. Using this new information, additional stability analyses were performed. These analyses indicated better than marginal stability of the dike under present conditions of strength and pore water pressure. However, because of the limited hydrologic record, further periodic observations of the pore water pressures was needed to ensure the maintenance of this stability.

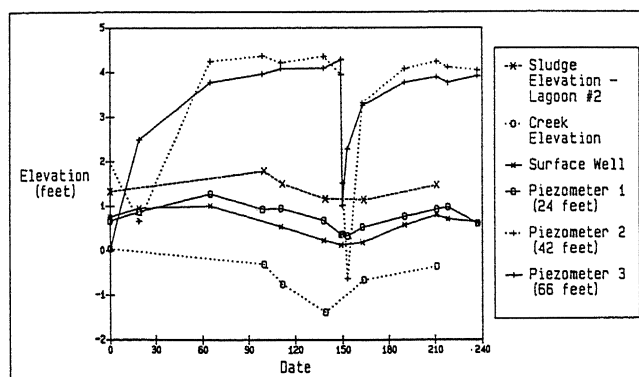
Figure 9. Ground Water Level and Pore Pressure Measurements

The data has been collected since late February, 1987 upon completion of the instrument installation. The water level data has been used to support the assumptions made in the dike stability analysis. The results as obtained from the monitoring instrumentation near boring B-14 are presented in Figure 9. The measured piezometric levels are similar to the values assumed during the analysis phase. It can also be noted that the previous assumptions of the region being a groundwater discharge zone is substantiated (see piezometric levels in Piezometers 2 and 3 compared to the surface well) The dramatic dip in the piezometric levels around early August in Piezometers 2 and 3 is due to pumping of these piezometers to determine the response of the system. It should also be noted that the surface well water elevation lies between the creek elevation and the sludge elevation, the two boundary elevations.

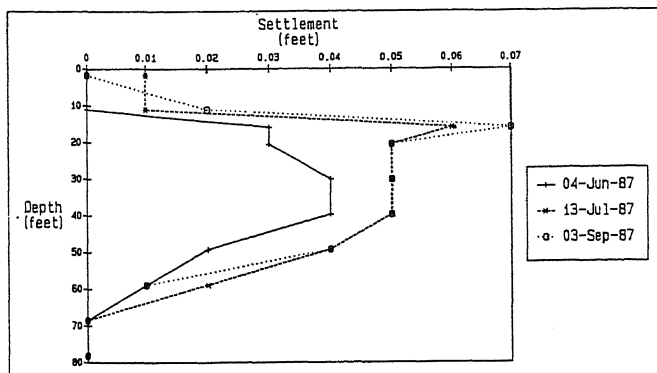
Figure 10. Settlement Measurements

The settlement data has been reduced and plotted in Figure 10. This figure indicates the small amount of settlement which can be measured using the Sondex system. The data is presented with the amount of settlement assumed to be zero at the time of installation. Even with only 240 days of settlement, the results show that the settlement is zero in the mineral soils at +68 feet, and the settlement occurring mainly in the soils in the 40-68 ft depths. Additional settlement can be seen in the 15-20 ft depth. The Sondex pipe was riveted to the inclinometer pipe at

the ground surface which is thought to account for the reduction in measured settlement at the ground surface. Based upon the measured rate of 0.07 feet occurring in 240 days, the additional total settlement expected between now and the year 2000 is under 1.5 inches assuming a logarithmic decline in the settlement rate. This value compares well with the previous prediction of less than 2.0 inches.
