Tank Settlement Due to Highly Plastic Clays

Ashraf El Far

John Davie

TANK SETTLEMENT DUE TO HIGHLY PLASTIC CLAYS

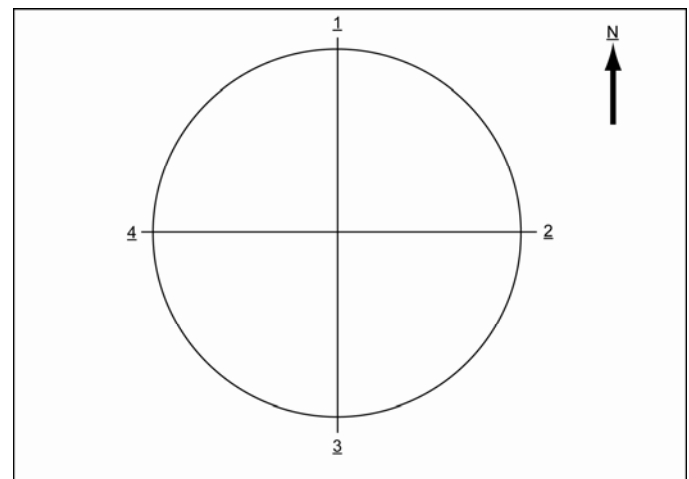
Figure 1 shows the locations of the settlement monitoring points on the perimeter of the 30-m diameter tank. The settlement of each of these points during hydro-testing of the tank is plotted against a natural time scale in Fig. 2. The percentage of hydro-test load applied is also shown in Fig. 2. Maximum (100%) hydro-test load was estimated as 127.5 kPa at foundation level. It took approximately 40 days to fill the tank with water, and the tank remained full for about 4 months. At that point, the total amount of settlement around the tank perimeter ranged from 190 to 230 mm, with an average of 210 mm. Figure 3 shows the detailed loading and unloading schedule for the hydro-testing.

Fig. 1 Locations of settlement monitoring points on 30-m diameter tank.

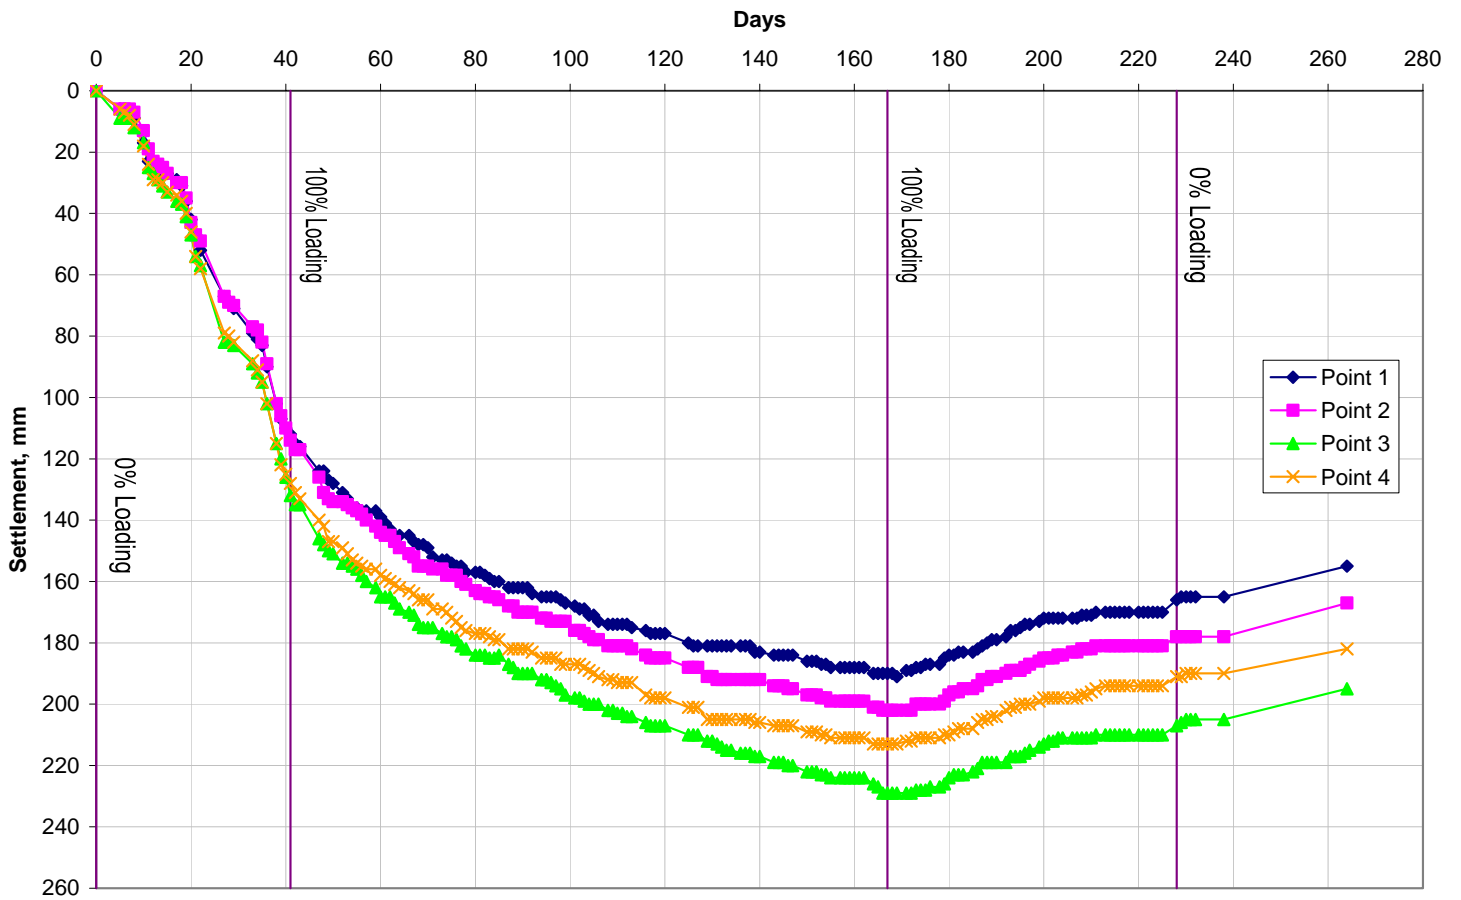
Note that the total rebound shown in Fig. 2 after 2 months of draining the tank and then another month of sitting unloaded is about 35 mm for all four settlement points.

Fig 2. Settlement of monitoring points vs. time.

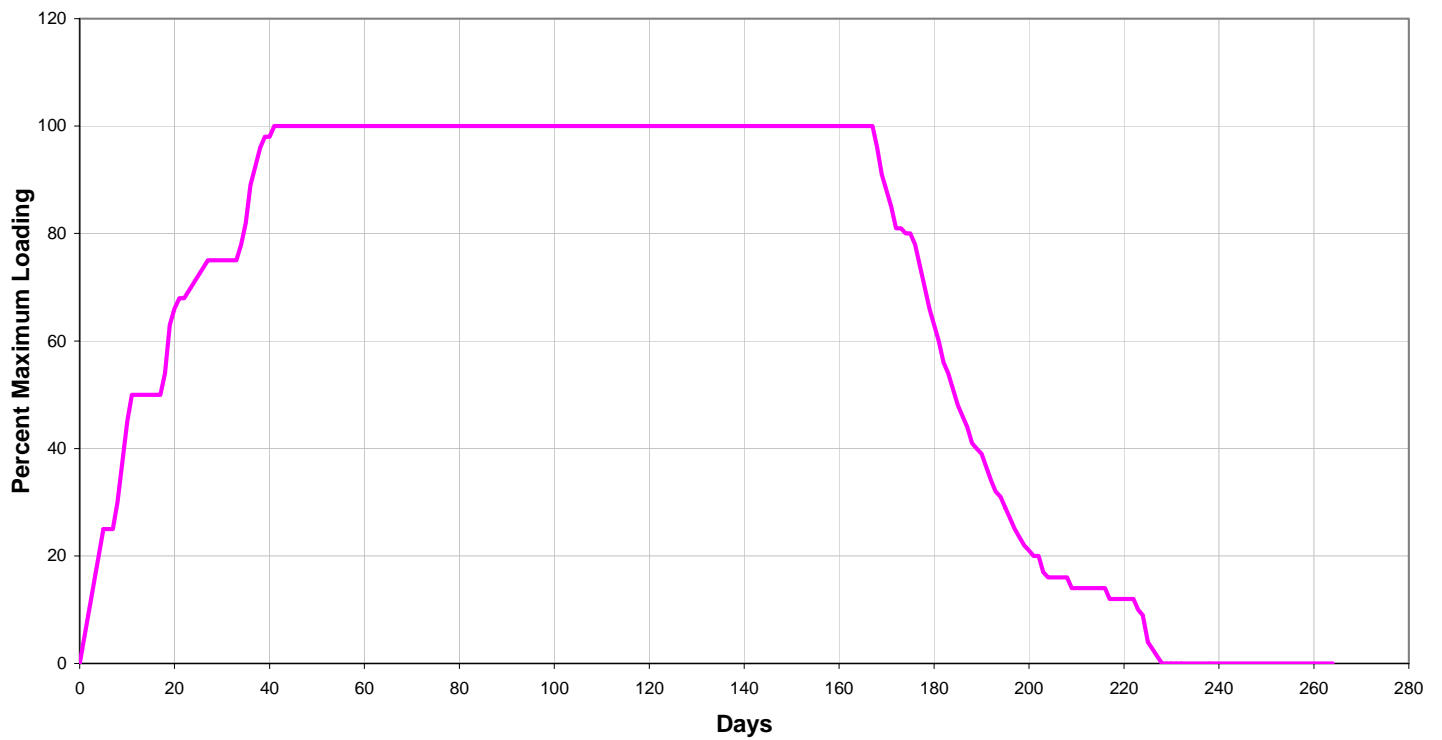
Fig. 3. Percentage loading of tank vs. time.

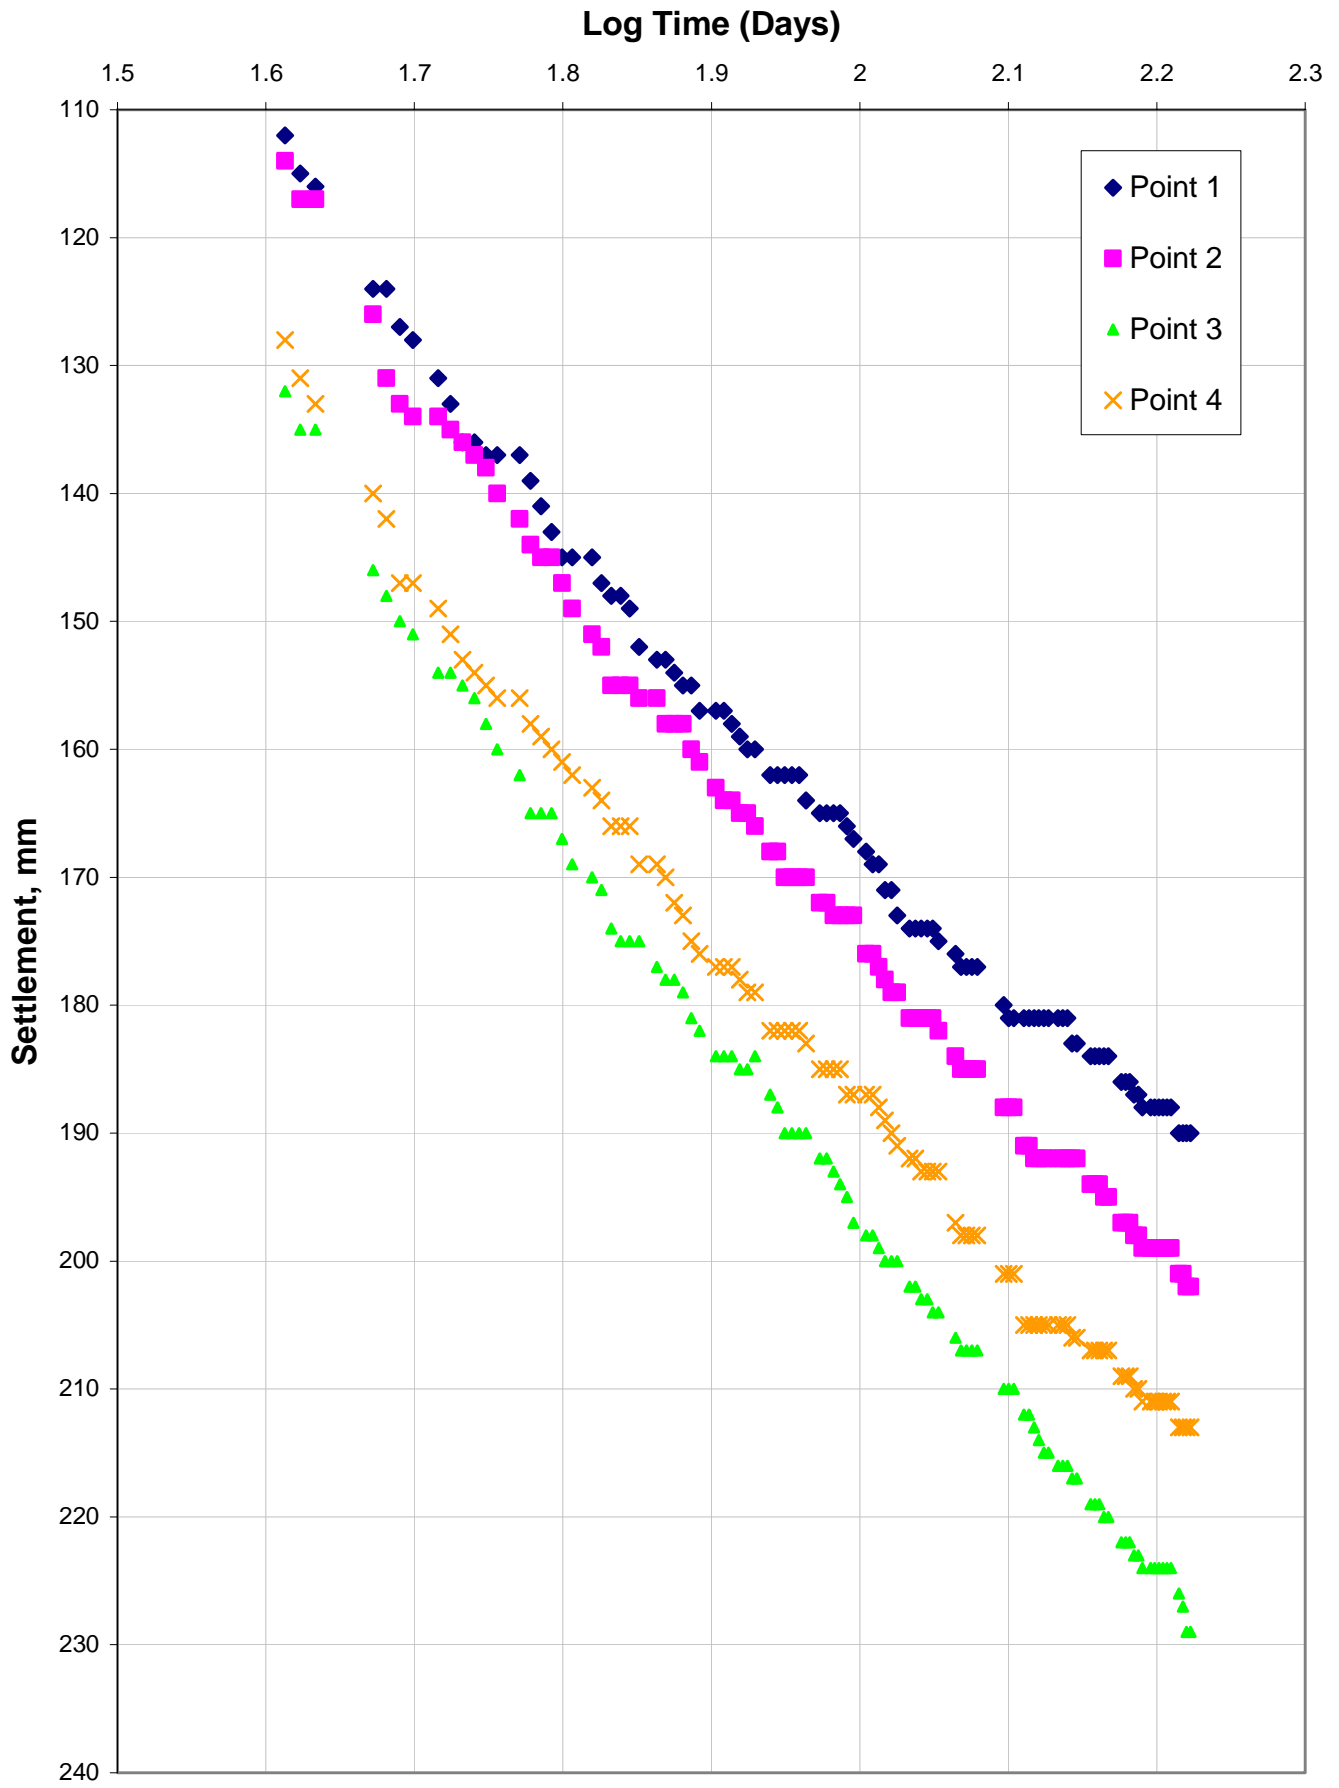
The settlement of the four monitoring points plotted against log time during the 4 months at 100% hydro-test load is shown in Fig. 4. Since the layer causing most of the settlement (Layer III) was assumed to be normally consolidated or close to that

state, the relatively linear relationship between settlement and log time was anticipated. During the second 2 months at maximum loading, the plots of Point 1 and, to a lesser extent, Point 2 indicate a decrease in the log rate of settlement. This is not the case for the other two settlement points.

The plots in Fig. 4 can be used to obtain an approximate estimate of the total settlement of the tank. (Assume here that 95% settlement is a reasonable approximation of total settlement.) Although there is not a great deal of differential settlement across the tank compared with total settlement, Point 3 consistently shows the most settlement. Based on the slope of the settlement-versus-log-time line for Point 3, it would take an estimated 1.4 years to reach 300 mm settlement. For Point 1, which consistently shows the least settlement, the time to reach 300 mm settlement would be 2.75 years, based on the slope of the settlement-versus-log-time line over the first 2 months. Based on the reduced slope for the second 2 months, this time increases to almost 10 years. Although only an approximation, it seems reasonable to adopt 300 mm as the average total settlement (95% consolidation) around the perimeter of the tank. Although the curves in Fig. 2 provide only a picture of the early stages of settlement, an average value of 300 mm extrapolated from these curves appears reasonable and possibly conservative.

Fig. 4. Settlement vs. log time at 100% loading.
