International Conference on Case Histories in  
Geotechnical Engineering

(1998) - Fourth International Conference on  
Case Histories in Geotechnical Engineering

## Observations on Landslide Incidences in Himalayas in Kashmir Area

## OBSERVATIONS ON LANDSLIDE INCIDENCES IN HIMALAYAS IN KASHMIR AREA

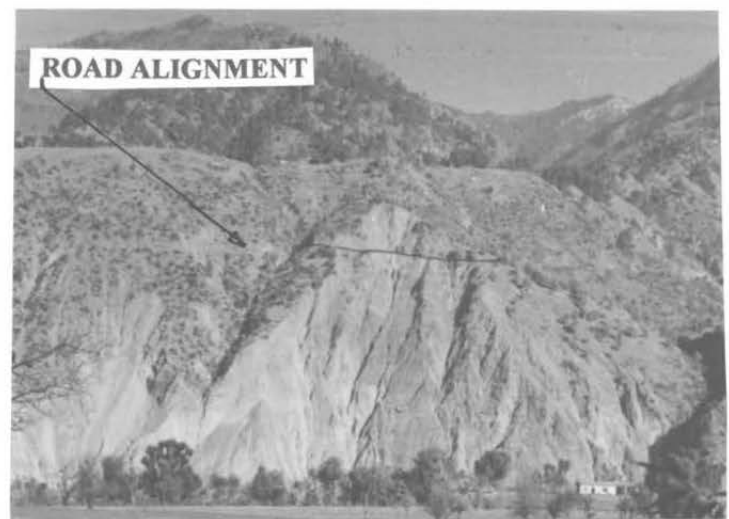
Fig. 1. General view of typical landslide

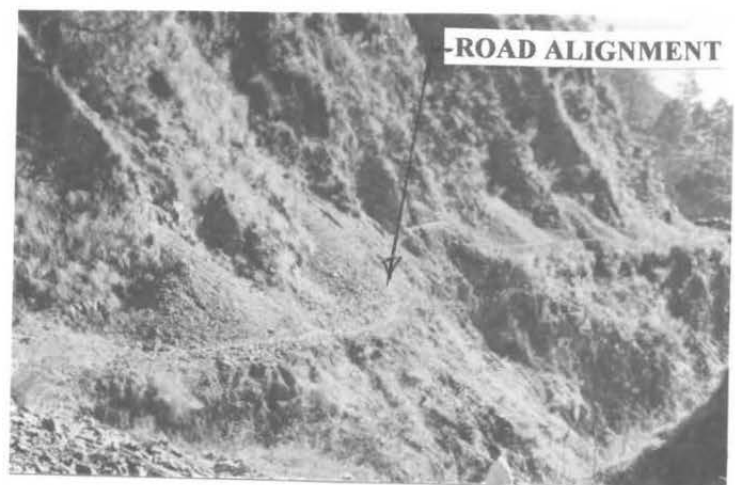
Fig. 2. View of road stretch damaged due to landslides

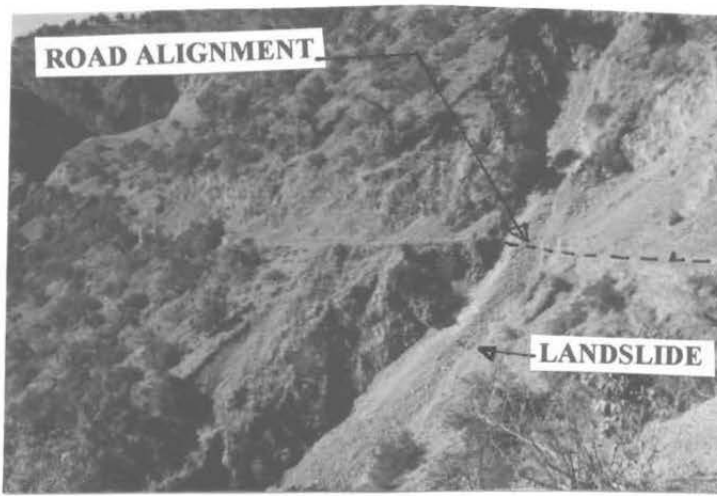
Fig. 3. Damaged condition of road stretch

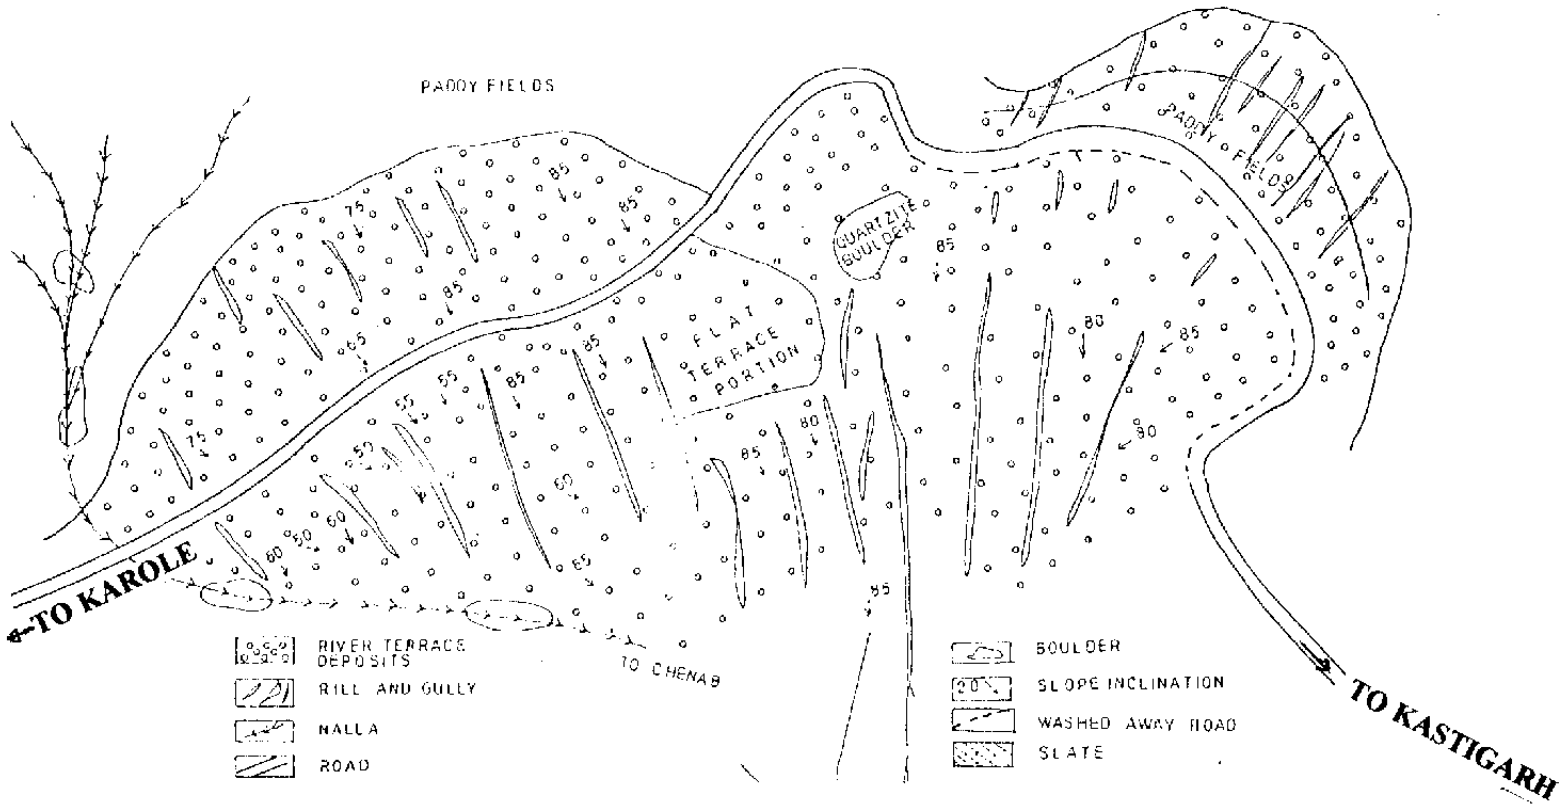
Fig. 4. Plan of landslide area at site 'A'

The total length of the affected stretch is about 125m. The maximum width of the affected area is about 15m above the road. The inclination of up hill and down hill slope vary from 55 to 85. The slope surface is denuded and does not show vegetation growth. The road traverses through the terraces comprising of loose mass compacted with pebbles, cobbles and rock fragments of various dimension associated with sand and silt. The terrace material is less cohesive and permits percolation of water leading to saturation. A nallah originating behind the crown of left side drains through the slide area. In rainy season the nalla receives surface water from its tributaries on the top. A number of rills have been observed on uphill as well as down hill slopes. A big tension crack and a few small tension cracks were observed in the area adjacent to the nallah. The plan of the slide area is shown in Fig. 4.

The slide failure in this stretch has been assessed mainly due to toe erosion by river Chenab. Blowing wind, subsurface water and surface run off caused wear and tear on the denuded slide to create steep slope. The terrace material is sensitive to water and gets washed off easily, forming scar on the surface. Continuous flow of water along the scar results in the formation of rills and gullies. As mentioned earlier that the terrace material is conducive to water seepage. During rainy season the ingress of water in the terraces increases the pore water pressure and reduces the shearing strength of the material, thereby, causing the instability of the slope.

away. Slumping type of failures were observed in the downhill slope due to cutting of toe support by river Chenab. It was suggested to change the alignment of the road towards the uphill side, away from the river.

- Measures to provide a lined road side drain all along the length of the road to avoid the spreading of water on the road surface and downhill slope.
- In order to reduce the toe erosion of downhill slope due to river Chenab and to divert the flow of river away from the existing toe levels, two spurs were suggested on the upstream side of the toe of the slide area.

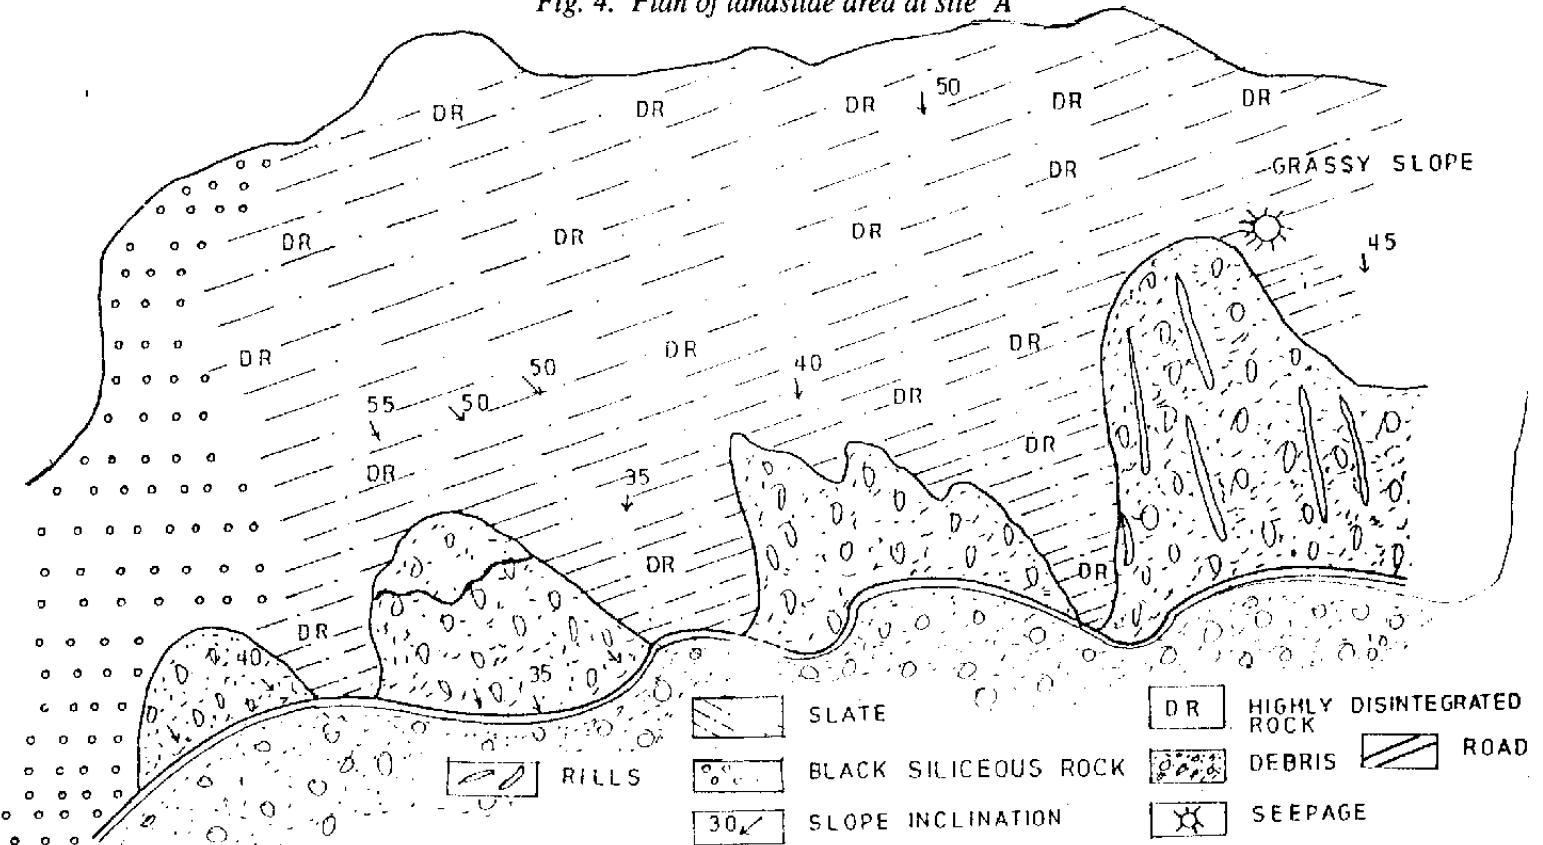
Fig. 5. Plan of landslide area at site 'B'

The affected stretch measures 250m along the road with the crown located at a height of about 60m above the road level. The affected area forms large steep slope consisting of highly jointed and disintegrated slate dipping inside into the slope. At places the rock is interbanded with black siliceous flags. The slope material comprised of small angular rock chips derived from the weathered shattered host rock. A number of seepage points were observed in the slide area. The plan of slide is given in Fig. 5.

The main cause of the slope instability may be described to be the debris flow and soil erosion. Failure of discontinuous plane by mechanical breaking was another factor. As the area experiences percolation of water and without proper drainage outlets, causes the accumulation of water leading to debris flow and other mass movements.

The debris flow and soil erosion are the main causes for slope instability. The stability analysis shows the present slope to be in unstable condition. The following remedial measures were recommended to improve the slope stability.

- Proper restructuring of the slope to bring the slope inclination at the angle of repose.
- Provision of lined catch water drains to divert water into main nallah.
- A lined road side drain all along the length of the road to discharge into the nearby natural nallah or culvert.
- A wire crated breast wall of 1.5m height all along uphill slope. The wire crated breast wall may be made with one step at one meter height.
- Levelling of the gully and growing of grass/vegetation using the technique of coir netting/jute geogrid.
- Construction of wire crated check walls, at a few locations in the nallah bed upstream of road levels.
- A culvert is suggested at the road level of nallah to prevent damage to road pavement during rains.
