International Conference on Case Histories in Geotechnical Engineering (1993) - Third International Conference on Case Histories in Geotechnical Engineering

Geotechnical Aspects of the Petrolia Earthquake

Robert K. Green
Woodward-Clyde Consultants, Oakland, California

Thomas L. Sawyer
William Lettis and Associates, California

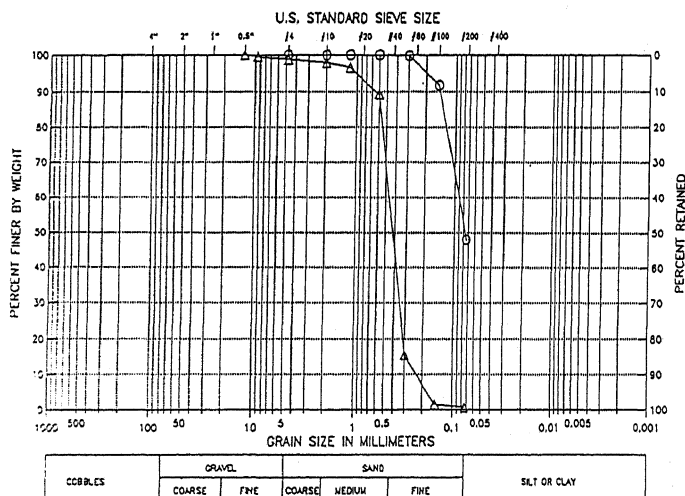
liquefaction of the underlying soils and the edge of the road fill moved laterally and downward. The ejected silty sand was very fine grained and produced many sand boils along a three to four mile stretch of the road. Some of the sand boils showed some slight variation in ejected material with a slightly cohesive material ejected after a cleaner sand with both soils overlain by a very thin layer of coarser sand. A sample of the ejected sand was collected for grain size analysis. The resulting gradation curve (circular symbols) shows that 48 percent of the particles passed the No. 200 (0.074 mm) sieve and only 92 percent passed the No. 100 (0.15 mm) sieve. Liquefaction of such a silty sand shows the importance of using more than just the percent fines in evaluating liquefaction susceptibility of soils.

The other location where we observed liquefaction from the ground was along a backwater (old channel still connected to the river) of the Eel River at the end of Sage Road. The eroded remnants of sand boils, observed within the tidal zone, revealed a faint structure of concentric rings. The ejected sand at this location was poorly graded and coarser than the liquefied sand along the Salt River. This was confirmed by the gradation curve (triangular symbols). This sand only has one percent passing the No. 200 sieve and a coefficient of uniformity of about 2.

In general, liquefaction did not appear to be widespread, and occurred in locations where it would most likely be expected to occur (low lying areas with very recent alluvial deposits and high ground water). The ejected materials were also the type of material most likely to liquefy (non-cohesive relatively uniform sands). A soil that was only two percent passing the No. 200 sieve from being classified as a silt liquefied.
