(2013) - Seventh International Conference on
Case Histories in Geotechnical Engineering

Bank Instability Problems Associated With the Riverside Construction

BANK INSTABILITY PROBLEMS ASSOCIATED WITH THE RIVERSIDE CONSTRUCTION

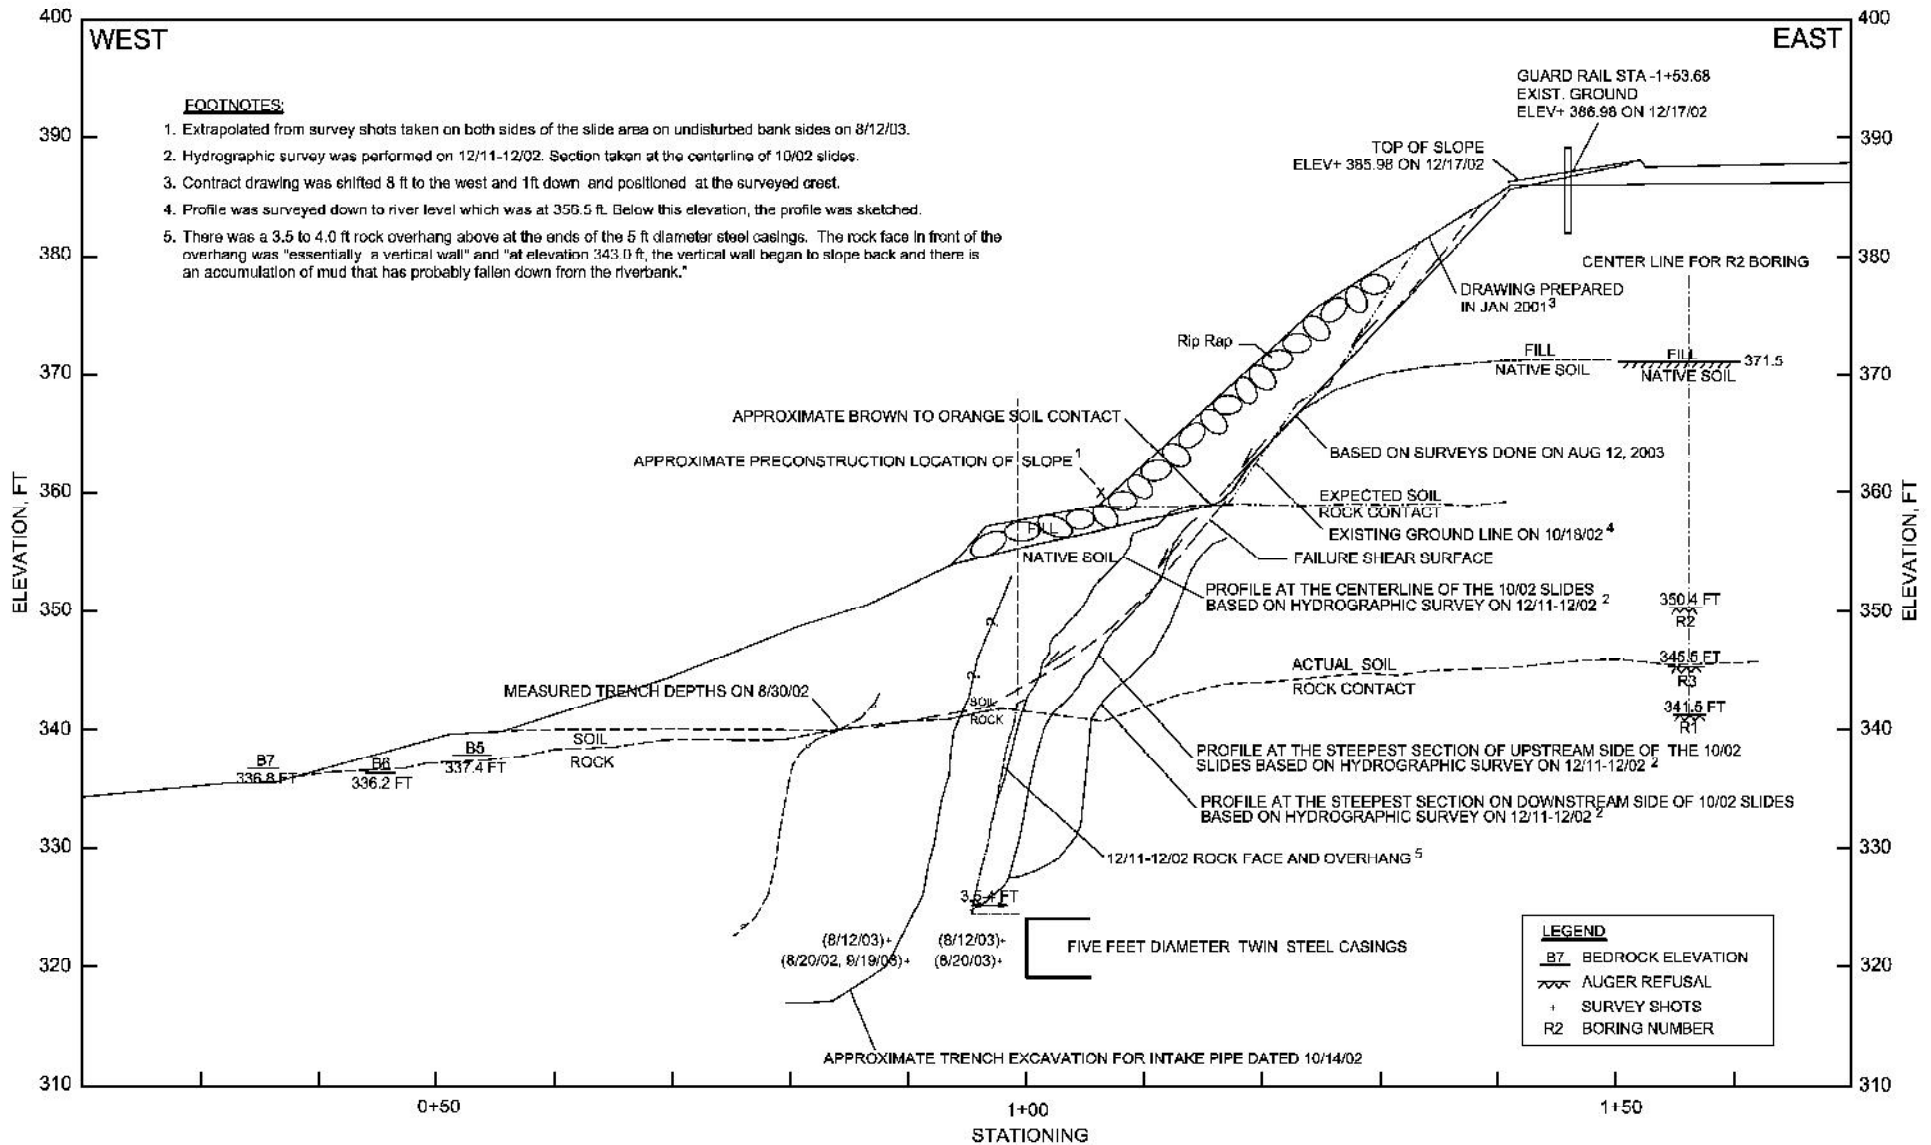
Fig. 2. Topographic profiles with ground conditions along the river bank during trench excavation

The post-construction geotechnical data revealed a lower soil-rock contact than expected and fill/residual soil on the slope below the Normal Pool Elevation (359 ft). According to Boring R-2 the rock surface is 8 to 17.5 ft lower than the indicated rock elevation based on the pre-construction information (see Fig. 2). In addition, the actual pre-construction ground surface was discovered to be 8 ft west of that shown on construction drawings. Therefore, the October

Figure 2 shows the subaqueous trench excavation limits as the work approached the riverbank. Available slope surveys performed above the water are on October 18, 2002 after the October 10-11, 2002 sliding and on August 12, 2003 after the February 20, 2003 adjacent downstream slide; thus these profiles approximate the sliding surface.

As can be seen in Fig. 2, the soil portion of the slope was undercut as the trench excavation preceded towards the bank. On October 10, 2002 the approximate location of the cut was at about Station 0+95. The “clamming” which was done by the contractor on this same day resulted in the nearly 12 ft soil undercut closer to the bank. Clearly this undercutting resulted in the bank instability as the sliding commenced later that same day. Based on the above data, a more representative depiction of the slide configuration is shown on Fig. 2. Consequently, the unstable slope condition resulted in the February 2003 embankment failure triggered by the rapid drawdown of the river.

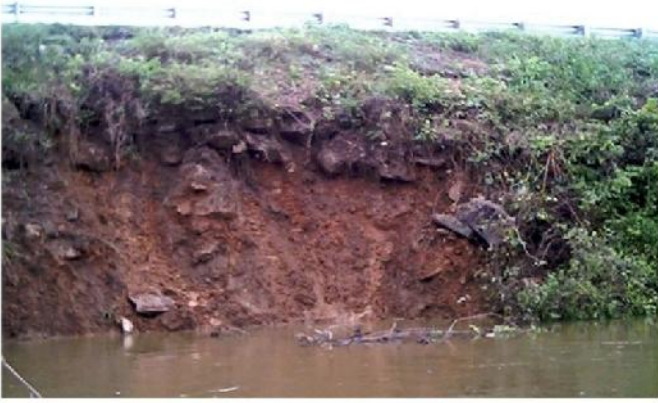
The first above-water slide occurred in the latter part of October 10, 2002. This slide was located about 5 ft upstream

to 20 ft downstream of the planned centerline of the intake pipes up to near the crest of the embankment. A photograph of this slide is shown in Fig. 3. On October, 11, 2002, there were two large cracks reported by the guardrail. Later in the day, this cracked portion of earth also slid off and the slide reached to only 4 ft from the back of the guardrail. It should also be noted that the recorded change in water level in the adjacent river from the period of October 1 to October 10, 2002 was only 555 ft to 559 ft.

Fig. 3. Photograph taken on 10/11/2002 of slide on 10/10/2002. Note pre-existing rip rap covering the slope and that the slide progressed up the slope by the end of the day

The contractor attempted to stabilize the above slide by placing riprap on the failed embankment section assuming bedrock was present, however, without toe support it raveled off the slope. As an alternative, it was decided to merely cover the slope with a tarp to prevent or minimize precipitation for saturating the slope surface (see Fig. 4).

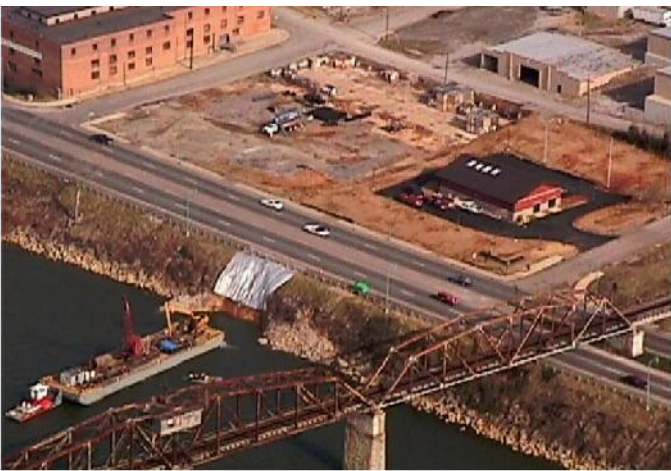
Fig. 4. Air photo taken on 1/22/2003 of tarp covered slide area with orange soil beneath tarp. Note river level on this day varied from Elevation 355.6 to 356.3 ft

Because the bedrock surface was actually over 17 ft deeper, the riprap would not stay on the slope and raveled down to the river bottom. After this attempt failed, the construction team concluded that the best solution was to tarp the slide surface until the intake pipe connections were made. After the bank had steepened for the October 2002 event, the slope became more susceptible to future failure from sudden drawdown conditions.

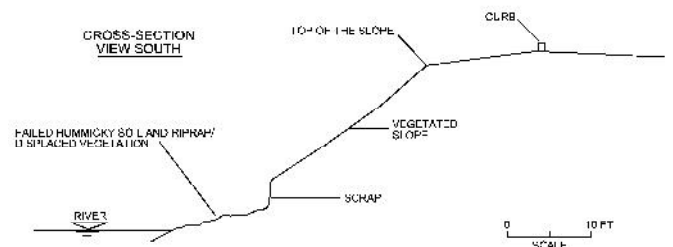
The slope conditions on the east side of the river were studied upstream and downstream of the intake excavation. Conditions were observed from 1400 ft downstream (north) of the project site to a point 800 ft upstream (south) in a rented boat and by walking the slopes. Evidence of minor past slope failures at the river line were extensive along the 2,200 ft long section of the east bank and occur on both the upstream and downstream sides of the intake alignment. The geometry of the slopes consisted of three basic elements starting from the top down to the river edge as follows (see Fig. 5 and Fig. 6):

- Upper vegetated unfailed slope
 - Below (west of) roadway
 - Approximate inclination: 40 to 46°
- Immediate steep slope face (scarp)
 - Approximate inclination: 78 to 90°
 - Typical height: 4 to 7 ft
- Lower flatter slope made up of failed soil and displaced vegetation
 - Approximate inclination: 10 to 33°
 - Typical land width: 5 to 17 ft (east-west)
 - Typical land height: 2 to 9 ft

Fig. 5. Typical cross-section of failed slopes east of riverside drive in project location

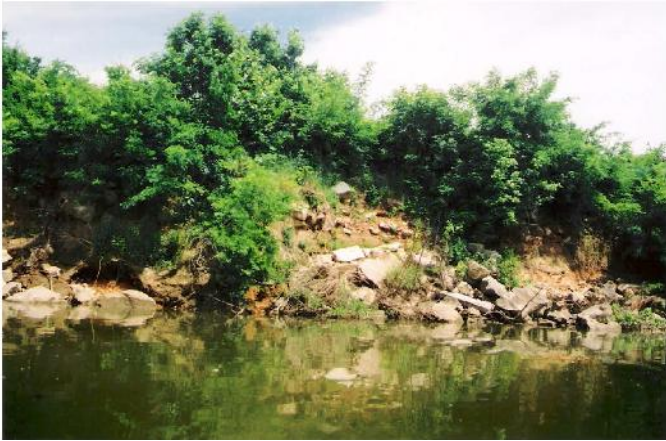
Fig. 6. Failed slope in east bank of river 210 ft south of intake pipeline

The visible slope failures along the east bank of the river occur primarily in the silty brown fill that makes up the highway embankment. In local reaches, the failures include the upper portion of the weathered rock profile and/or colluvium. Bank instability is greatest during and shortly after periods of high

river flow (such as in February 2003) when the second slide occurred. This slope failure mechanism involves oversteepening of the bank by erosion on the outside meander of the river and/or excess pore water pressures in the slope as the water level recedes. A submerged open cut excavation into the toe of a soil slope during placement of the intake pipeline would clearly reduce the stability of the bank similar to a natural river erosional mechanism.

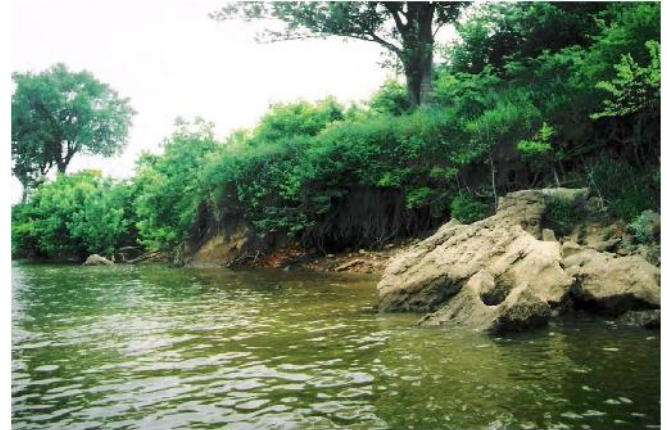
LOCATION: 770 FT SOUTH OF PIPELINE (VIEW NORTH)

At some locations, overhangs have developed along the tops of the immediate slopes as a result of bank failure/erosion and the presence of a thick root mat (see Fig. 7). It is important to

Fig. 7. Overhangs above failed slopes related to bank instability and root mat

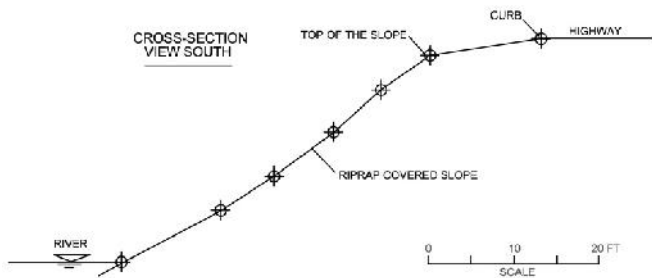
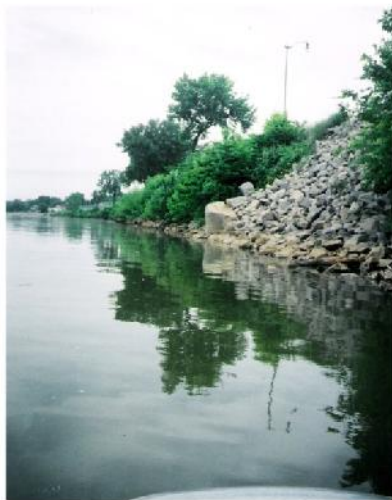
At the time of the site visit, the slope above the intake pipeline was covered by rip rap from the crest down to some unknown distance below the water line. The general profile of the repaired project slope above the pipeline was mapped as well as the slopes immediately adjacent to the project alignment (see Fig. 8). The inclination of the rip rap slope varies between 27° and 42°. The steepest portion of the repaired failed slope is 4 ft below the crest. The vegetated slopes north and south of the pipeline alignment are inclined at angles ranging between 36° and 46°.

Fig. 8. Cross-section along riprap slope above intake pipeline

The 40 to 60 ft wide repaired slope is bounded by upstream and downstream banks that failed in the past and older riprap was visible above and below the water line. Clearly based on a simple site investigation, there was ample evidence of potentially unstable slopes at the river line near the intake pipeline alignment indicating the bedrock surface at some distance below the river level. Due to the close proximity of the roadway to the edge of the bank (approximately 13 ft) and the presence of visible slope failures upstream and downstream of the intake pipe alignment, protection of the roadway during tunnel/open cut construction would be a key design issue.
