Performance of a Pier Consisting of Three Sections

SYNOPSIS A deteriorated 600 ft. long pier in Quincy, Massachusetts consisting of timber pile supported relieving platform and anchored steel sheet pile bulkhead sections was replaced with a new pier. The majority of the new pier consists of a deadman anchored steel sheet pile bulkhead. Due to the proximity of adjacent structures and another existing pier, two areas along the new pier could not accommodate an anchored bulkhead system. In these two areas, relieving platform and double steel sheet pile wall systems were constructed. Inclinometer data showing horizontal movements in the sheeting during the construction and post-construction periods are presented.

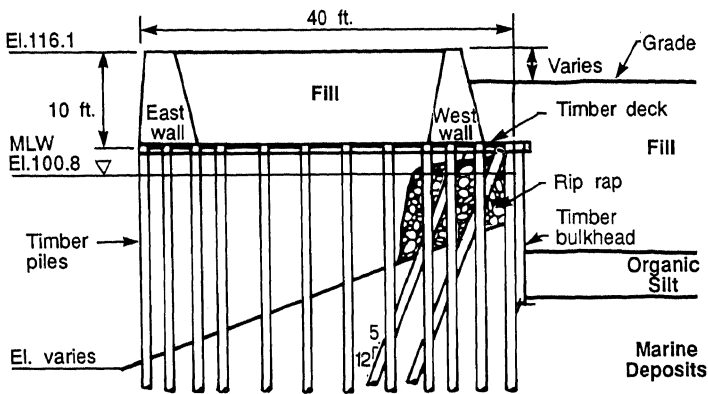
Figure 2 - Previously Existing Relieving Platform

The previously existing pier was approximately 600 ft. long. The northern 500 ft. of the pier consisted of a timber pile supported relieving platform. A typical section across this portion of the pier is shown on Figure 2. The relieving

platform was approximately 40 ft. wide. Vertical and battered piles were situated in bents spaced approximately 5 ft. on-center along the length of the pier. The relieving platform timber deck supported miscellaneous soil fill and two 10 ft. high concrete "walls" which, in turn, supported a crane which ran along the pier. The relieving platform included a timber bulkhead to retain the adjacent soil.

A survey of the previously existing relieving platform indicated that the timber bulkhead and many of the timber piles were rotted. In the anchored bulkhead portion of the pier, corrosion had led to the development of holes in the steel sheeting, resulting in the loss of retained fill and ground subsidence.

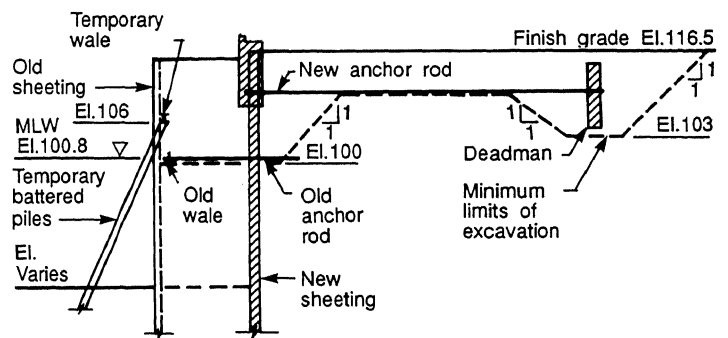
Figure 3a - Anchored Bulkhead at Previously Existing Anchored Bulkhead

The southern 100 ft. of the old pier consisted of a steel sheet pile anchored bulkhead. The dredge line to top of wall height varied from 25 to 30 ft. The bulkhead consisted of PZ38 size interlocking steel sheeting connected to 3 in. diameter steel tie-rods spaced approximately 6 ft. on-center. The tie-rods were anchored to a massive H-pile supported concrete deck which was used in connection with former shipbuilding activities at the site.

A deadman anchored interlocking steel sheet pile bulkhead was adopted as the replacement system for the majority of the pier as the most economical option. Based on an analysis performed using the Free-Earth Support Method with appropriate moment reduction, PZ40 size steel sheet piling was selected for the new bulkhead. The bulkhead consists of 60 ft. long steel sheet piles anchored to a concrete deadman with 3 in. diameter steel tie-rods spaced 6.5 ft. on-center. Sections of the new bulkhead superimposed on the previously existing pier are shown on Figures 3a and 3b.

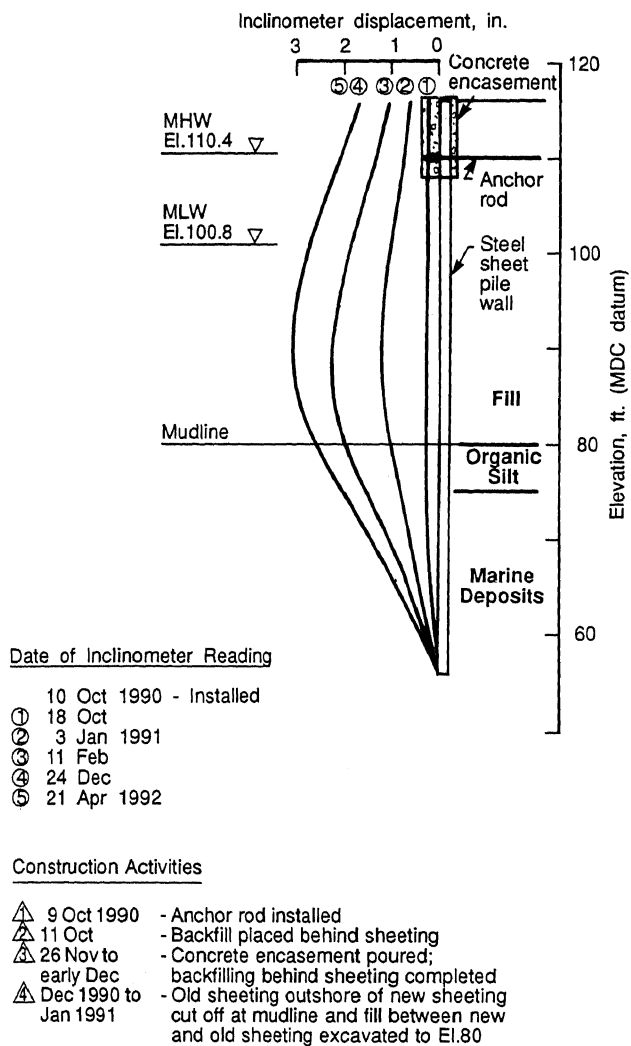
Figure 4 - Measured Displacements at Incliner I-1

Inclinometer I-1 was installed in the portion of the anchored bulkhead along the previously existing steel sheet pile bulkhead. Inclinometer surveys are presented graphically on Figure 4 and discussed below, along with corresponding construction activities.

2. On 9 October 1990, the anchor rods in this area were installed. On 10 October, inclinometer I-1 was installed and surveyed.
3. Backfill was placed behind the steel sheeting to near finished grade on 11 October. An inclinometer survey performed on 18 October indicated resulting total outward horizontal movements of 0.3 in. It is likely that existing fill between the new and old steel sheeting contributed to limiting horizontal movements to these levels.

4. From 26 November to early December, the concrete encasement over the wale and top of sheeting was constructed and backfilling completed to the finished grade of El. 116.5. A survey performed on 3 January 1991 indicated total outward horizontal movements of up to 1.3 in.

5. In December 1990 and January 1991, the old steel sheet pile wall and temporary bracing system were cut off at mudline and removed. The fill between the old and new sheeting was excavated to El. 80. A survey performed on 11 February 1991 indicated total outward lateral movements of up to 2.3 in. with the largest movements occurring just above the mudline, as expected.

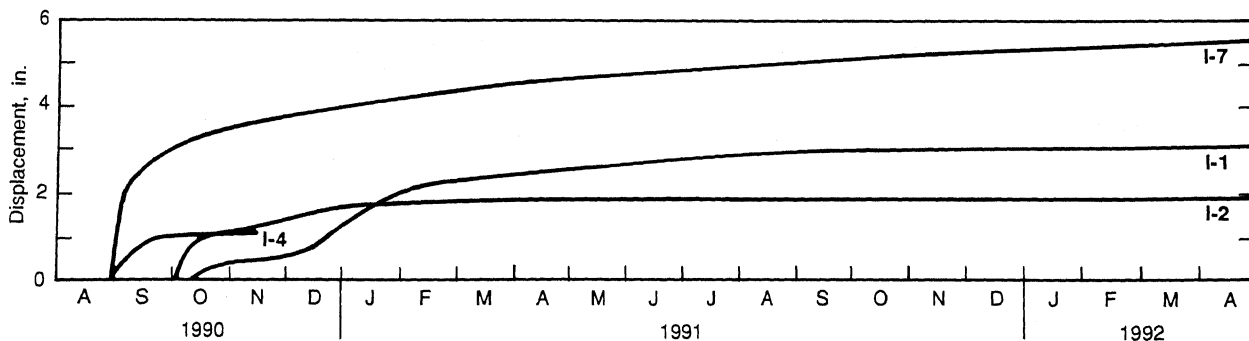
Figure 5 - Incliner Measured Maximum Horizontal Displacements vs. Time

6. Periodic inclinometer surveys performed during the 15 month period following the completion of construction activities indicated outward horizontal movements continued at a decreasing rate, and stabilized after approximately one year, as shown on Figure 5.

5. Periodic inclinometer surveys performed during the 17 month period following the completion of construction activities indicated outward horizontal movements continued at a decreasing rate, and stabilized after approximately one year, as shown on Figure 5.

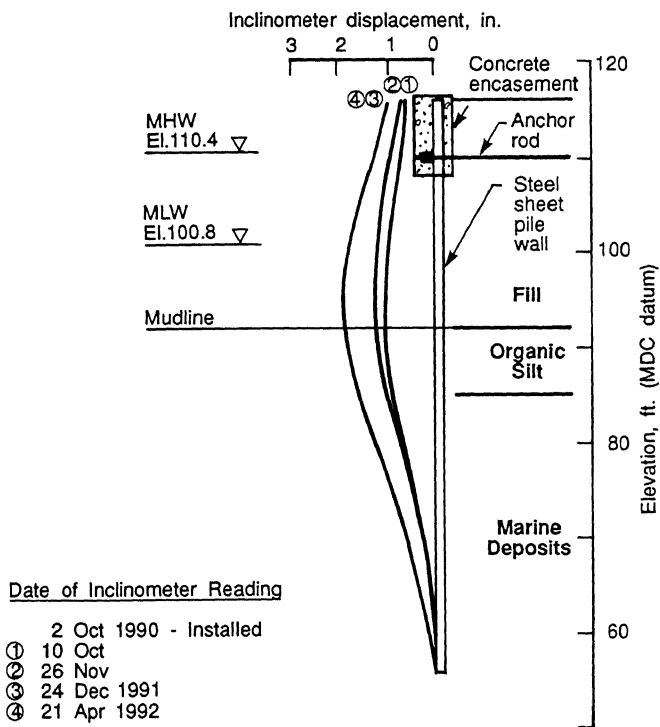
Figure 6 - Measured Displacements at Inclinerometer I-2

Incliner I-2 was installed in a portion of the anchored bulkhead along the previously existing timber relieving platform. Incliner surveys are presented graphically on Figure 6 and discussed below, along with corresponding construction activities.

2. On 2 October 1990, the anchor rods were installed. Incliner I-2 was installed and surveyed on the same day.
3. On 4 October, the majority of the backfill behind the steel sheet pile wall was placed to approximately finished grade, El. 116.5. A survey performed on 10 October indicated total outward horizontal movements of up to 1 in.

4. From 16 to 26 November, the concrete encasement was constructed and backfilling behind the sheeting completed. A survey performed on 26 November indicated total outward horizontal movements of up to 1.3 in. with the largest movements occurring just above mudline, as expected.

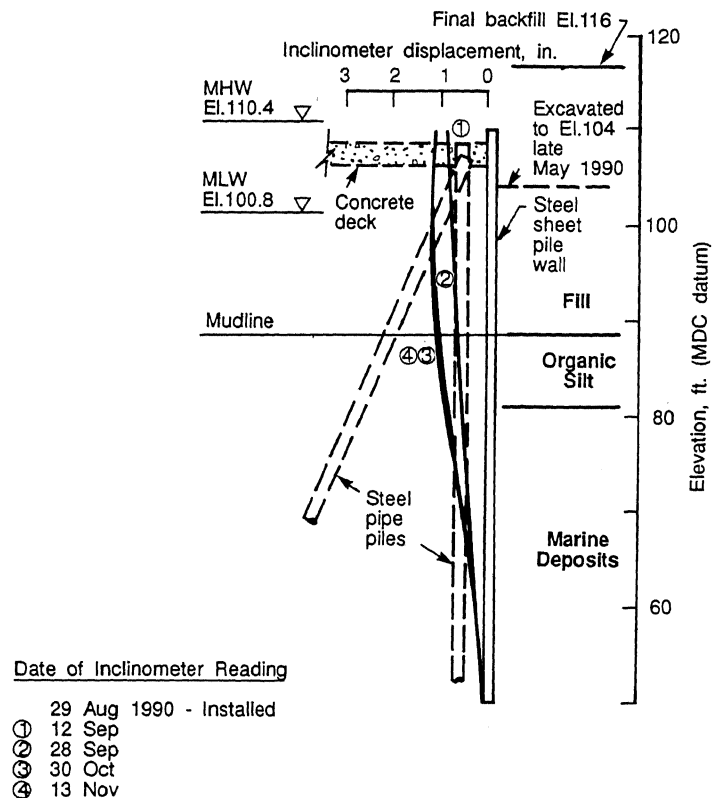
Figure 7 - Measured Displacements at Inclinerometer I-4

Inclinerometer I-4 was installed in the new relieving platform. Inclinerometer surveys are presented graphically on Figure 7 and discussed below, along with corresponding construction activities.

On 29 August 1990, inclinerometer I-4 was installed and surveyed. A survey performed on 12 September indicated total outward horizontal movements of up to 1 in. at the top of the steel sheeting, which was acting as a cantilevered system during this period. Visual observations indicated significant outward horizontal movements had occurred prior to installation of the inclinerometer. These movements were caused by

lateral earth pressures against the sheeting from the existing fill, disturbance from construction activities and reduction in passive earth resistance in front of the sheeting due to the wood pile extraction.

3. On 17 September, the relieving platform concrete deck was constructed, engaging the lateral resistance provided by the battered steel pipe piles. A survey performed on 28 September indicated total outward horizontal movements of up to 1.2 in.
4. On 30 September, backfilling was performed behind the steel sheeting and above the relieving platform deck to approximately finished grade, El. 116.5. A survey performed on 3 October indicated that the filling caused negligible movements of the sheeting. The final survey performed on 13 November indicated no additional movements from the previous reading, suggesting the relieving platform had stabilized, as shown on Figure 5.

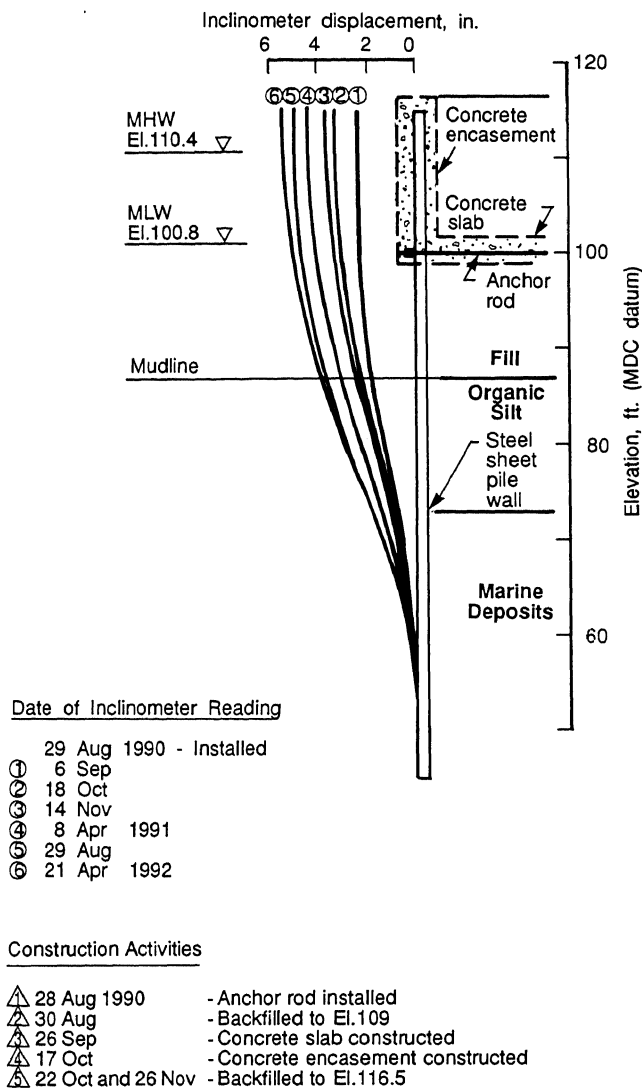
Figure 8 - Measured Displacements at Inclinometer I-7

Inclinometer I-7 was installed in the outshore wall of the double wall section. Inclinometer surveys are presented graphically on Figure 8 and discussed below, along with corresponding construction activities.

3. On 30 August, the zones between the double walls and inshore of the double wall were backfilled to El. 109, or just below the anchor rod elevation. A survey performed on 6 September indicated total outward horizontal movements of up to 2.4 in.

4. On 26 September and 17 October, the concrete slab and encasement, respectively, were constructed. A survey performed on 18 October indicated outward horizontal movements of up to 3.2 in.

5. On 22 October and 5 November, backfilling was completed above the concrete slab to finished grade at El. 116.5. A survey performed on 14 November indicated small additional outward movements of up to 0.4 in. from this activity.

6. Subsequent surveys performed for the 17 month period after the completion of construction activities indicate movements continuing but at a decreasing rate, as shown on Figure 5.
