Dutch Dike Breach, Wilnis 2003

DUTCH DIKE BREACH, WILNIS 2003

S. Van Baars

University of Technology Delft
Delft, The Netherlands

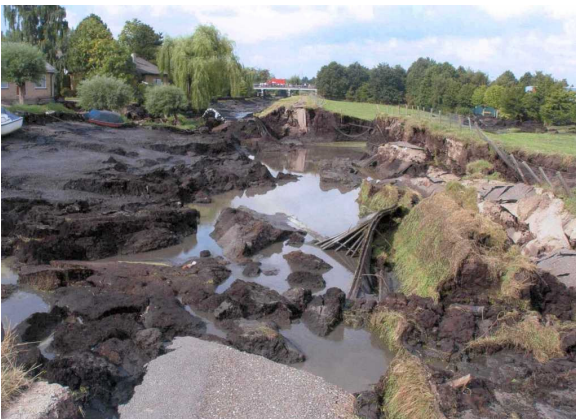
Therefore the Dutch were very much surprised at August 26th 2003, after the warmest and driest summer in fifty years, that a dike along a canal failed. Figure 1. shows the empty canal on the left and the dike on the right. Figure 2. shows the dike after failure. About 50 meter of dike was shifted towards the north (left of the picture), leaving two breaches through which the water from the canal streamed into a lower quarter of the village Wilnis, 30 km Southeast of Amsterdam.

Fig. 1. Canal (left) and dike(right)

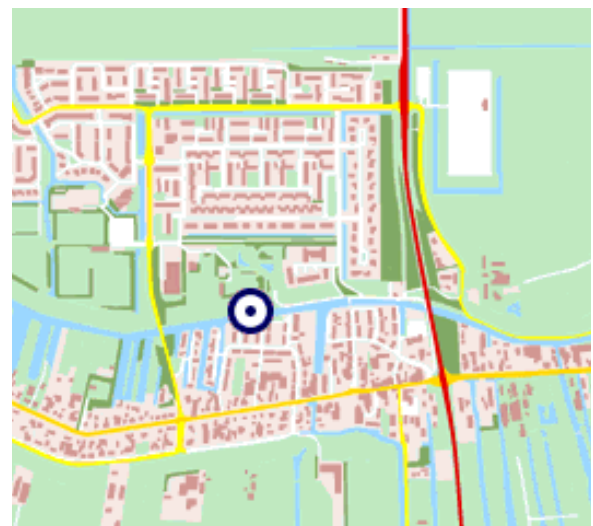
Fig. 4. Wilnis along the ring canal

In figure 4, a dot marks the location of the dike failure. The new housing area Veenzijde is North of this dot and is one of these excavated peat areas. The secondary ring dike between Veenzijde and the canal is not like most of the Dutch dikes man-made, but is a left-over from the peat-excitation. The area south of the ring canal is not excavated and is therefore as high as the

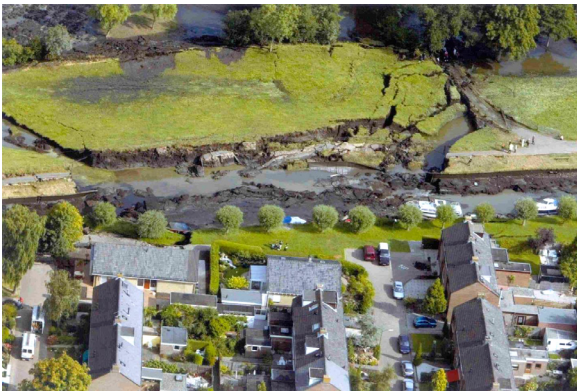
Fig. 5. Shifted part north-dike

In the night of Monday on Tuesday August 26th, at 1:30 h, about 50 m of the secondary dike along the ring canal near Wilnis was translated sideways over 15 m. Because of this, the water in the canal started to run, along both ends of the shifted dike part, into the new housing quarter Veenzijde.

The failure mechanism of the dike is a horizontal pushing aside of the dike. The forces reacting on the dike and sizes are more or less as shown in figure 5. The stability of this dike can be checked easily with a simple one page computation.

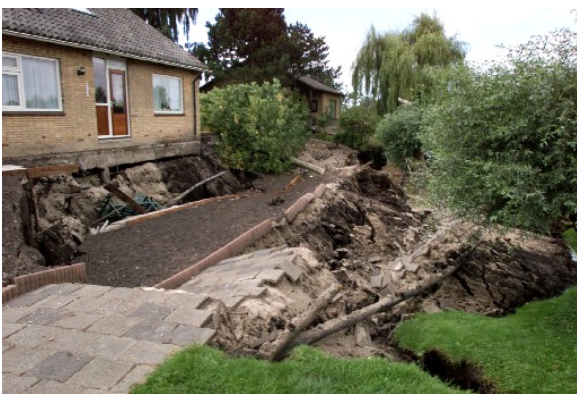
Fig. 6. Circular slip surface failure of the south-quay

Almost all residents could return to their homes the same evening after the water was pumped out of this area. Because of the failure of the north-dike, the water level in the canal dropped instantly. Because of this the supporting horizontal water pressure on the south-quay disappeared, creating this quay to fail by a circular slip surface, see figure 6.

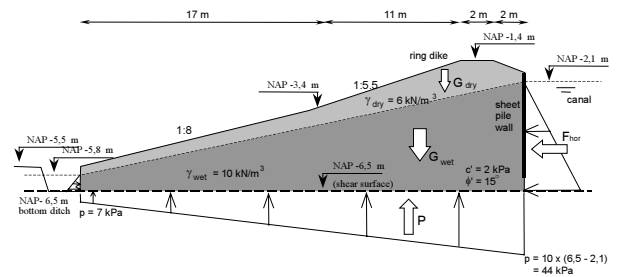
Fig. 7. Cross section and failure mechanism

In figure 7, the total cross section of the dike above the horizontal slip surface is $I_{tot} = 99,85 \text{ m}^2$. The cross section of the peat below the diagonal freatic line is $I_{wet} = 81,6 \text{ m}^2$, so the part of peat which is able to dry out is: $I_{dry} = I_{tot} - I_{wet} = 99,85 - 81,6 = 18,25 \text{ m}^2$. The vertical uplifting water pressure P is identical to the weight of the wet part of the dike G_{wet} , since in this case the specific weight of peat is the same as the specific weight of water.

$$f = 93.35 / 94,35 = 0.99$$

which explains the failure of the dike of Wilnis.

Interesting is that in this case about 2/3 of the maximum shear resistance is obtained from cohesion ($c' A = 2 \times 32 = 64 \text{ kN/m}$) and not from friction. This makes the dike in fact less sensible to mass reduction caused by drying out. So, the drying out was more like the last straw that broke the camels back. The safety of the dike was already rather low.
