Underseepage Control Measures at Painted Rock Dam

SYNOPSIS: Painted Rock Dam, a 181 ft (55.2 m) high, zoned earth embankment detention structure near Gila Bend, Arizona, retained approximately 2.3 million acre ft ($2.8 \times 10^9 \text{ m}^3$) of water for an extended period during the winter of 1978-1979.

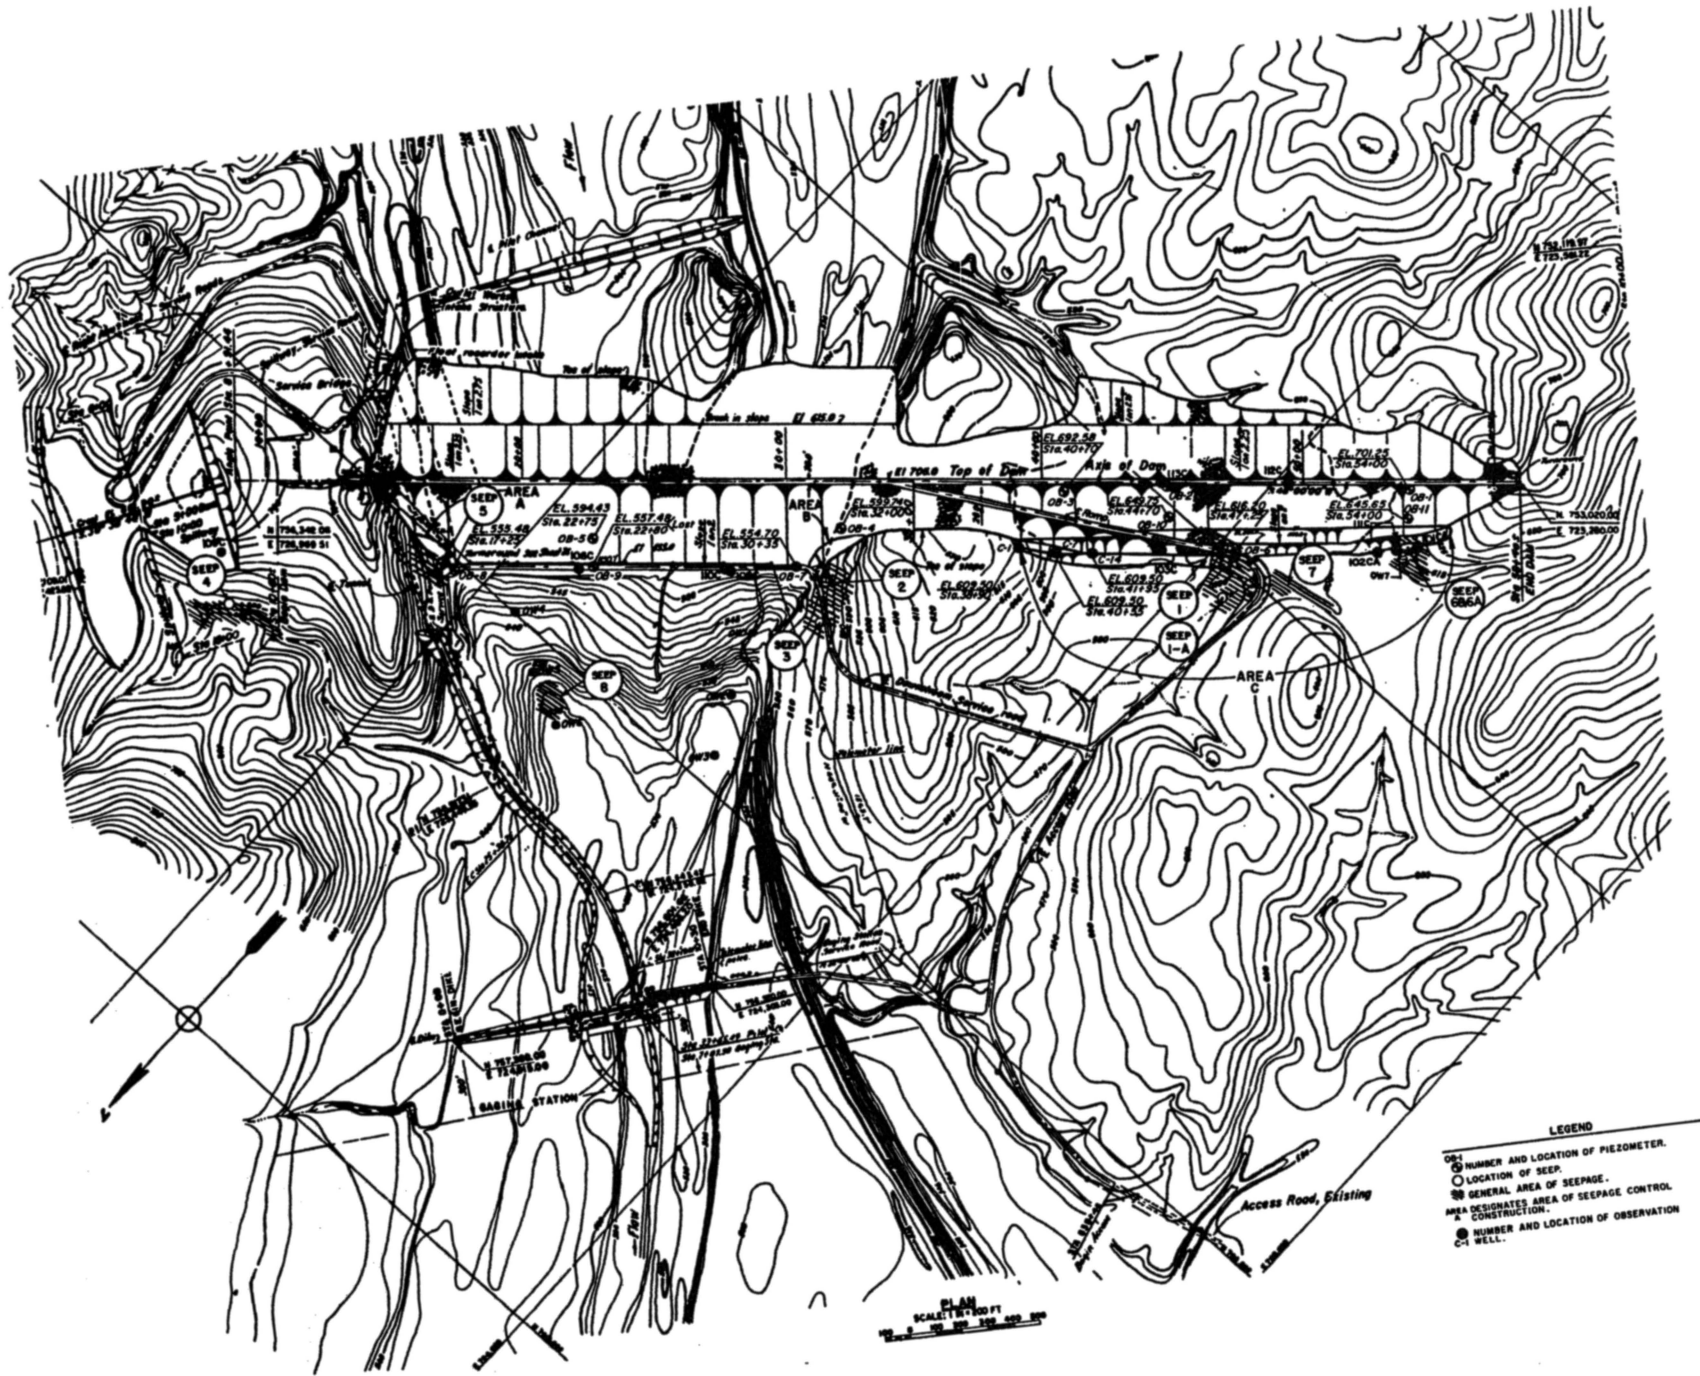
Figure 4. Plan view of Painted Rock Dam showing sequentially numbered seeps in their order of occurrence.

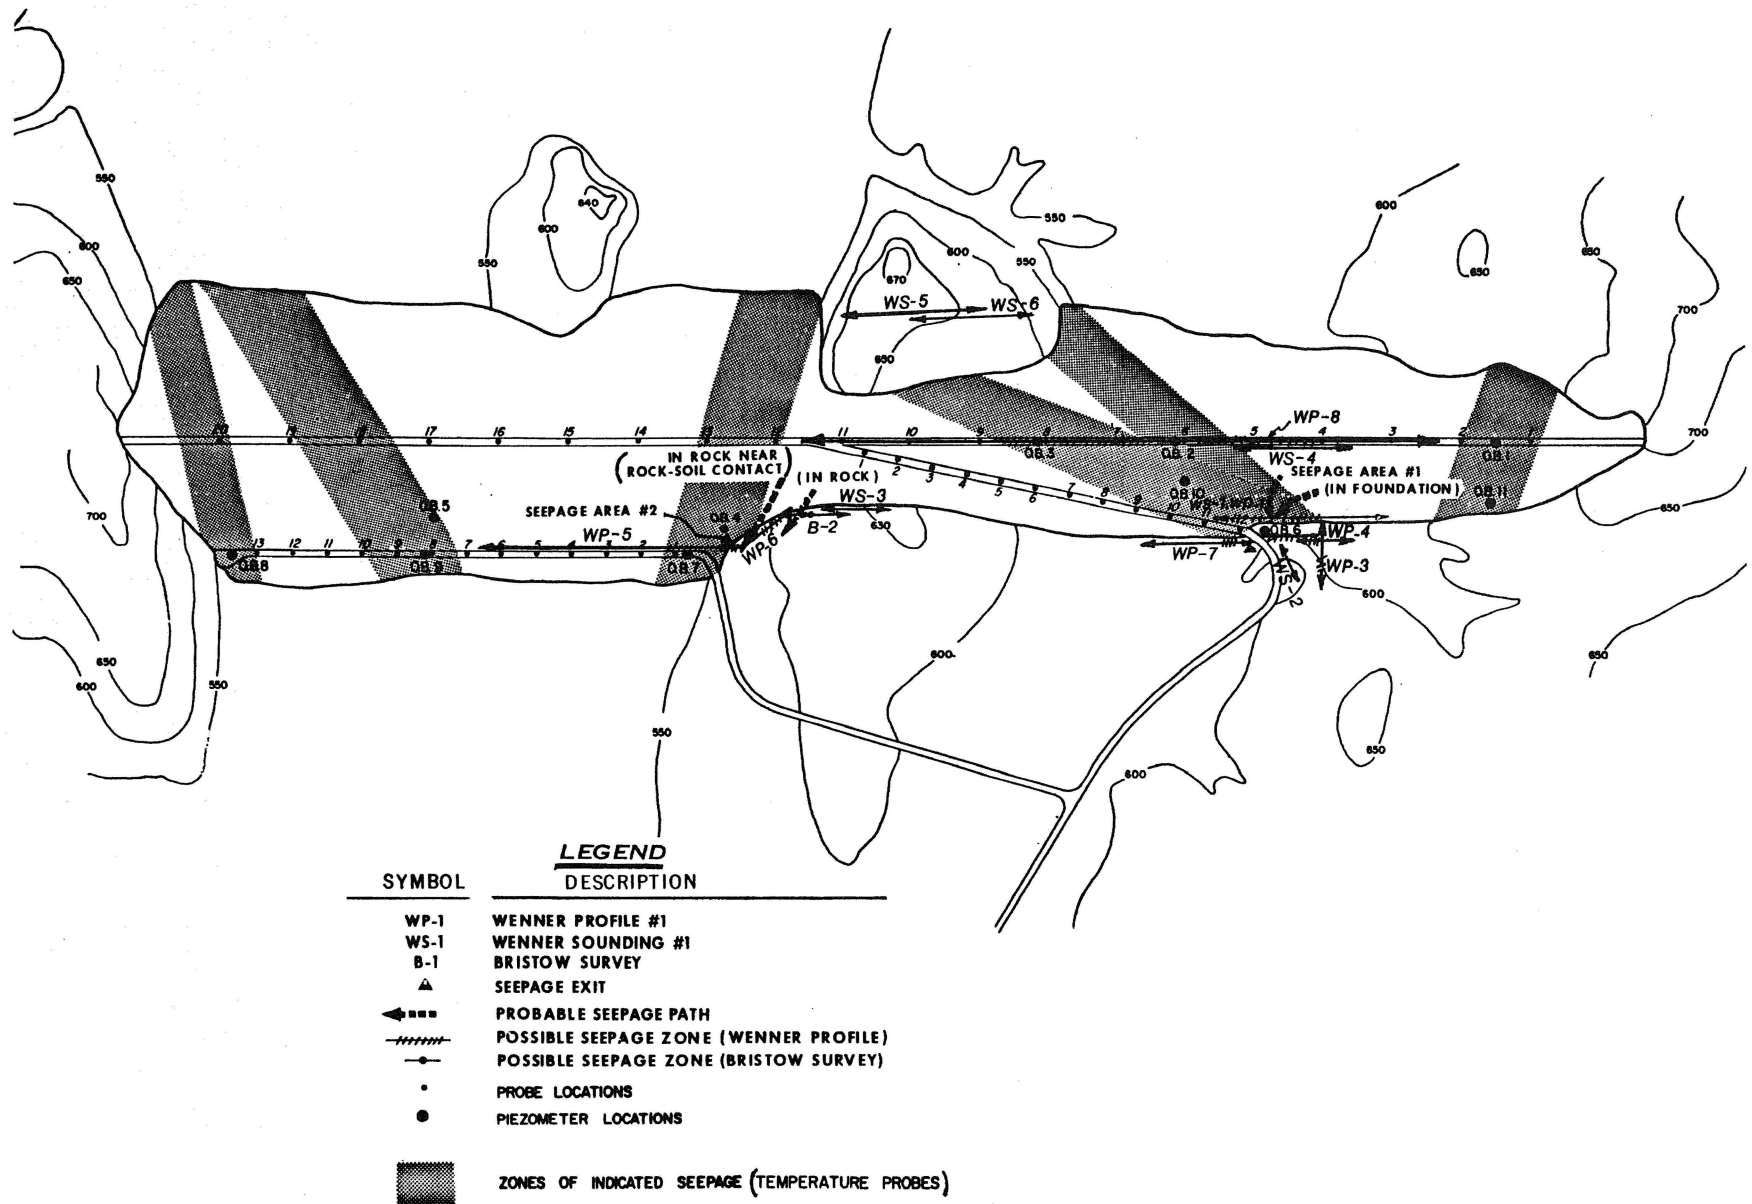
During the period of January 19 to 26, 1979, electrical resistivity surveys were performed in the vicinity of Seeps 1, 2 and 3. The use of Wenner and Bristow arrays resulted in interpreted seepage paths under the dam associated with the rock ridge near Seeps 2 and 3, and in the foundation near Seep 1, where several shallow seepage paths appear to converge.

Figure 5. Plan view showing locations of instruments and surveys used to study seepage. Also shown are the probable seepage paths inferred from the various methods.

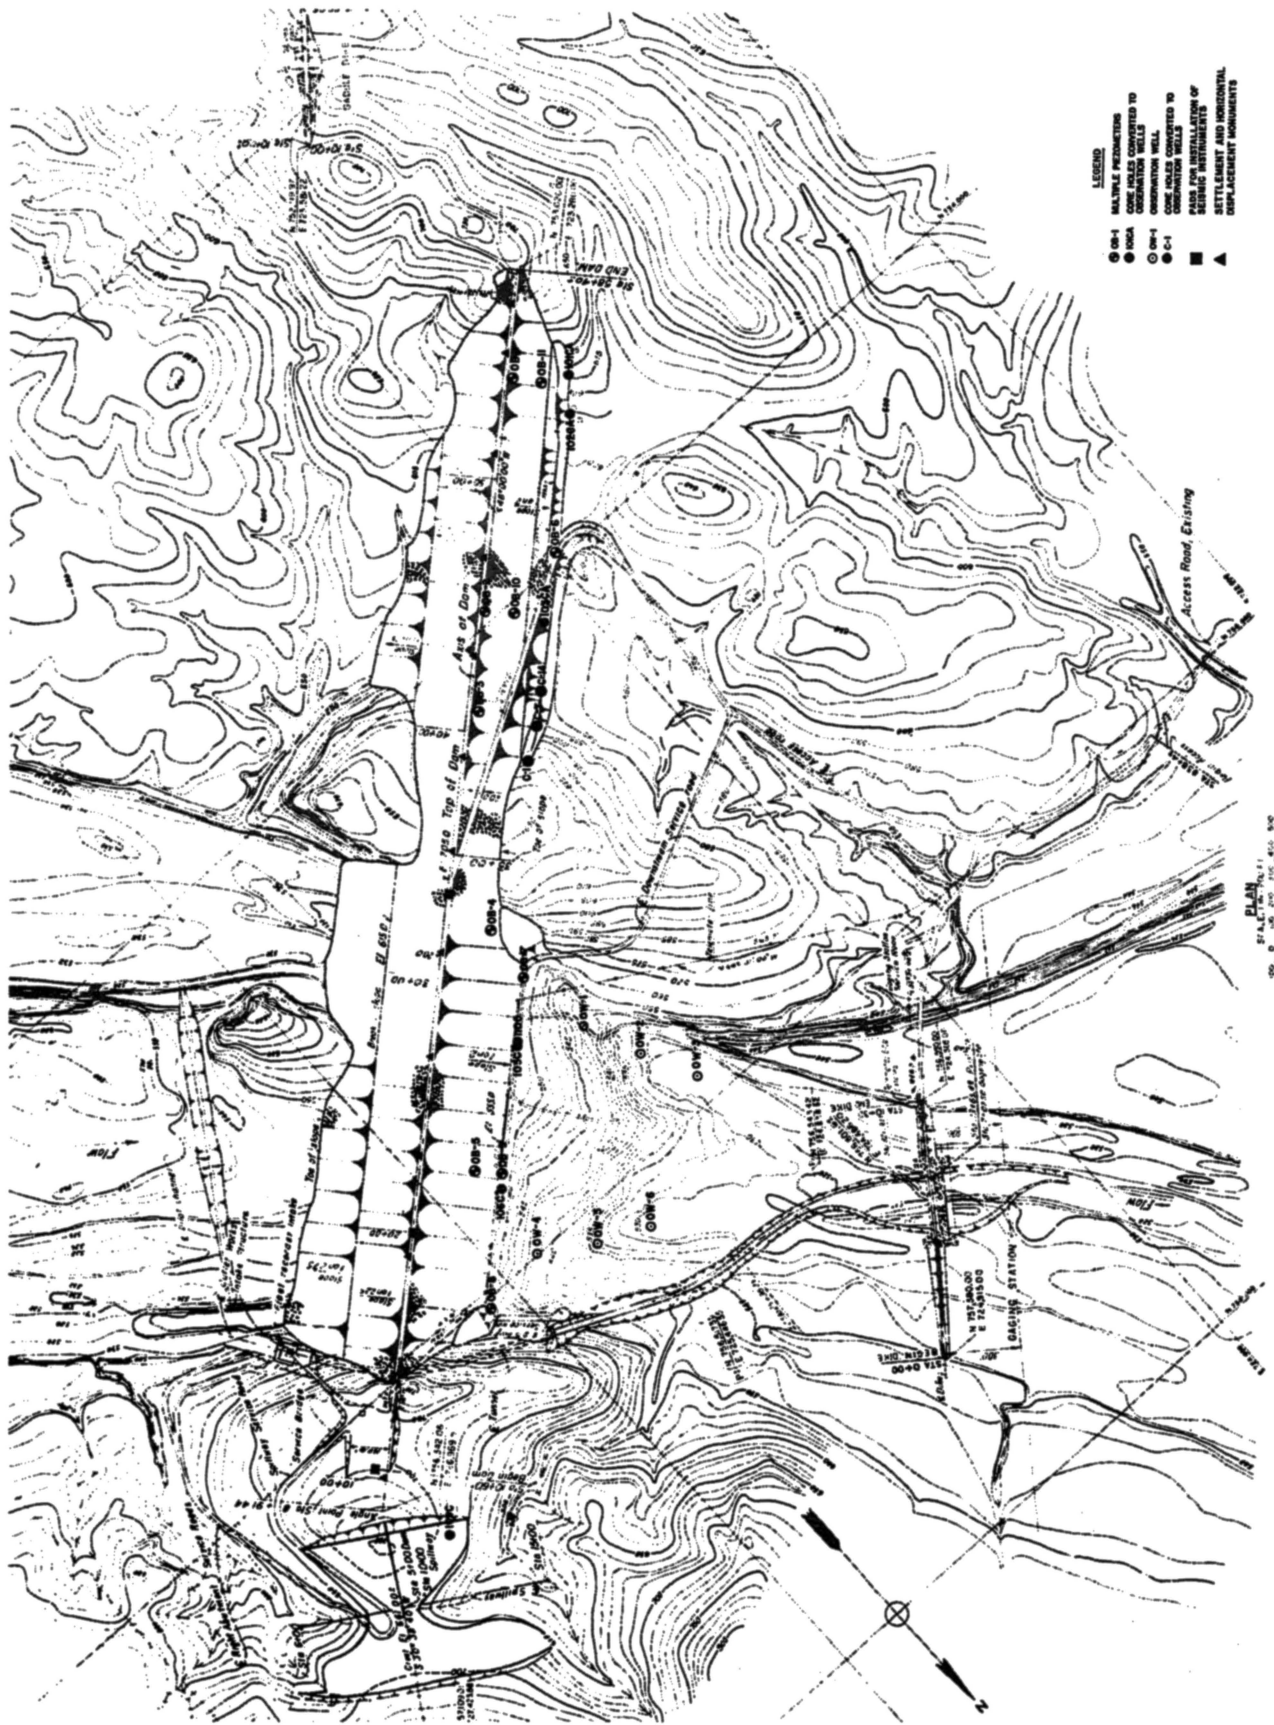
Figure 6. Plan view showing areas of remedial measures and all instrumentation which is presently installed and operating.

Seeps were grouped to form three areas, identified as Areas A, B, and C in Figure 6. Typical cross-sections for the systems constructed in each area are shown in Figures 7 and 8.

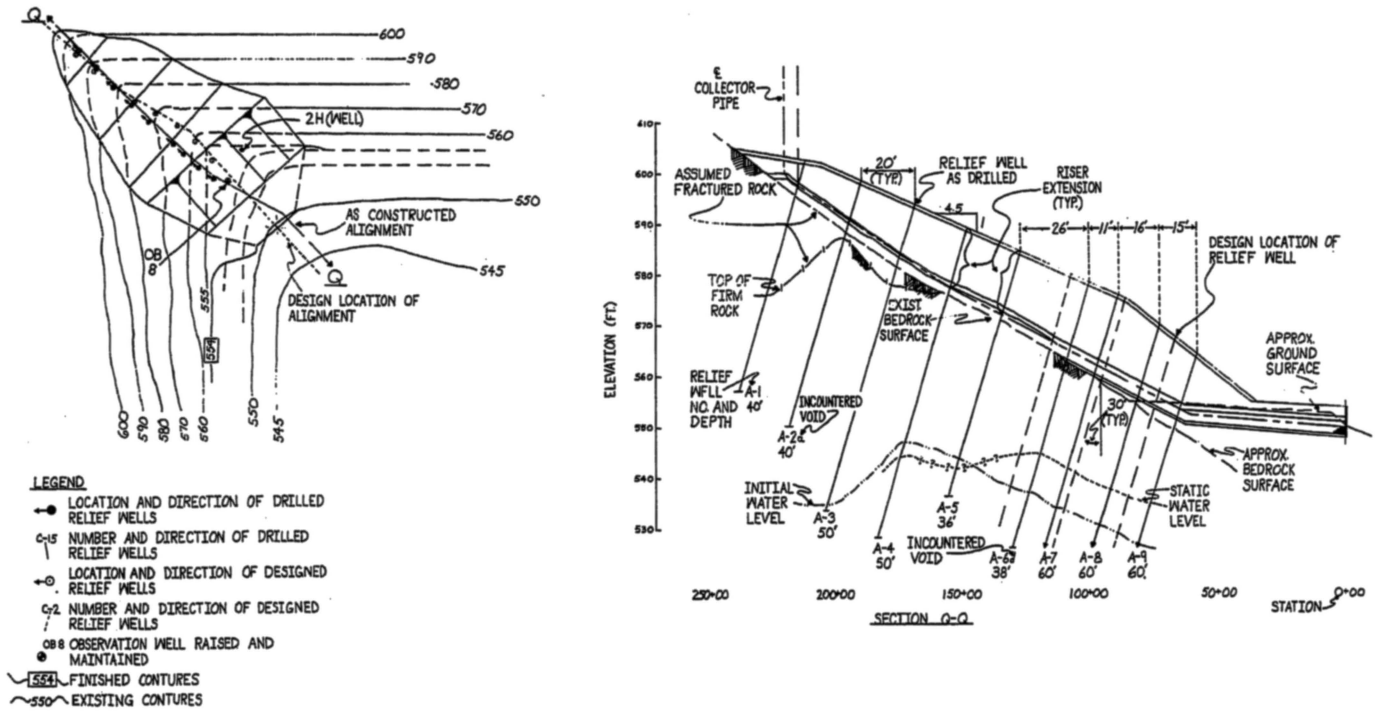
Figure 7. Plan and section of seepage control systems and stability berm constructed in Areas A and B.

Area A, encompassing the right abutment contact and extending to Sta 17+35, contained Seep 5 and had eight wells drilled at least 40 ft (12.2 m) into rock on 20 ft (6 m) centers along the contact. The contact was blanketed with a drain extending over the abutment and embankment 15 ft (4.6 m) in each direction, and a 15 ft (4.6 m) thick stability berm constructed over the area. Drainage discharge was routed through a headwall located on the downstream side of the access road at the toe, Figure 9.

Area B included the embankment-rock ridge contact at the left side of the main valley, extending from Sta 30+72 to 32+76 and encompassing Seeps 2 and 3. The system is the same as described for Area A, with nine wells installed along the contact.

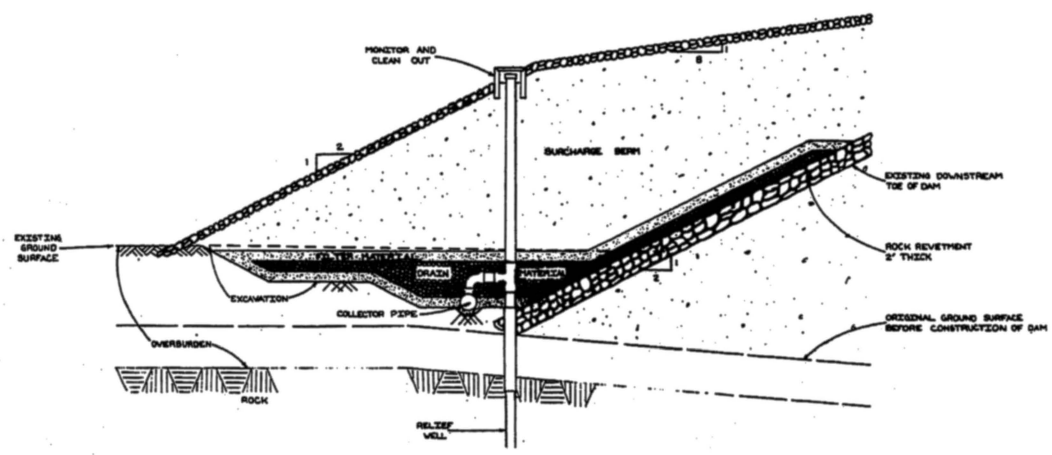
Figure 8. Section of seepage control systems and stability berm construction in Area C.

Area C extends from Sta 40+00 to 54+70 and contains Seeps 1 and 6. It was considered the most critical area due to the shallowness of the foundation alluvium and a contained basin in the rock surface at depth. Four gravel packed relief well systems were installed in this area, totaling 40 wells drilled 40 ft (12.2 m) into rock at 20 ft (6 m) spacing. Wells were deleted when the alluvium exceeded the 15 to 20 ft (4.6 to 6 m) depth. Discharge from each group of wells was routed into a manhole which contains silt basins and provisions for measuring flow quantities. From the manholes the flow is routed to a headwall for discharge. The area was covered with a drainage blanket and stability berm extending onto the embankment, Figure 8.

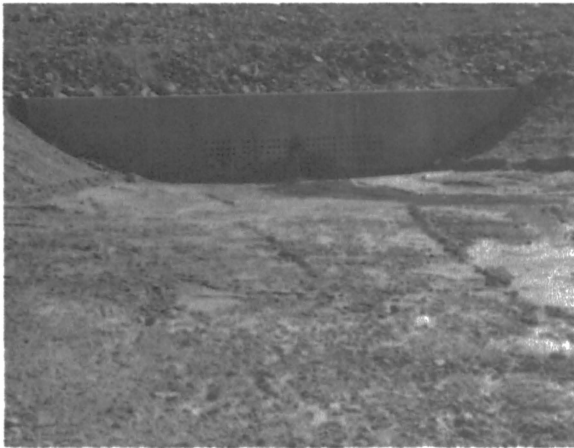
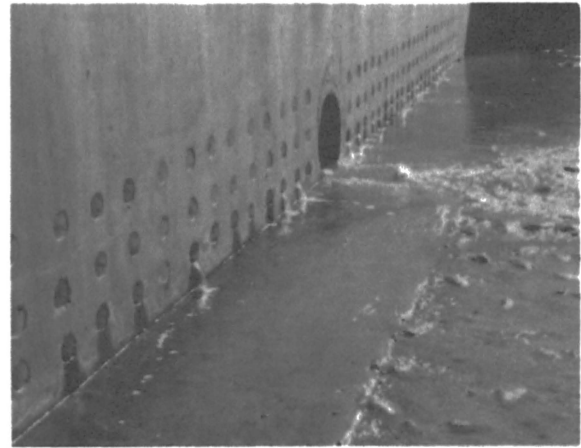
Figure 9. Completed headwalls in Areas B and C. The weephole discharge is from the gravel drainage blankets and the discharge from the larger pipes is from the relief wells.

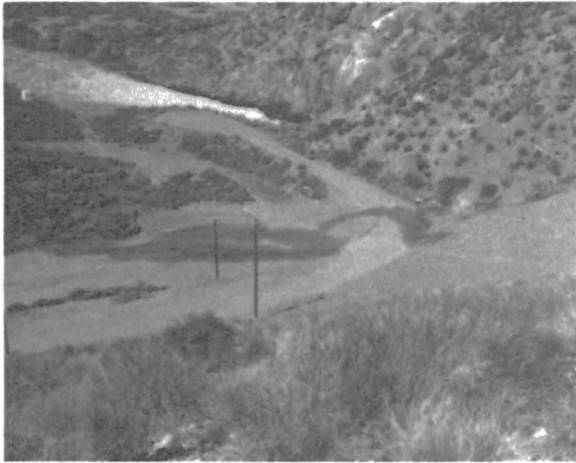
Seeps appeared on the right abutment downstream of Area A, on the rock ridge downstream of Area B, and downstream of the headwall in Area C on March 3, 1980. Additional seepage appeared in Area C on March 4, expanding downstream in a linear fashion a distance of about 35 ft (10.7 m), see Figures 10, 11 and 12.

Figure 10. Area A completed. Flow along toe of surcharge berm is from observation well OB-8 which became artesian with high reservoir elevation and a small seep in the abutment rock.

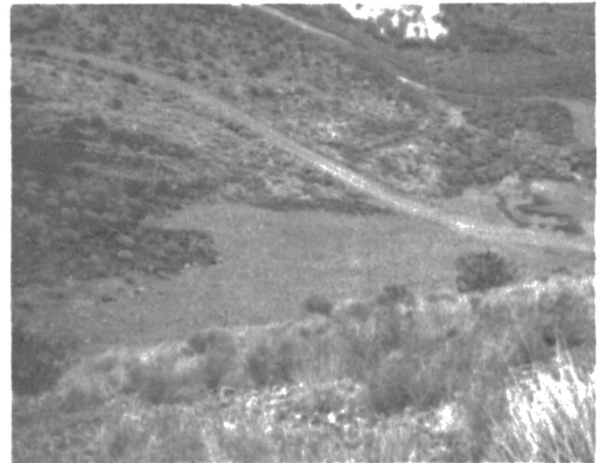
Figure 11. Area B completed. Damp spot in center is from seepage exiting through fractures in the bedrock.

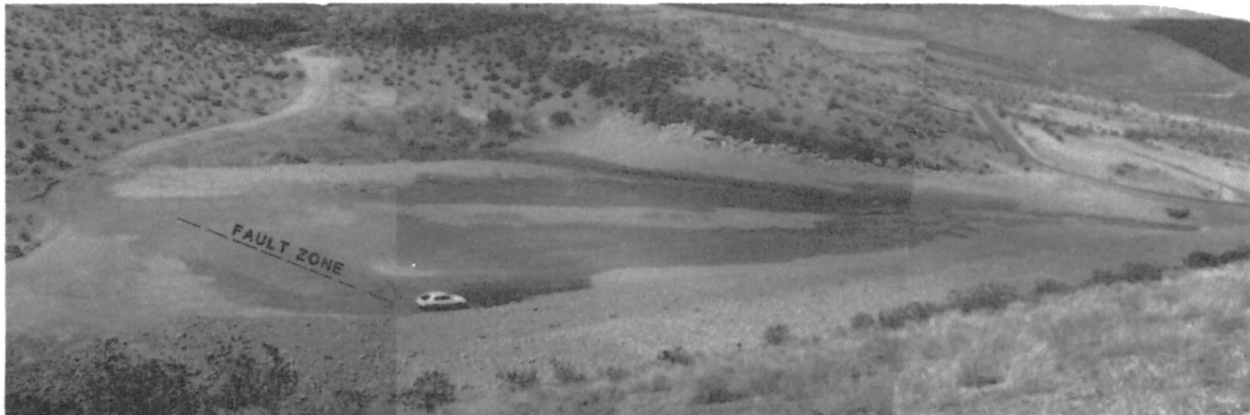
Figure 12. Area C completed. Nuisance surface flow exists along what could be a fault zone. Seepage expanded downstream in a linear fashion along this line.
