Geotechnical Problems of the Underground Excavation in the Deccan Basalts of Sardar Sarovar (Narmada) Project, Gujarat, India

Indra Prakash and J. S. Sangneria

Engineering Geology Division, Operations Gujarat, Geological Survey of India, Gujarat, India

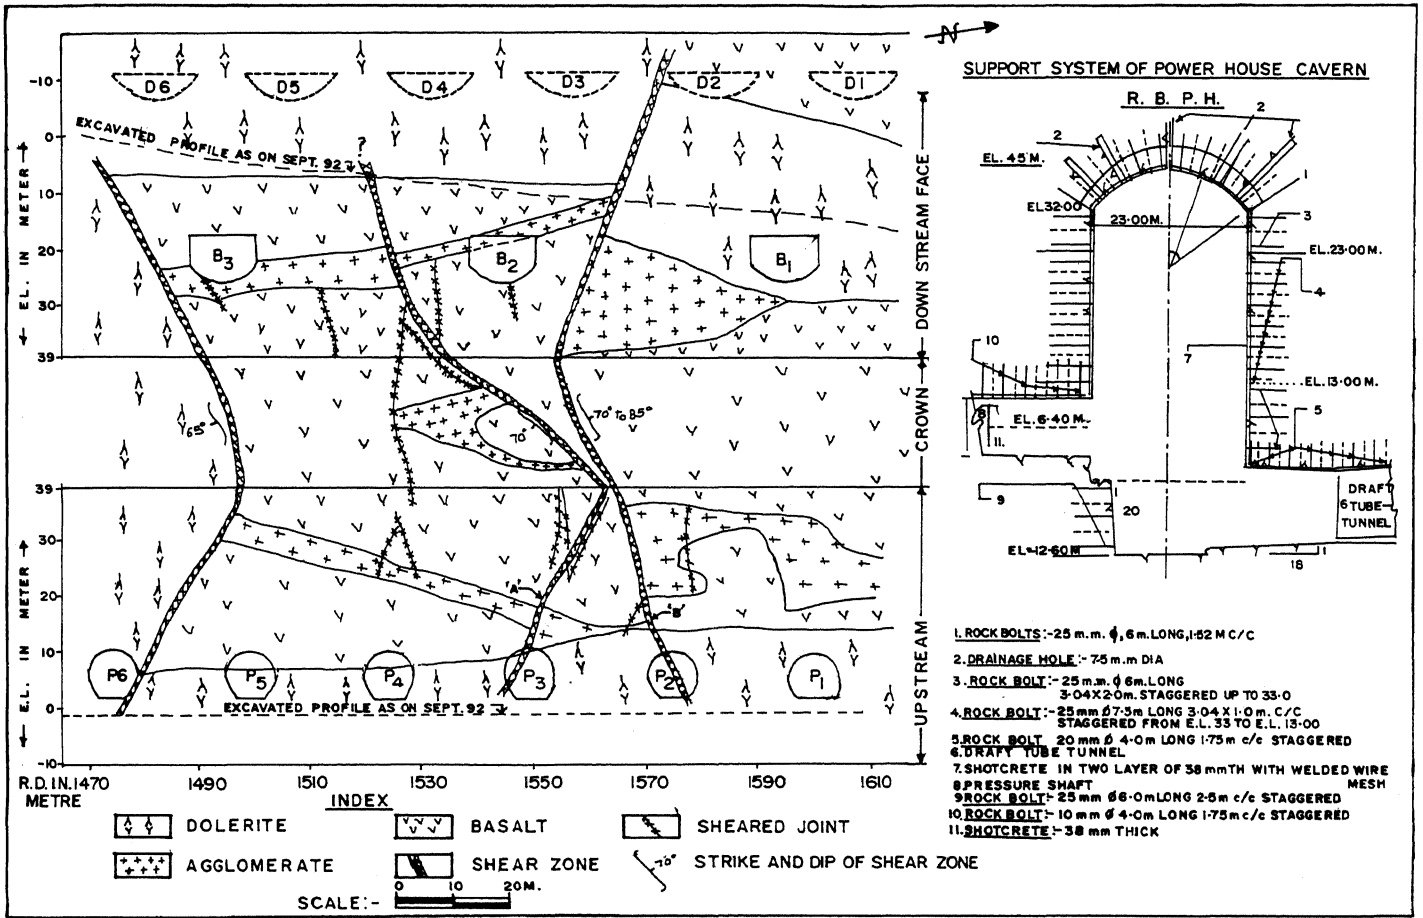
FIG. 3. 3-D GEOLOGICAL LOG OF MACHINE HALL

cracks are developed along and adjacent to shear zones 'A' and 'B' above pressure shafts - 2 & 3 between E1.11 and 37 m. Extension of the cracks inside the rock mass has been observed by opening windows in the shotcrete. Snapping of the wiremesh has also been noticed. Detachment of the shotcrete has been observed just below the spring line of the machine hall in about 30 m length. Maximum dislocation of the shotcrete from rock face of the order of 200 mm has been noticed between E1.36.5 and 37.5 m, that is just below the spring line E1.39 m (Fig.4).

stresses acting on the walls; (d) Sliding or rotational movement of wedge formed between two shear zones 'A' and 'B'. The wedge formed **converges** inside the rock mass in the upstream of the cavern (Fig.3). The size of the wedge is smaller at top and gradually widens towards bottom.

The supports are being provided based on the New Austrian Tunnelling Method (NATM) depending on the rock mass classification of power house cavern. The rock mass is supported by tensioned grouted rock bolts of 6 to 7.5 m length at a spacing varying from 1 m to 1.75 m staggered and two layers of 38 mm thick shotcrete with wiremesh (Fig.3).

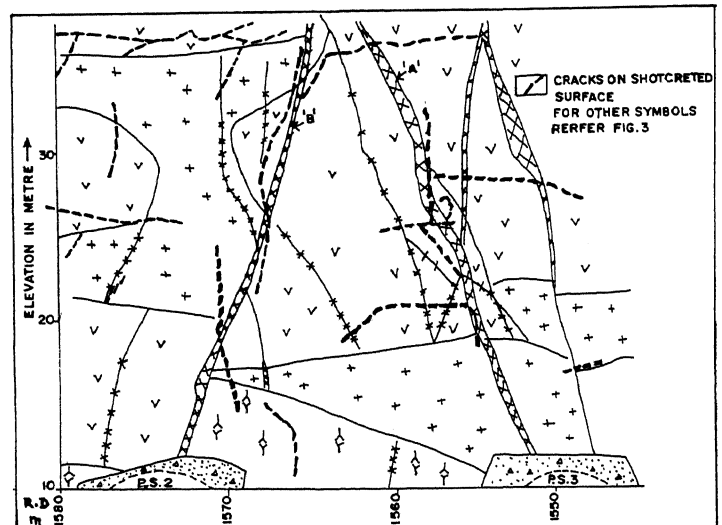
FIG. 4:- PART OF UPSTREAM FACE OF THE MACHINE HALL SHOWING DISPOSITION OF CRACKS.

The crack started developing in the wall when excavation progressed to E1.14 m. The first 18 m high crack at RD 1569 m was noticed in March, 1991. Length of the crack increased from 18 to 22 m in Sept.1991, and new cracks developed during benching operation from E1.14 m to (-)2 m till April 1992. Most of the cracks developed between RD 1547 and 1580 m are vertical in nature with maximum opening of the order of 15 mm. A few horizontal cracks have also been noticed. These vertical & horizontal

Deformation of the rock mass has continued since March, 1991. Reappearance and development of new cracks in the shotcrete and widening of the existing cracks during benching operation from E1.14 to (-) 2 m are some of the evidences of continuous deformation. Glass plates installed across the cracks are also found broken. Monitoring of these cracks by Demacpoints and crack meter is in progress.

The probable reasons for the development of cracks can be one or the combination of (a) Differential movement of rocks in the vicinity of shear zones; (b) Adjustment of rock mass between inadequately supported pressure shaft openings; (c) High in-situ

The remedial measures includes provision of additional longer rock bolts at shorter spacing and or long tendons besides additional layer of shotcrete and improvement of the disturbed rock mass by grouting and drainage. The exact dimension and spacing of the tendons will be governed by the results of finite element analysis under progress.

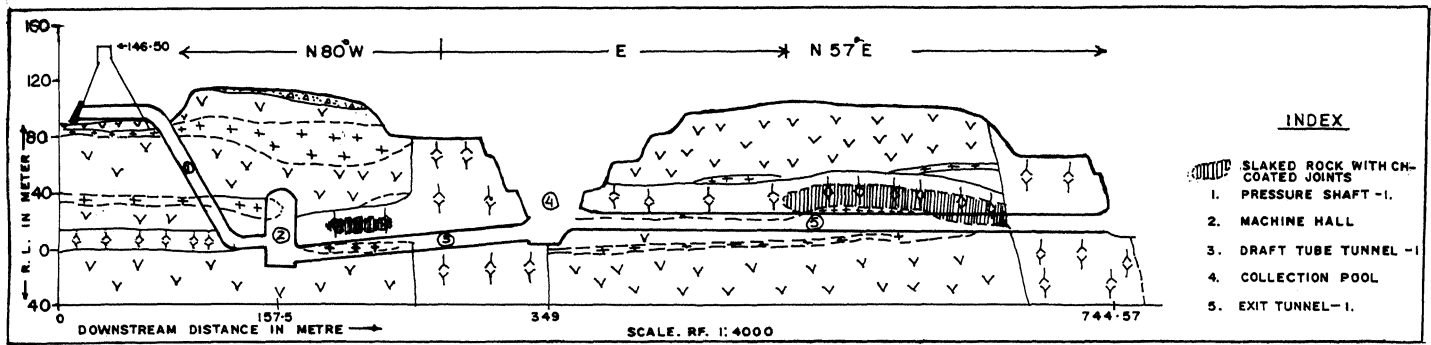
FIG.5.GEOLOGICAL SECTION ALONG WATER CONDUCTOR SYSTEM (A - A') (FOR INDEX REFER FIG-3)

Horse shoe shaped exit tunnels (E.T) of 12.5 m diameter are passing through basalt, agglomerate, dolerite dyke and sill. The Akkalbar fault runs parallel and close to the alignment of E.T-1 from the outlet portal (RD 0 m) to kink point (RD 222 m). Joints sympathetic to the fault are traversing all the three tunnels, but they are more prominent in the E.T-1. A low dipping shear zone dipping 30° towards south (outlet end) is crossing the alignment of E.T-1 at RD 100 m, E.T-2 at RD 62 m and E.T-3 at RD 50 m. Minor water seepage has been noticed along this shear (Prakash & Chidamburanathan, 1991). About 50% of the tunnel length is passing through slacked dolerite/chlorite coated joints (Fig.5). The physico-engineering properties of the dolerite are given in the table-3.

Laboratory shear tests of the chlorite coated joints have given the value of C as zero and $\phi = 18^\circ$. Low value of the shear parameters of the chlorite coated joints are indicative of poor shear strength of rock mass.

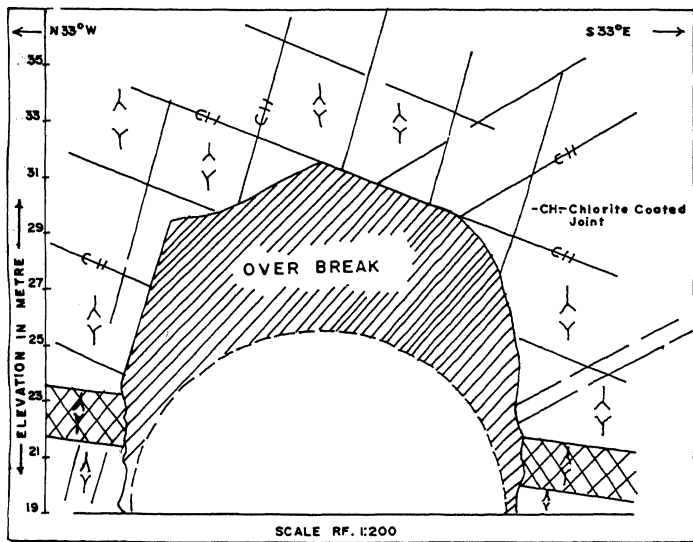
FIG.6. GEOLOGICAL CROSS SECTION OF EXIT TUNNEL-1. RD.79 m. (FOR INDEX REFER FIG.3)

Major roof falls/block falls occurred in the exit tunnel-1 between RD 0 and 113 m after the installation of the rock bolts (Fig.6). About 50% rock bolts have been reported to be slipped in the slacked/chloritized zone during tensioning. Second layer of the shotcrete with wiremesh was not provided in the month of May 1990 and subsequently resulted in the roof falls in the month of Sept.1990 after the entry of flood water. Intersection of three sets of chlorite coated joints are forming removable/detachable blocks of size varying from 0.5 x 1 x 2 m to 1 x 2 x 3m resulting in block falls in the exit tunnels at places. Pattern rock bolts could not prevent the collapses in the slacked rock zones. Design support system based on rock mass classification included pattern tensioned grouted rock bolts and shotcreted with intervening wiremesh. Goodman & Hatzor (1990) opined that in highly discontinuous rock formations general rock classification is questionable. After the collapses support system was reviewed and steel rib supports were introduced in all the tunnels at critical locations.
