Performance of Lightweight Structures During Liquefaction From Recent Earthquakes

PERFORMANCE OF LIGHTWEIGHT STRUCTURES DURING LIQUEFACTION FROM RECENT EARTHQUAKES

Jorge F. Meneses, PhD
Kleinfelder Inc.
San Diego, CA, USA

Yun Liao, PhD
Kleinfelder Inc.
Oakland, CA, USA

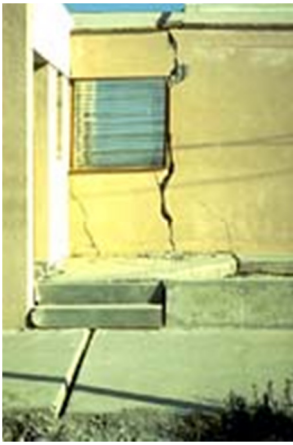
Cauçete is a city in the province of San Juan, Argentina. The epicenter of this destructive earthquake was located approximately 80 km northeast of the city of San Juan. The shallow main shock triggered landslides and liquefaction in the epicentral area. Several hundred square kilometers, and possibly thousands of square kilometers, were affected by liquefaction in low areas north and northwest of the epicenter. Hundreds of adobe and brick masonry housing partially or completely collapsed as a result of induced soil movements due to liquefaction. Surface manifestation of liquefaction included not only sand boils but large linear and arcuate fissures. Reports indicate that this feature was one meter wide and more than two meters deep. Also it was reported vertical movements up to approximately one meter (NISEE 1997; EERI 1997). Figures 1a and 1b present some representative liquefaction-induced damage to one-story houses.

Figure 1a. Liquefaction-induced differential settlement of a one-story masonry house (NISEE 1997)

Figure 1b. Damaged reinforced concrete slab of same one-story masonry house (NISEE 1997)

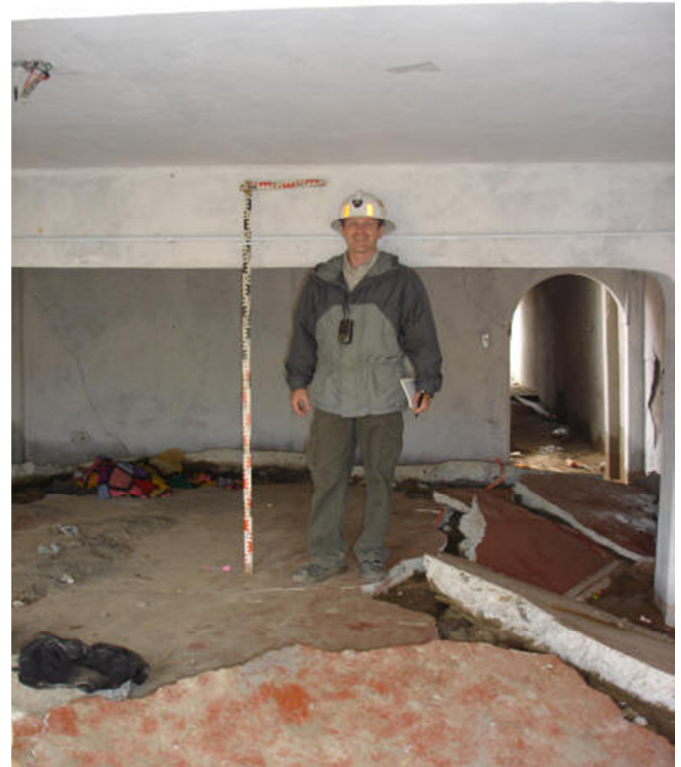
Figure 2b. Interior of a one-story masonry house affected by liquefaction with settlement of approximately 0.7 m. Note the completely damaged concrete slab on ground (GEER 2007)

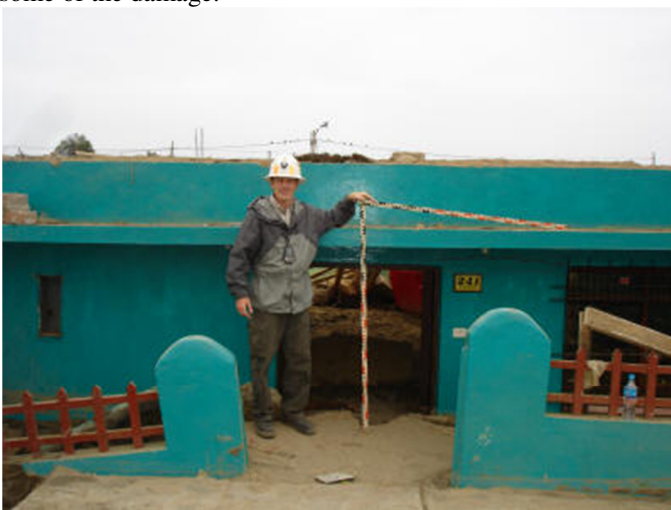
This earthquake caused severe ground-failure induced damage to urban and transportation infrastructure over a wide region south of Lima, the capital of Peru. Widespread foundation bearing capacity failures induced by liquefaction of about one hundred relatively light weight one- to two-story buildings in the town of Tambo de Mora (measured settlements up to 0.9 m) were reported by Meneses (2008). In addition, a low intensity lateral spread failure of an embankment in the Villa area of Lima (approximately 90 km north of the rupture plane) severely damaged to the verge of collapse more than one hundred confined brick masonry houses. Estimated lateral spread was up to approximately 3.9 m (GEER 2007). Local authorities at Tambo de Mora decided to relocate the entire town to a higher ground location. Figures 2a and 2b illustrate some of the damage.

Figure 2a. Liquefaction-induced settlement of about 0.9 m of a one-story masonry house in Tambo de Mora, Peru (GEER 2007)

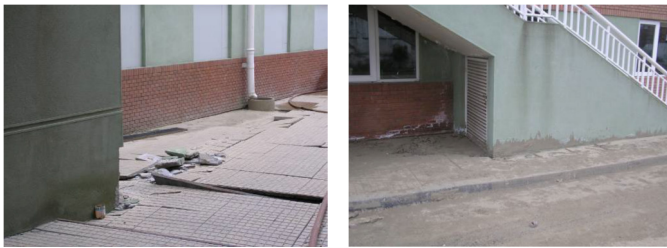
Sediment ejecta were observed in many locations as shown in Figure 3. The ejecta appeared to range from plastic silts to low plasticity silty sands. Liquefaction-induced ground deformation caused translational movements and tilts of the building. There was also evidence of internal distortion of these structures and their foundations.

Figure 3 Sediment ejecta observed around Hospital Provincia wings (GEER, 2010)

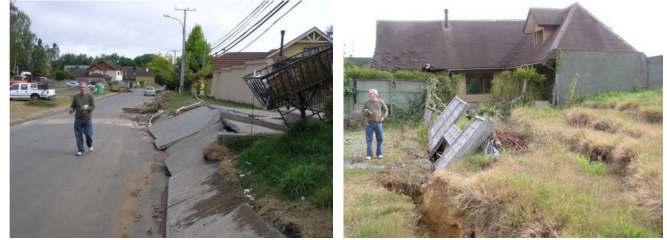
Several up-scale homes in the northern part of Concepción were damaged by a translational landslide movement. Shallow groundwater was observed at the site near the toe of the slide. The slide appeared to be relatively shallow with its toe compressing ground in a zone that was about 8 m wide, its head scarp causing a series of parallel extension cracks over a zone that was about 11 m wide (Figure 4), and its body between the toe and head scarp showing little evidence of internal ground distortion within it (GEER, 2010). At the toe of the slide, the ground shortened about one m and pushed up about one m due to compression across a zone that was initially 8.5 m wide.

Figure 4. A damaged house located at toe of landslide (left); a damaged house located at head scarp of landslide (right) (GEER, 2010)

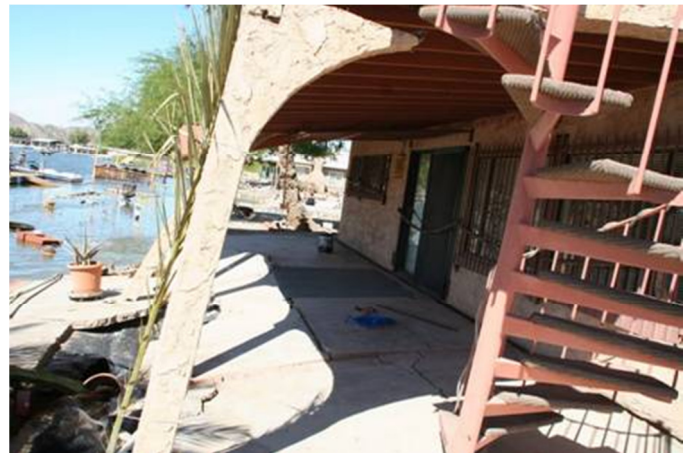
Figure 5 – House affected by lateral spread in Rio Hardy, Baja California, Mexico.

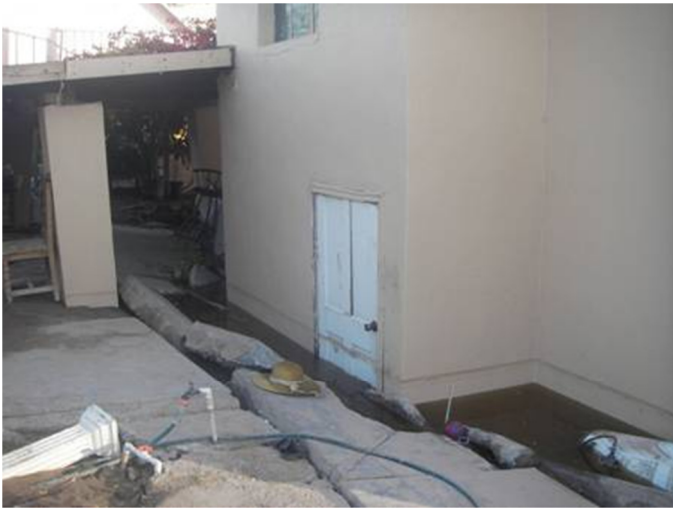
Figure 6 – Settlement of approximately 1 meter in a two-story house in Oaxaca, Mexicali Valley, Baja California.

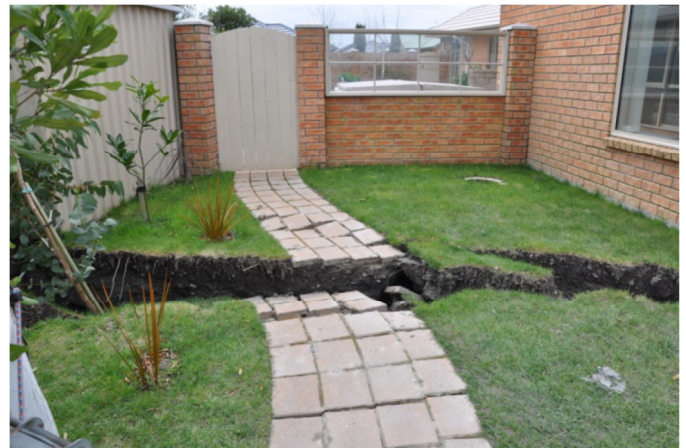
A large number of residential houses in Bexley were damaged by widespread liquefaction and associated lateral spreading. Bexley is bounded by the Avon River on the east side and by the Bexley wetland on the south side. Figure 8a shows a large ground crack due to lateral spreading at Kokopu Place. Cracks occurred in unreinforced slabs induced by lateral spread were also observed as shown in Figure 8b.

Figure 8a. Large ground cracks due to lateral spreading at Kokopu Pl (GEER, 2010b)

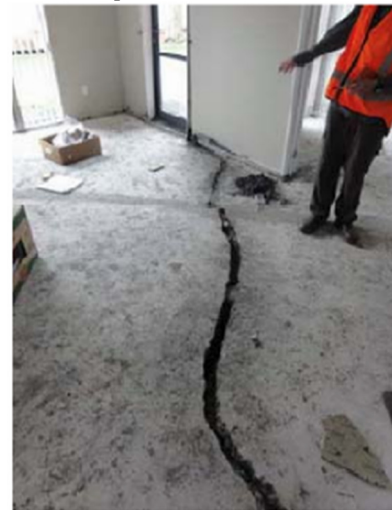
Figure 8b. Cracks in unreinforced slab induced by lateral spreading (GEER, 2010b)

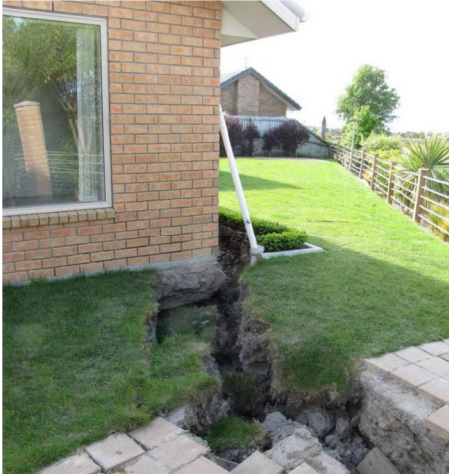
Figure 9 shows the compromised ground support beneath the

concrete slab-on-grade house foundation induced by lateral spreading. The floor slab fissure measured 5 to 7 cm wide extended through the full width of the house. The house was observed to be subject to no significant tilting despite the house being subject to settlement. No significant damage to the walls of the building was observed as well.

Figure 9. Lateral spreading compromising ground support beneath the concrete slab-on-grade foundation at Kokopu Street (outside of the building) (GEER, 2010b).

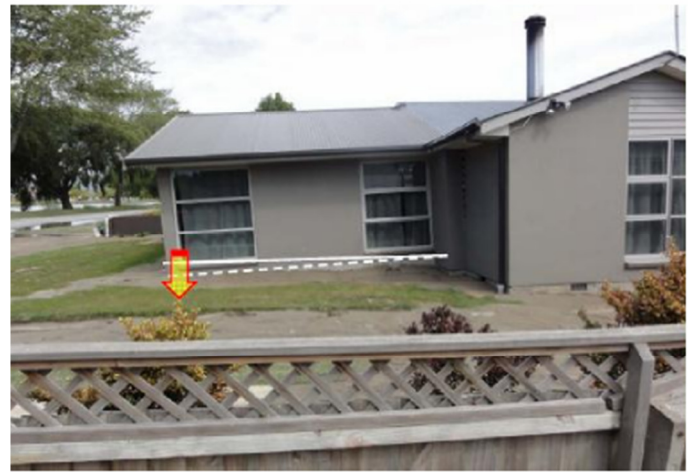
Figure 10 shows a one-story residential house in the suburbs that was damaged by differential settlements. Liquefied foundation soils led to the loss of bearing capacity of the foundation, which further caused the separation of walls. The soils in the suburbs are predominantly loose fluvial deposits of liquefiable clean fine sands with non-plastic silt. The top 5 to 6 meters are in a very loose state with uncorrected cone penetration test tip resistance varying between 2 to 4 MPa.

Figure 10. Damage building due to differential settlement (GEER, 2011).

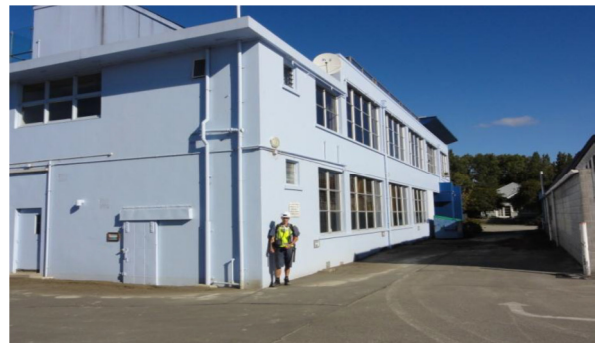
Liquefaction-induced punching settlements were observed to damage several buildings founded on shallow foundations located within the liquefied zone. Figure 11 illustrates one example of punching settlements of the structure. This structure is a two-story industrial building. It was observed that the continuous sand ejecta around the perimeter of the footing and signs of punching shear failure mechanism. The building settled about 25 cm with respect to a fence at its southeast corner and settled about 10 to 20 cm relative to the ground at its northwest corner.

Figure 11. A two-story building subject to liquefaction-induced punching settlements (GEER, 2011)

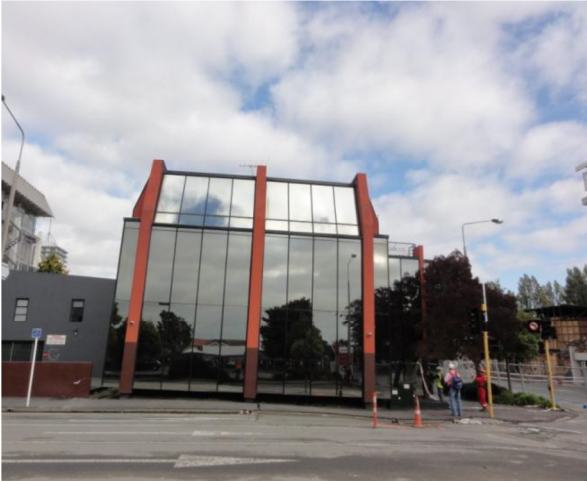
Figure 12 shows a three-story building supported on shallow foundations that settled at its front (i.e., north), which created large differential settlements. The building was tilted about 2 degrees by the differential settlements. The building was also uniformly displaced laterally about 15cm toward the area of the significant liquefaction near the front of the building. A large volume of sand ejecta was observed at the front part of the building. Ground tension cracks were also observed to propagate east and south of the building, which agree with the observed lateral movement of the building toward the north.

Figure 12. A three-story building subject to liquefaction-induced differential settlement and sliding (GEER, 2011)

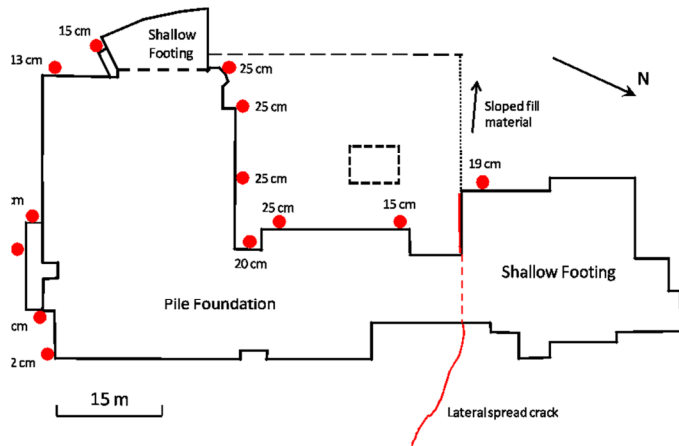
After the 2010 Darfield earthquake and prior to the 2011 Christchurch earthquake, the Preparatory School building at St Andrews School was demolished and renovated. A new two-story structure was built on the 18 m deep screw piles. The building was connected to two existing buildings that are supported on shallow raft foundations. The portion of the structure on the shallow raft foundation moved away from the pile supported portion by about 20 cm and settled about 20cm, while the pile supported portion of the structure remained in place and the surrounding ground settled up to 25 cm. Figure 13 shows the layout of the Preparatory School and measured ground settlements relative to the structure.

Figure 13. Layout of the Preparatory School and measured ground settlements relative to the structure (GEER, 2011)
