## Landslide Stabilization Along The Ohio River Using Cantilevered Stub Piers

## LANDSLIDE STABILIZATION ALONG THE OHIO RIVER USING CANTILEVERED STUB PIERS

Paper No. 3.34a

Ohio Department of Transportation  
Hamilton-50-6.50 Landslide  
Addyston, Hamilton County, Ohio

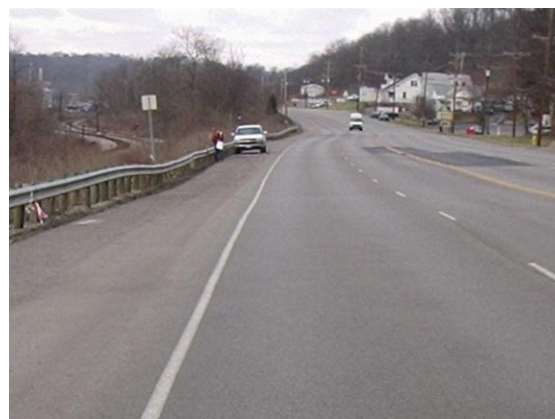
After only a few weeks of monitoring, the inclinometer casings sheared off about 50 feet below grade, near the soil /

*Fig. 1: Pre-repair road distress (2005).*

bedrock interface (see Figure 1). Soon after, the roadway distress worsened, causing ODOT to close 3 of the 4 lanes to

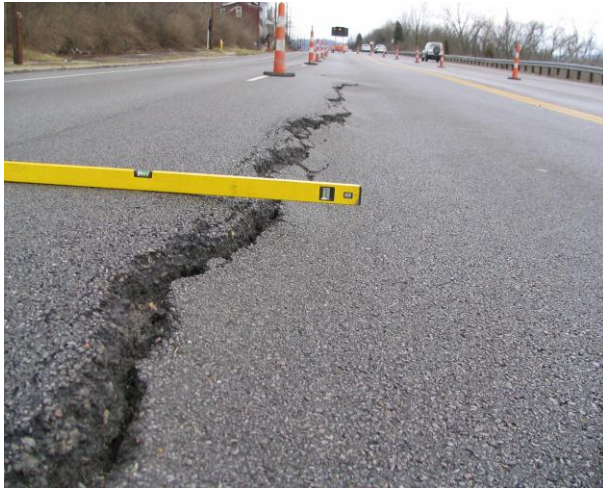
Fig. 2: Road distress and lane closure (2005).

(Figure 2). Terracon was asked to develop a stabilization design under emergency repair conditions. However, funds were limited at the time, necessitating a direction by ODOT that the solution be at least “pseudo” short-term (3 to 5 years).

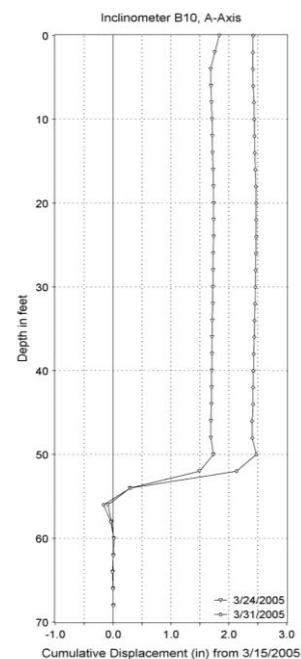
Inclinometer data clearly shows the deep-seated shear plane has been successfully cut off by the Stub Piers. Figure 11 shows a typical inclinometer before construction. The deep shear plane is clearly evident.

Fig. 11: Inclinometer data before slope repair (2005).

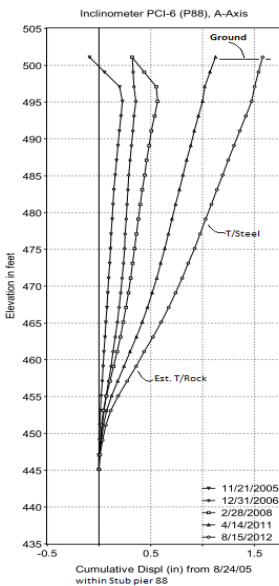
Figure 12 shows a typical inclinometer installed within a Stub Pier and monitored over seven years.

Fig. 12: Inclinometer data installed within a stub pier and monitored over seven years.

At the Stub Pier locations, lateral movements have been virtually stopped at the soil/bedrock interface, or original shear plane. One of the five instrumented Stub Piers shows 1.8-inches of movement at the top-of-steel, whereas the remaining four Stub Piers show are less than an inch of movement at the top-of-steel.

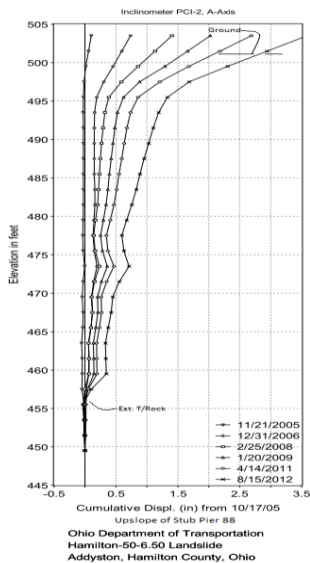
Figure 13 shows an inclinometer installed during construction and located just upslope of the Stub Pier referenced in Figure 12. As shown, slope movements have been slowed considerably. Slight continuing creep movements are evident.

Fig. 13: Inclinometer data installed during construction and located upslope of stub pier.

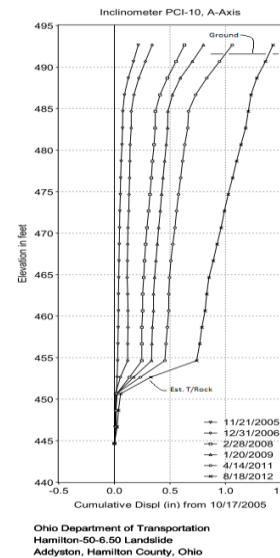
Figure 14 shows an inclinometer located just downslope of the Stub Pier referenced in Figure 12. As shown, creep movements along the original soil/bedrock shear plane have

continued since construction, but at a much lesser degree than pre-repair landslide conditions.

Fig. 14: Inclinometer located downslope of the stub pier.

Moving further downslope from the Stub Piers, there are two inclinometers. Each of these continue to show creep movements at the original shear plain (near top-of-bedrock); however, the maximum deflection measured at the ground surface is on the order of 0.75 to 1.3 inches and well below pre-repair slope movements.

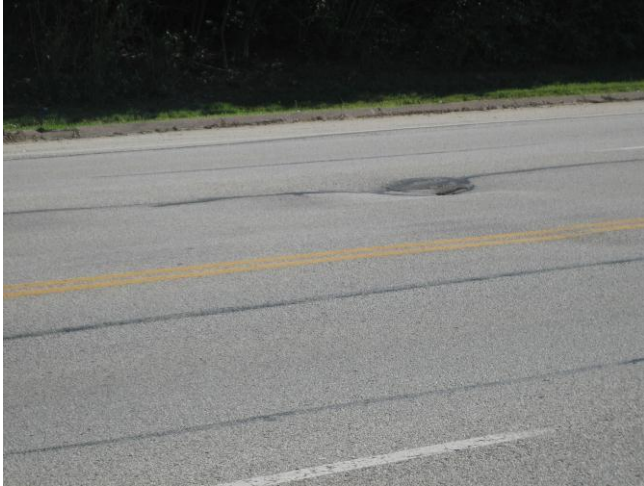
A small sink hole observed in 2005 has reopened in the existing roadway (see Fig. 15). This feature was deemed to be caused by a leaking sewer. The sewer was not repaired during the 2005 construction and only the pavement hole had been sealed with concrete at the time.

*Fig. 15: Sinkhole over leaking sewer.*

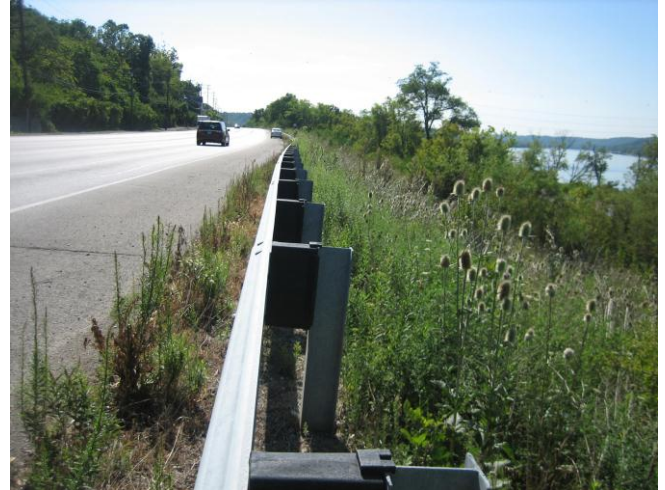
Overall, the pavement appears to be in good condition seven years after construction. Some crack sealing is evident which is most likely the result of post-construction residual creep. Figures 16 through 18 compare conditions on the downhill edge of the road over a 7-year period.

*Fig. 18: August 2012 conditions.*

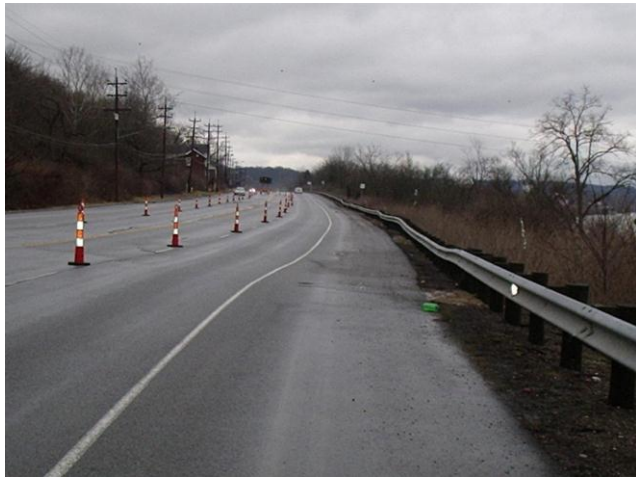
*Fig. 16: Road damage in 2005 (pre-repair).*

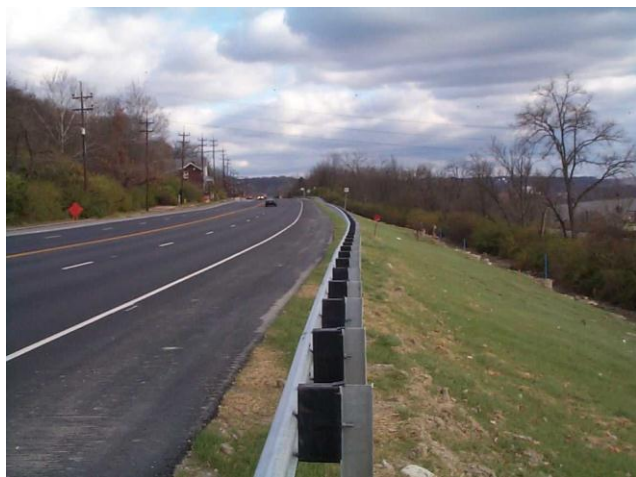
*Fig. 17: 2005, after Stub Pier construction.*

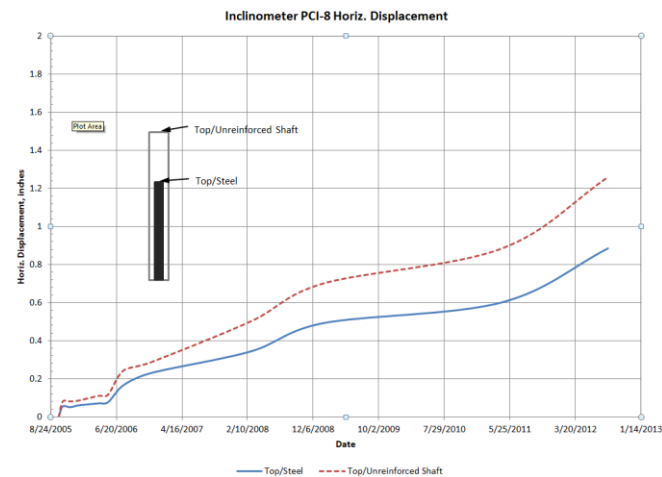
Comparing measured lateral displacements with time, it is evident that movements have continued steadily since the 2005 construction. Accelerated movements have also been evident during certain periods that have coincided with heavier than normal rain fall. For example, annual recorded Cincinnati precipitation varied from about 39 to 45 inches during the interim of 2005 to 2010. However, in 2011, annual precipitation increased to 75 inches. These values are based on published information and assumed snowfall equaling 10% rain.

In some cases, recorded inclinometer movements showed about half of the total occurred between 2005 and April 2011 (about 5.5 years) and the remaining half occurred within the monitoring period of April 2011 to August 2012. Figure 19 shows a typical rate of lateral deflection at the top-of-steel.

Fig. 19: Typical rate of lateral deflection at the top-of-steel.
