Repair of the Church of La Purisima Concepcion of Huelva (Spain) with Jet-Grouting, for Damages Caused by the Construction of Diaphragm Walls in its Proximity

REPAIR OF THE CHURCH OF LA PURISIMA CONCEPCION OF HUELVA (SPAIN) WITH JET-GROUTING, FOR DAMAGES CAUSED BY THE CONSTRUCTION OF DIAPHRAGM WALLS IN ITS PROXIMITY

ABSTRACT

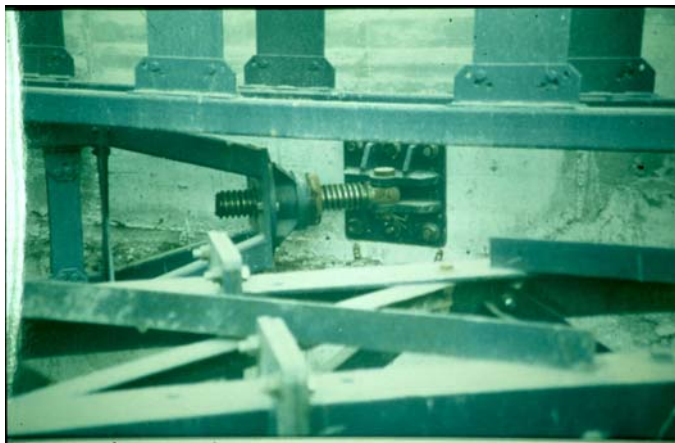
Fig. 3. Pinned fix detail.

The struts that were placed to avoid the movements of the walls suffered very important elastic shortage, because of fundamentally of the inflexibility of their nodes. The diagonals of the struts were fixed to the main cords by a screw, which does not permit to guarantee the fixing among these two elements, should calculate like an pinned fix.

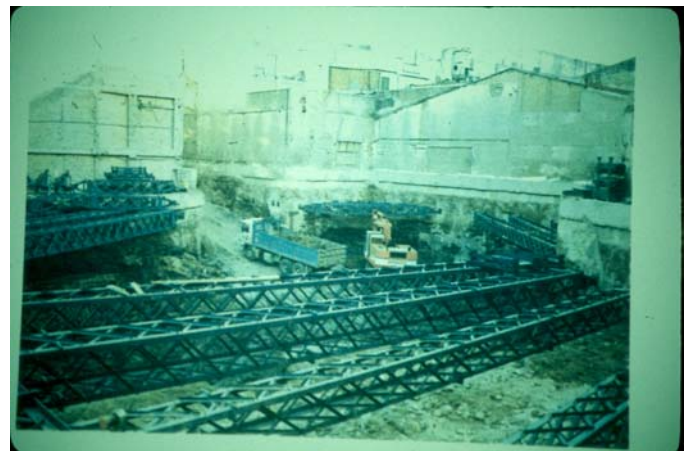
Fig 5. Bracing support.

Because of the irregular geometry of solar, the bracing supports were not arranged perpendicular to the walls, but are placed in angles even in 41°, what complicates clearly the

transmission of efforts and the efficacy of the pre-stressed. Besides the lengths of many of the support are next to the 30m. The wall was built in very long parts in many cases, longer than the 5 meters.

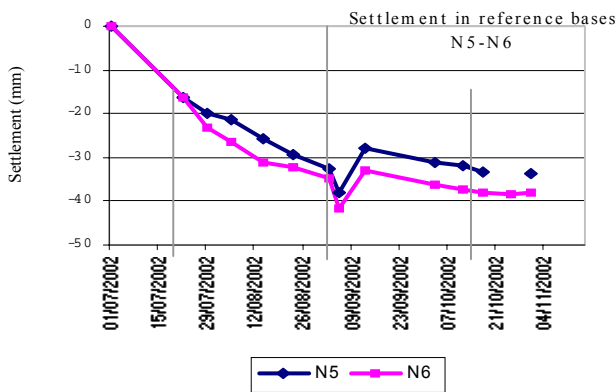
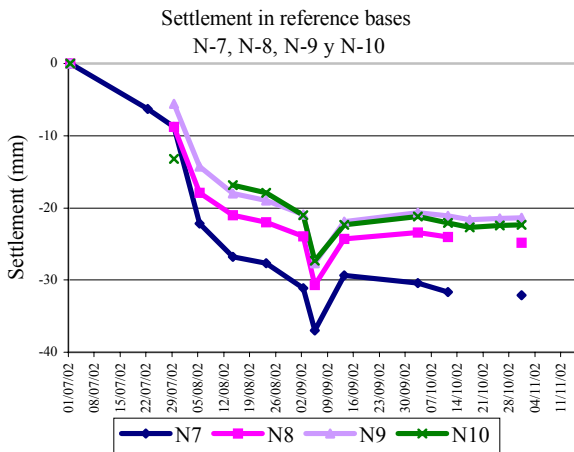
Fig 8. Settlements in reference bases.

The measured heaves went of 9 mm maximum in some points, oscillating most of them, around 1-2 mm, as we can see in the graphics (fig. 8).
