## Ellis Island: Vibration Effects on Historic Buildings Caused by Pile Driving

## ELLIS ISLAND: VIBRATION EFFECTS ON HISTORIC BUILDINGS CAUSED BY PILE DRIVING

Sixto Fernandez, MSc.

Schnabel Engineering

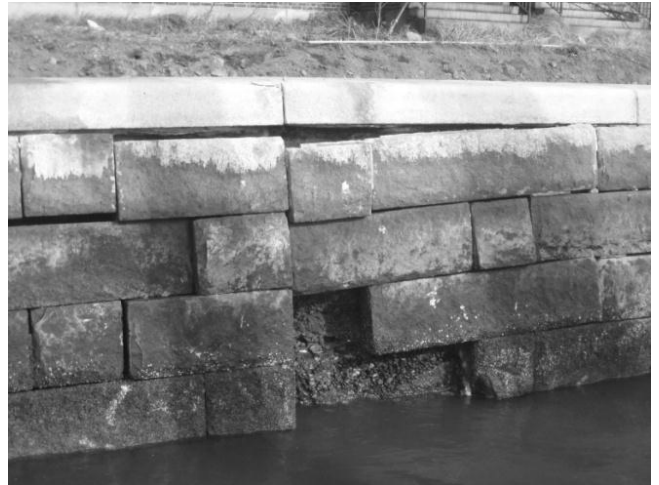
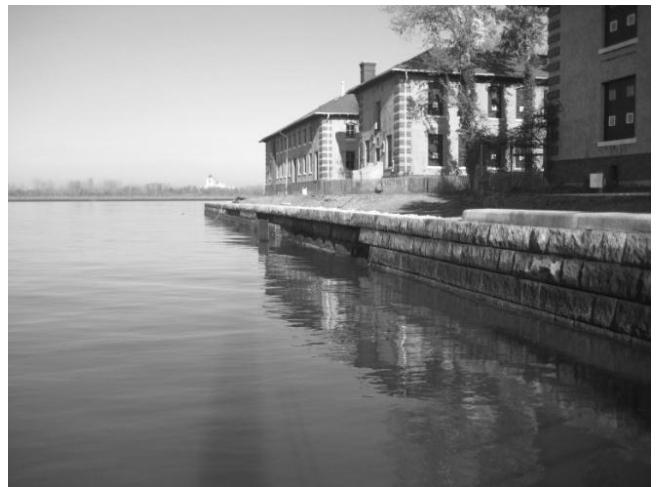
The south island seawalls of Ellis Island show varying degrees of deterioration. The distressed conditions range from aesthetic concerns to wall stability issues (Figure 2). Wall instability was evident in portions of the seawall that are on timber-relieving platforms and those sitting directly on timber cribbing. The wood was decaying and being attacked by marine borers (Robinson and Gomez, 2008).

*Fig 2. Ellis Island seawalls condition before remedial stabilization.*

As noted in the previous paragraphs, the seawalls at Ellis Island present various grades of deterioration. To prevent further damage to the historic buildings and address the instability of the seawall, the construction of a system that consisted of soldier piles and anchors was undertaken. Sheet piles were also installed (vibrated) at the areas of the island where the seawall is founded on timber cribbing. The objective of the sheet piles is to protect and enclose the cribbing. This paper only focuses on the vibrations induced by pile driving. However, this paper presents the effects of both pile and sheet pile driving on the historic buildings.

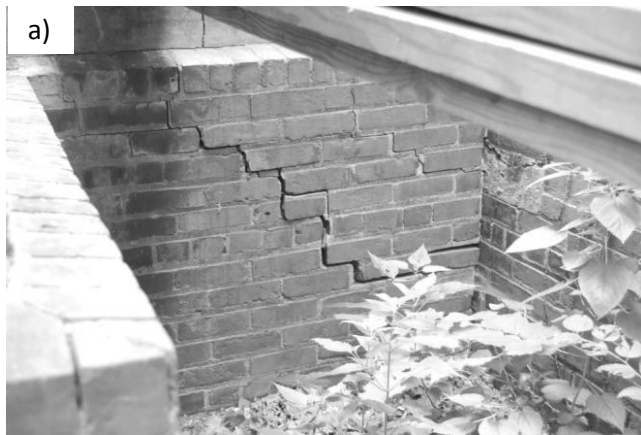
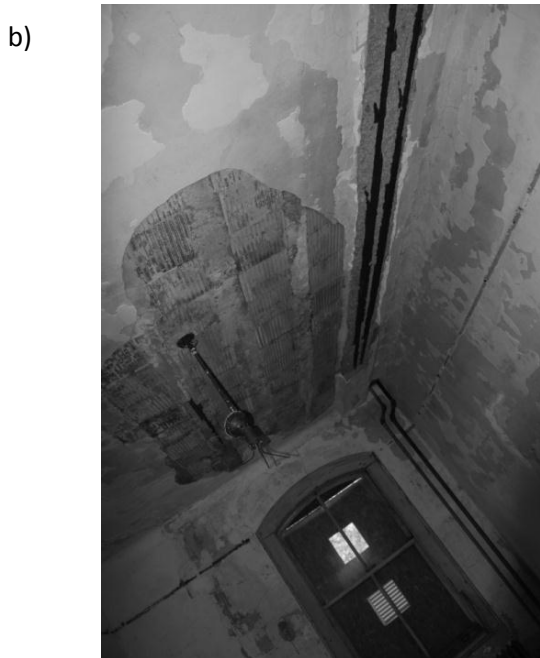
The historic buildings on the south portion of the Island were deteriorated. The signs of deterioration range from plaster loss and hair line cracks to cracks of about 1 inch wide and step cracks that goes from foundations through the 4<sup>th</sup> floor of some buildings. Figure 3 (a) shows a step crack of about ½ inch at one of the exterior walls of one of the buildings. Figure 3 (b) presents the deteriorated condition of the inside of one of the buildings. It shows the exposed reinforcement of one of the main beams, as well as plaster loss at the ceiling. Many of the buildings at the south island present a similar degree of deterioration and structural damage.

Fig 3. Deteriorated conditions of buildings at the South Island.

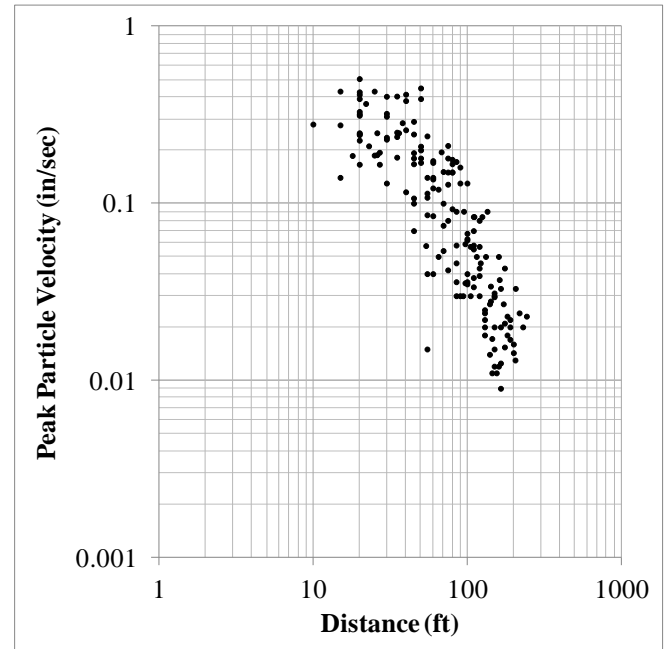
Schnabel recorded vibrations for more than 120 driven piles at the Island. However, for the sake of this paper, only the vibration records of 40 piles are presented. These piles were selected based on the amount of energy that was transmitted to the surrounding soils. We present the piles that generated greater values of PPV. Figure 7 shows the general attenuation of the pile driving vibrations at the Ellis Island site. The PPV values represent the maximum vector sum of the lateral, longitudinal and vertical directions. The distance represents the measured diagonal (in plane) distance from a specific driven pile to the seismographs. From this Figure it is noted that the maximum recorded PPV due to pile driving was about 0.51 in/sec, for a distance of about 20 ft. However, this value of PPV seems to be isolated, with a more typical maximum PPV of about 0.4 in/sec for the same amount of distance. At this site, the energy transmitted from the pile to the ground attenuates quickly. The recorded PPV diminished from 0.4 in/sec at 20 ft, to 0.015 at 200 ft.

Fig 7. Attenuation of PPV with distance.

However, as shown in Figure 7, the recorded PPV well exceeded the limits established for the project.

The recorded PPV induced by the majority of the driven piles at Ellis Island exceeded the limits established on the project specifications. Also, some of the piles exceeded the maximum PPV commonly used in the literature. The common maximum recorded PPV was 0.4 in/sec, which is 5 times higher than the 0.08 in/sec established limit.

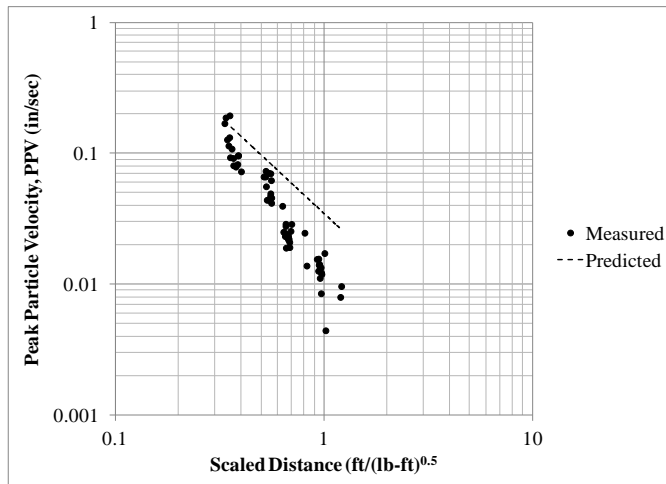
pile was driven from a depth of 36 ft until refusal at a depth of about 57 ft from the ground surface. Figure 8 presents the energy attenuation of the selected pile in terms of the scaled distance. The scaled distance is defined as the distance from source divided by the square root of the transmitted energy. The distance from source was taken as the diagonal distance from the tip of the driven pile to the seismographs. The PPV is presented in terms of the peak vector sum. Also, a comparison of predicted PPV attenuation using Equation 2 is presented. The maximum recorded PPV for this pile is about 0.2 in/sec at the station located closest to the pile, and about 0.01 in/sec at the farthest station.

Fig 8. Relationship of PPV versus scaled distance.

The calculated PPV with scaled distance using Equation 2 suits well the recorded PPV for scaled distance of less than 0.6  $\text{ft}/(\text{lb-ft})^{0.5}$ . It over predicts the PPV for scaled distance greater than 0.6  $\text{ft}/(\text{lb-ft})^{0.5}$ .

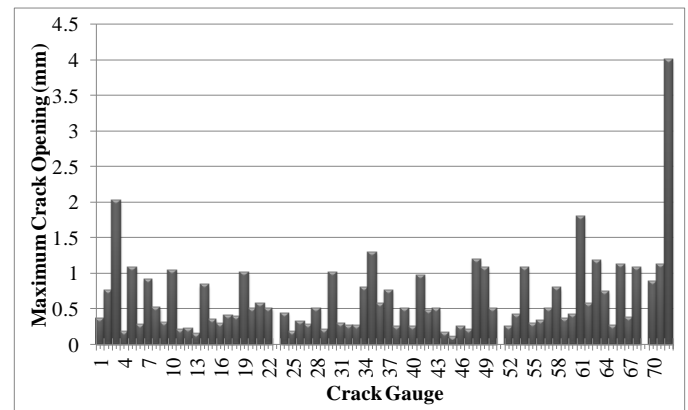
Figure 9 presents a summary of the maximum recorded crack opening for the period of time that the crack gauges were read. The abscissa is the crack gauge number, the ordinate denotes the resultant crack gauge opening from the horizontal and vertical components. The presented maximums include any increase in crack opening caused from pile driving, sheet pile installation, vibrations from equipments and seasonal expansion contraction of the materials were the crack gauges were installed (concrete, brick, etc.).

Fig 9. Maximum recorded crack opening during construction.

The maximum recorded increase in crack opening, with the exception of crack gauge # 72, was about 2 mm ( $7.87 \times 10^{-2}$  in). Crack gauge #72 was not installed on a crack, but on a joint between an old and a new construction of a hallway. For this crack gauge, the maximum recorded opening was about 4 mm (0.16 in).

The recorded crack gauges readings indicate that the constructions activities at the Island did little to none effect on the historic buildings.

The recorded PPV exceeded the threshold established on the project specifications, as well as the limits established by the Swiss Standards, Whiffen (1971) and ASSHTO (1990). However, the crack monitoring shows that the existing cracks didn't open significantly. The maximum recorded increase in opening of a crack was about 2 mm throughout the course of construction. This amount of increase in crack opening is considered nominal and not of a concern for the historic structures.
