Monitoring and Stabilisation of the Giants Seat Landslip, U.K.

David E. Jones
Bechtel Ltd., Warrington, Cheshire, UK

MONITORING AND STABILISATION OF THE GIANTS SEAT LANDSLIP, U.K.

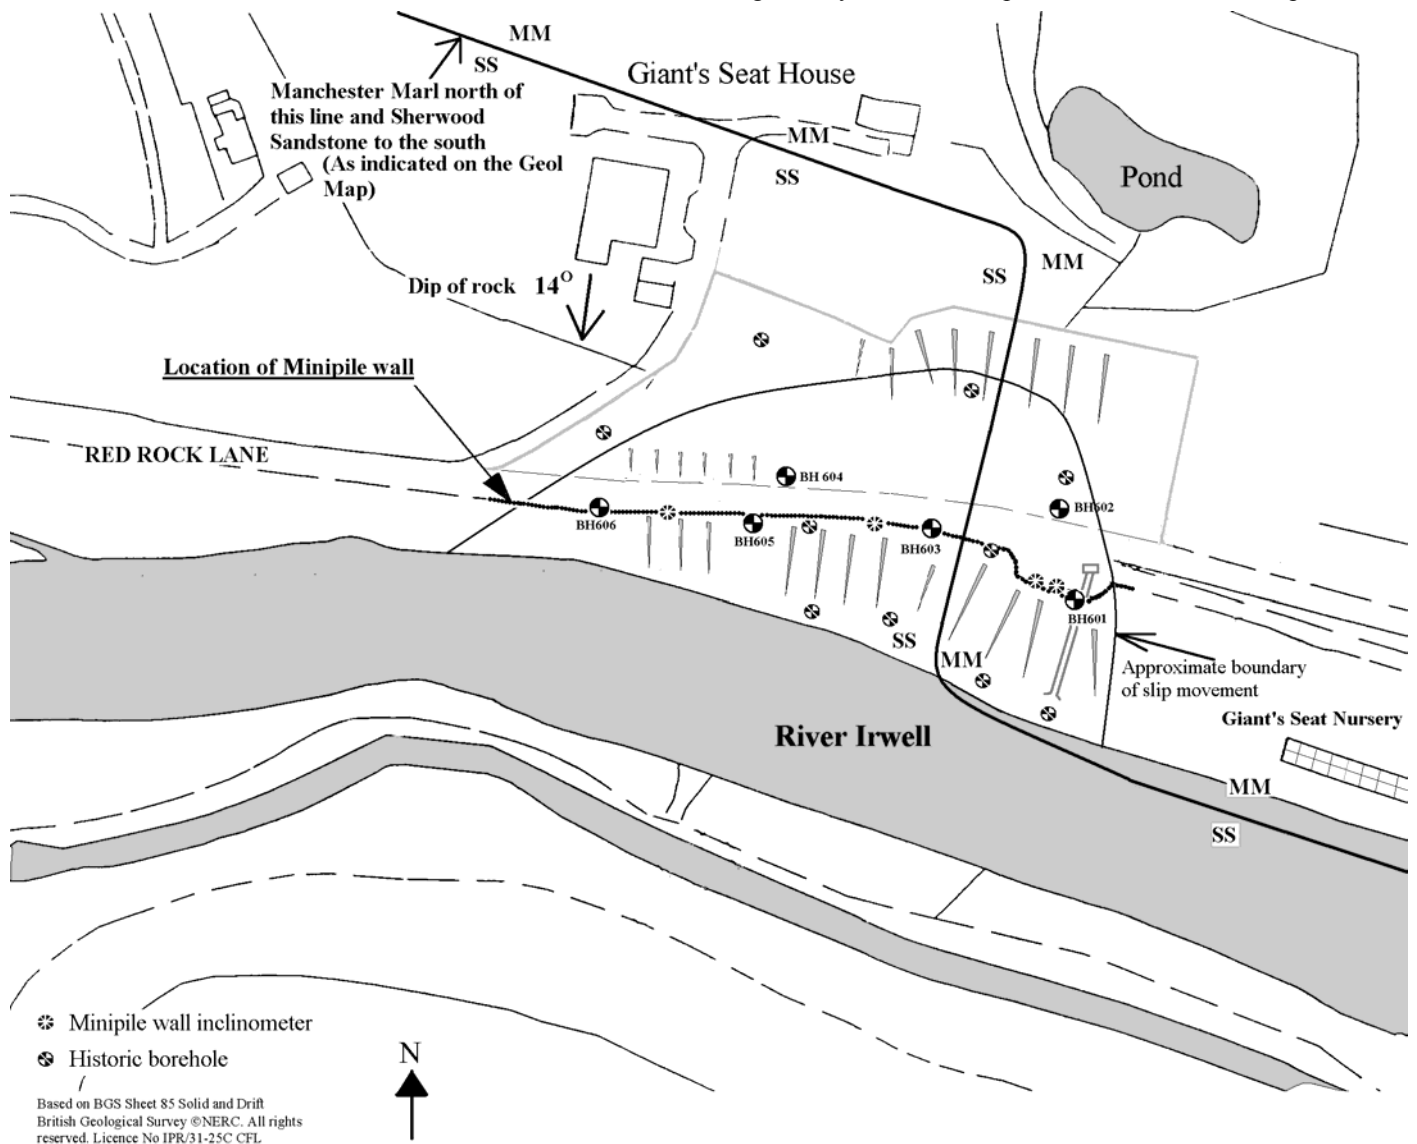
Figure 2. shows the location of the site and the area that had exhibited ground movement, problems with services and cracking and settlement of the road.

Fig.2. Site Location indicating the area of slip movement, the location of boreholes and the line of the stabilising wall.

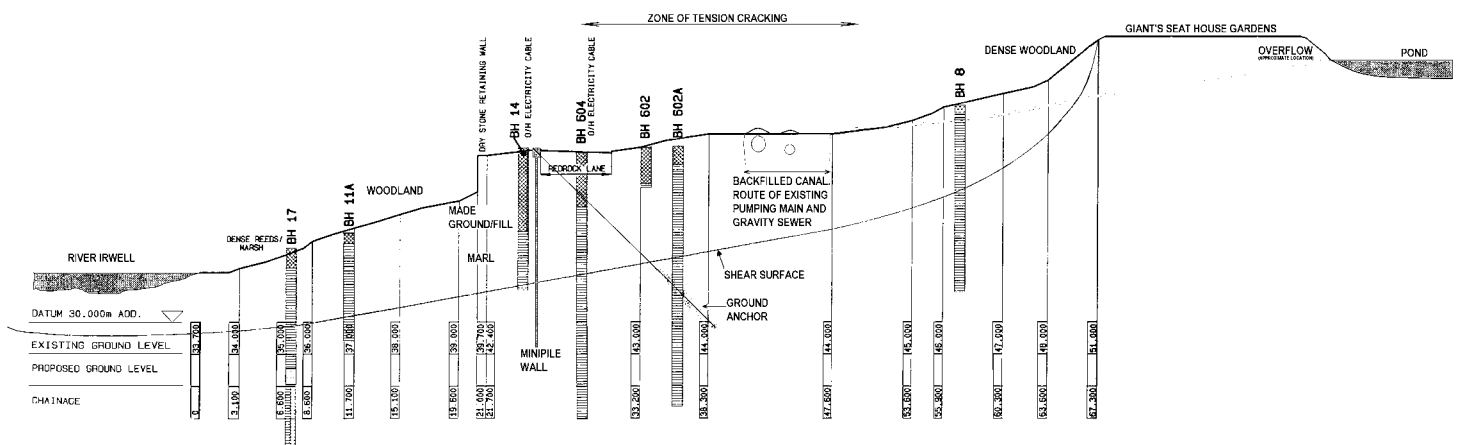
Figure 4. is a section through the site from the river in the south to the pond in the north. The significant depth of the fill materials above the marl can be seen. The base of the fill was initially believed to be the possible failure plane. The location of the pond and overflow pipe is indicated along with the 'design' slip surface in the marl. The approximate zone where various tension cracks had been noticed over the years has also been illustrated.

Fig. 4. Section through the Giant's Seat Landslip (the design slip surface is indicated as are the approximate locations of boreholes, mini-pile wall and anchors)

Thus the wall provides the improvement in shear capacity at the slip plane. However, although the FOS for the lower slope below the wall was improved it was recognised that it was lower than the overall FOS. An additional design case was considered assuming that down slope of the minipile wall the ground moved away (either as failure or tension crack) from contact with the wall to a depth of 4-5m. A capping beam with 40 ground anchors was also included in the design although it was recognised that the anchors would not need to work at their full design capacity unless the specific design condition arose in service. All anchors were to be tested to prove their design capacity. The 32mm double corrosion protected ground anchors had a design fixed length of 10m and a free length 15m and were designed at 2.4m centre-to-centre spacing. The location of the wall capping beam and anchors is indicated on the section in Fig. 4.

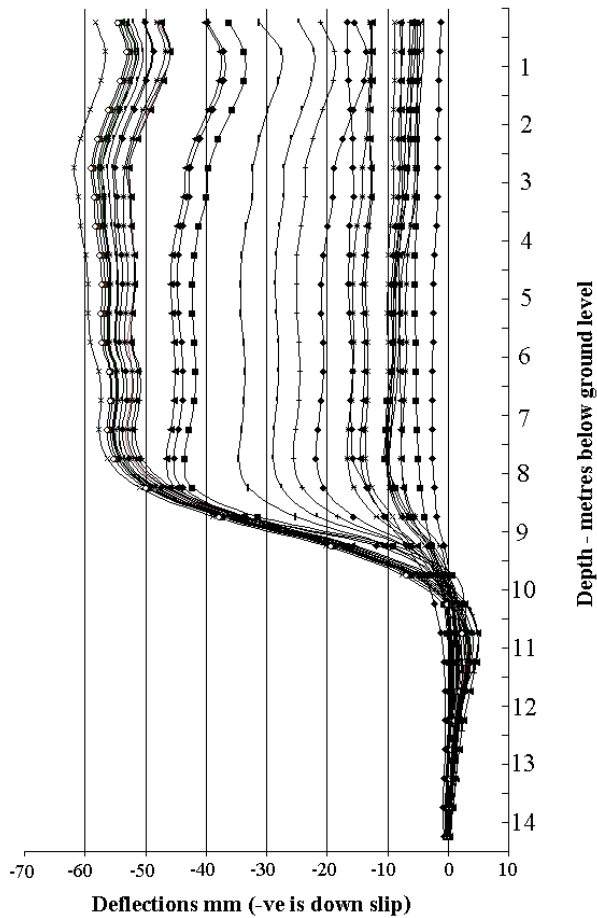
Borehole 603 Inclonometer Readings
Axis A-B (up/down slip)

In preparing the slip model for analysis, information regarding the depth of failure surface was provided by the instrumentation installed in 1996. Figures 5. and 6. illustrate the inclinometer results in two of the boreholes next to the road alignment. The lines on the plot represent regular readings indicating progressive increase in deflections over a period of about 8 to 9 months. A clear displacement of the ground can be seen just above the failure surface.

Fig. 5. Inclonometer readings over 9 month period BH603.

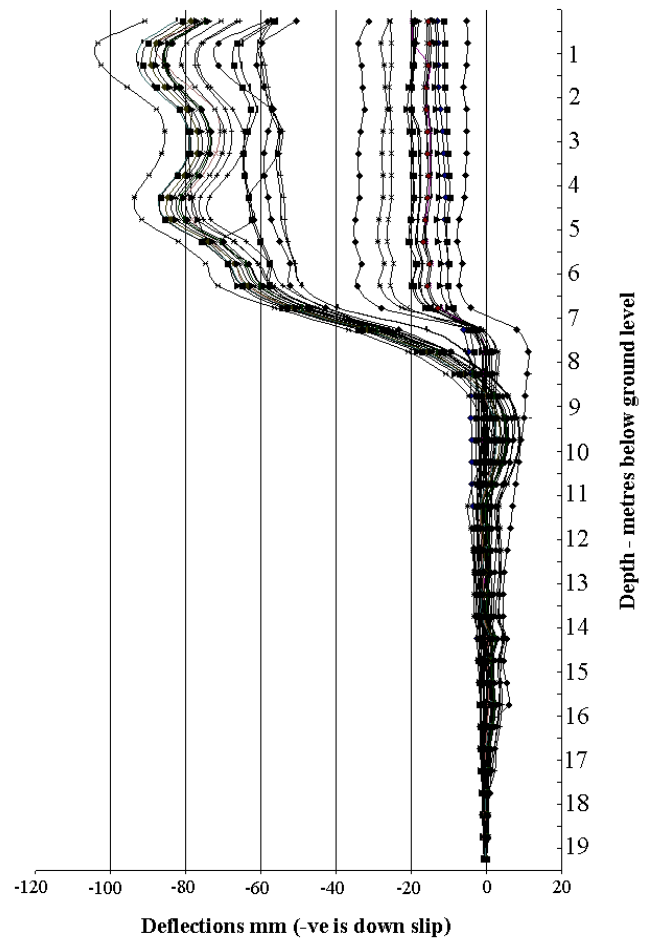
Borehole 604 Inclonometer Readings
Axis A-B (up/down slip)

Fig.6. Inclonometer readings over 9 month period BH604.

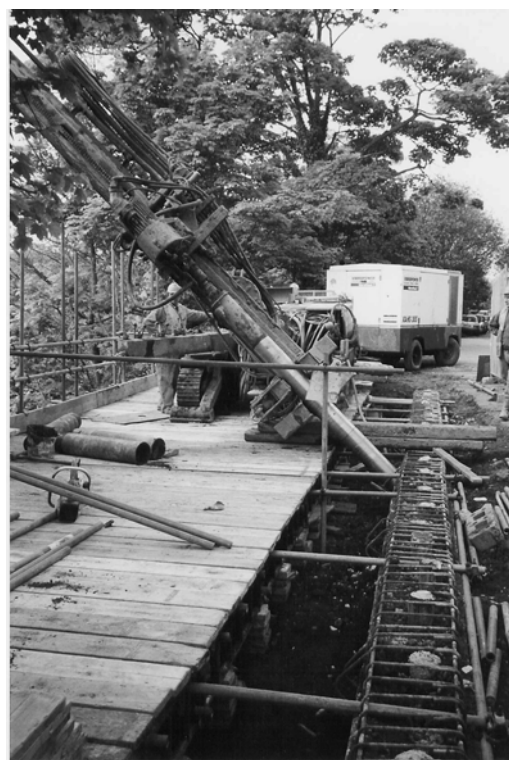
Rotary drilling and down hole hammer work with air flush were used to form the piles and anchors (Fig. 7.). These techniques can have a detrimental effect on the friction capacity of pile and anchors in marly ground due to smearing and the air flush can be potentially disruptive to shear surfaces. However due to the sensitivity of the slip to groundwater levels it was considered that carefully controlled

Fig. 7. Anchor installation work from temporary staging (Mini-pile wall capping cage visible in foreground)

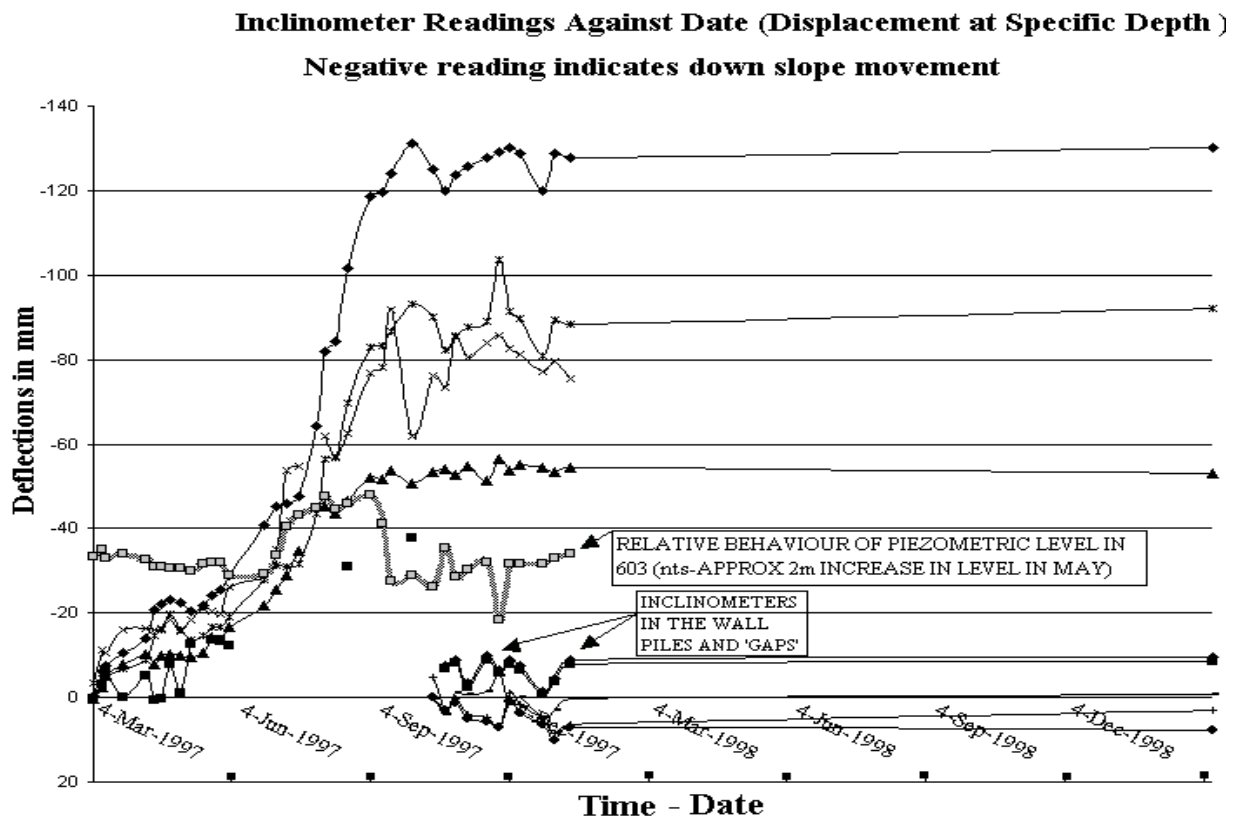
It can not be determined conclusively that the increased failure rate was due to increased groundwater levels, recorded in one of the piezometers. However, the two occurred at the same time and it had been established theoretically, and through historical reports, that the slip was very sensitive to groundwater level fluctuation. Furthermore, from Fig 8. it can be seen that, after the work to improve gap permeability, the groundwater level BH603 rapidly returned to its steady level and this is followed by a slowing of the rate of movement of the slip. Again these events are very likely to be connected although, at this stage of the project, the rate of slip movement was also being slowed by an increasing number of installed piles. Figure 9. shows the piezometer readings from the boreholes monitored during construction

The rate of slip movement began to slow about 3 months into the construction of the wall and, as can be seen from Fig. 8. had effectively been curtailed after 4-5 months of pile

Fig. 8. Slip movement against time indicating change in rate of slip due to groundwater level rise and curtailment of movement at completion of piling in late June early July 1997.

to the steel in the pile. In order to prevent further groundwater level increase, and if possible reduce it, the gaps between the piles in the vicinity of BH603 were drilled and the gaps filled with gravel.

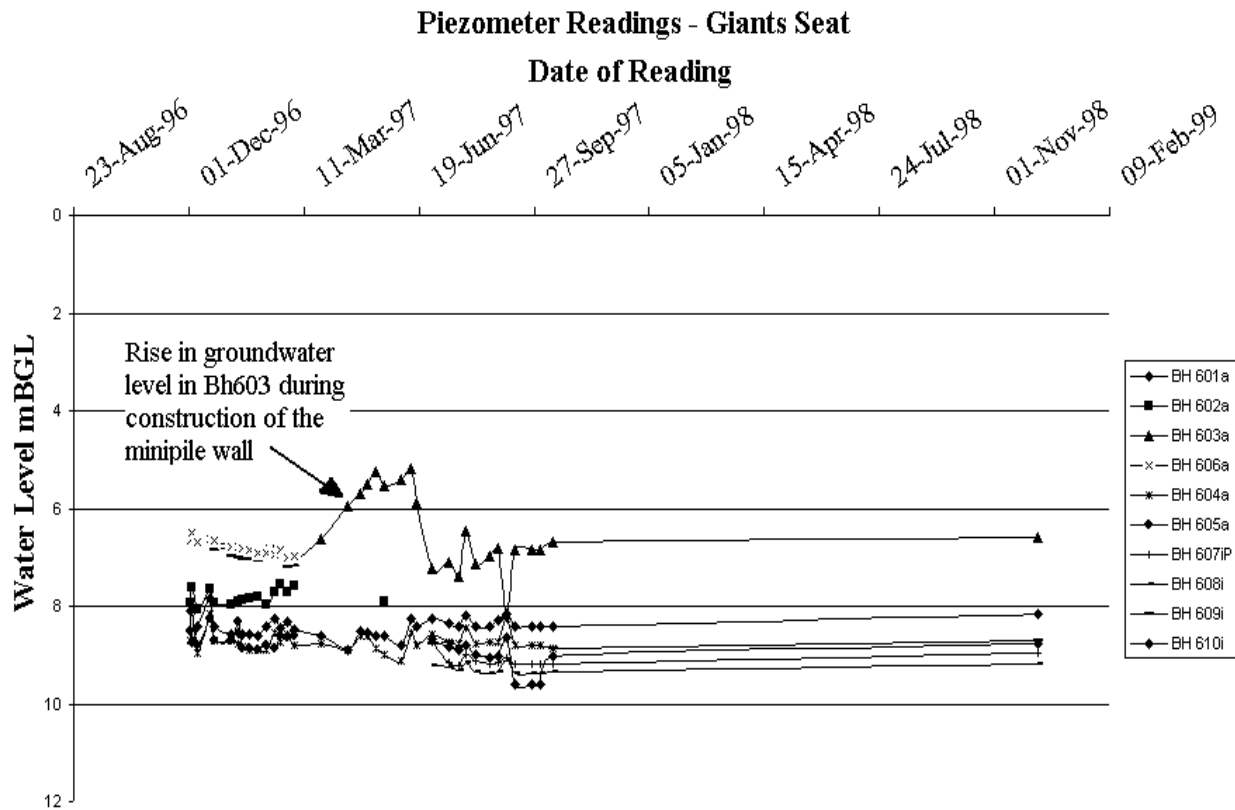
In addition to the inclinometer checking during the construction phase the ground water levels were also monitored. Construction work commenced in March 1997. Three to four later a significant rise in groundwater level was noted in the piezometer in BH603. This borehole is on the uphill side of the wall. Over the same period it was noted that the rate of slip movement increased from about 15mm/month to about 28-40mm/month. Figure 8. shows the cumulative movement of the inclinometers at a specific depth. The change in slip rate can be seen occurring from about May 1997 onwards. Included on the same plot is the relative behaviour of the piezometer in BH603 showing the rise, of about 2m in water level, over the same period of time.

Fig. 9. Groundwater level monitoring from piezometers in the slip area before, during and post construction of the mini-pile wall.
