## Failure Investigation of a Helical Anchor Tie-Down System Supporting an Olympic Size Swimming Pool

## **FAILURE INVESTIGATION OF A HELICAL ANCHOR TIE-DOWN SYSTEM SUPPORTING AN OLYMPIC SIZE SWIMMING POOL**

**Tom Labuda, P.E., P.G.**  
CTLGroup  
Columbia, Maryland-USA 21044

### **ABSTRACT**

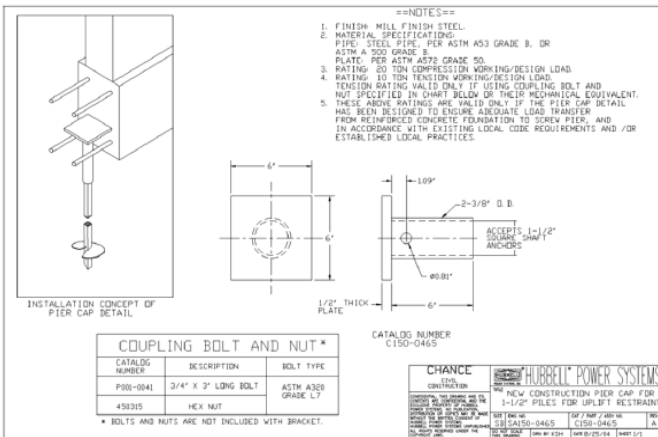
The anchorage system used also depended on the connection between the helical anchor and the pool bottom slab to transfer uplift forces from the slab to the helical anchors. The anchor cap assembly consists of a pipe sleeve and steel cap plate that are fitted loosely over and connected to the square shaft of the helical anchor. After being assembled and attached to the helical anchor, it is embedded (cast) into the pool slab. Pipe sleeves used on this project were originally designed to be connected to the helical anchor shaft using a bolted pin-connection, as shown in Fig. 3. This pile cap connection has been rated in the catalog for a maximum tensile capacity of 20 kips.

Fig. 3. Anchor Cap Detail – Hubbell Power Systems.

In the original anchor cap connection design by Hubbell/Chance, a ¾-inch diameter ASTM A320, Grade L7 bolt was indicated, Fig. 3. The allowable shear strength of the bolt was evaluated following Chapter J, Section J3.6, of the AISC Specifications and found to be inadequate to resist the specified design service load of 27 kips. It should be noted, however, that because ASTM A320, Grade L7 bolts are not covered in the AISC Specification the properties for an ASTM A325 bolt were used for analysis. The ASTM A325 high strength bolt has nearly the same minimum tensile strength as an ASTM A320, Grade L7 bolt (120 ksi vs. 125 ksi) and similar minimum yield strengths (92 ksi vs. 105 ksi).

Uplift forces calculated for the original design were found to be non-conservative, particularly when the groundwater table fluctuation criteria reported in the project geotechnical report are considered. Moreover, the service design load of 27 kips indicated on the structural drawings was higher than the 20 kips capacity for the pile cap connection provided in the Hubbell/Chance literature.

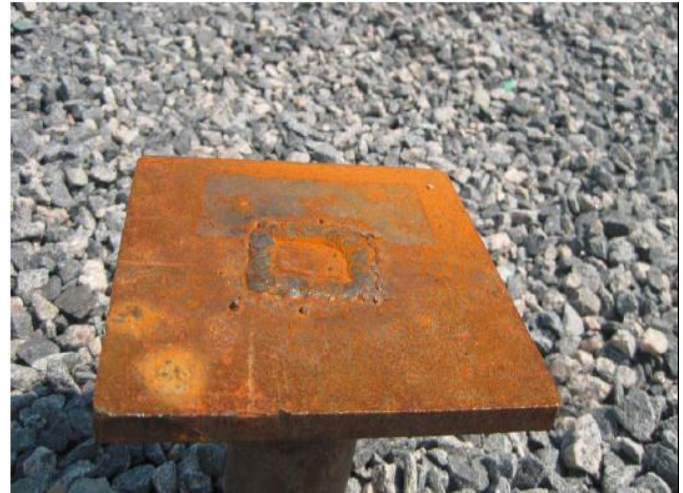
However, this connection was field modified so that the as-built shaft-to-cap connection was welded using inconsistent weld types and procedures, Fig. 4.

Fig. 4. Field Modified Anchor Cap Where Helical Shaft Has Been Inserted Through a Hole in the Cap Plate and Welded.

1. Embedded sleeve anchors did not show any sign of pullout from concrete slab.
2. Slab hold-down failure appeared to have originated with the welded connection between the embedded pipe sleeve cap plate and the helical anchor shaft. The weld connection failure was evident for most helical anchor shafts exposed during demolition. It was apparent that the failures occurred and propagated along the weld lines.

A photograph of the actual cap assembly, Fig. 4, shows this weld not to be a true fillet weld, but rather it resembles a partial penetration butt weld. In any case, the photograph shows that the weld quality was not consistent with a quantifiable weld procedure and any strength calculations for this weld are somewhat speculative. Allowable design values calculated using the AISC Specifications are based on quality welds made by certified welders. The welds observed in the field were not consistent with good weld quality and therefore could be expected to have strengths less than that calculated by the AISC Specifications.

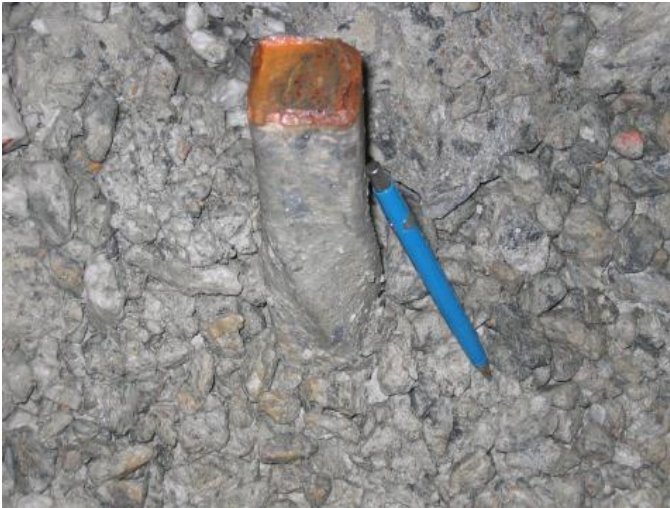
Exposed steel rod tops were generally at their design elevations indicating adequate embedment and sufficient uplift capacity. Most of the helical shaft rods exposed during demolition showed inelastic twist deformation of approximately ¼ turn in the upper eight inches of exposed shaft length. The observed permanent twist deformation very likely occurred during installation at the maximum installation

torque which was sufficient to produce inelastic torsion in the shaft, Fig. 5.

*Fig. 3. Twisted Helical Anchor.*
