Failure Slope in Clay Shales in Aratu Bay - Brazil

SUMMARY Three slides at the same slope, 35m high, on clay shale are analysed. Geological and geotechnical features are shown. Back analysis from the last two slips and sensitivity analysis were done. Good predictions and mistakes are shown.

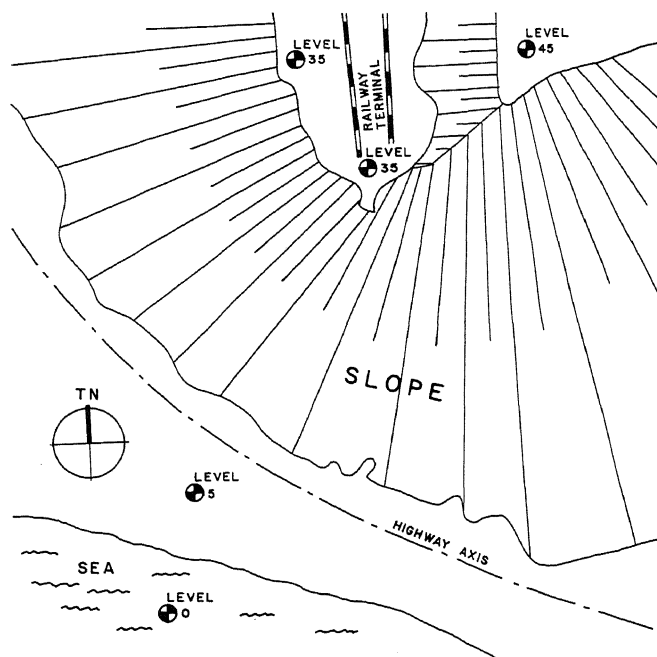
Fig. 1

The former was on may 78, when the slope was cut to enlarge the highway passage. At the top of the slope there is a railway terminal, the projection of which would cross the highway line design, fig.1. This slip has happened at the upper half portion of the slope with a volume lower than 20 000 cubic meters. The railway was left intact.

Sketch of the slope situation

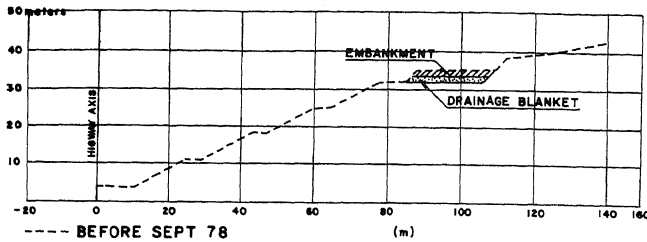
Fig. 2

Typical cross section of the former re-design

The first re-design had recommended a flattening, of the slope, an embankment compaction upon a drainage blanket at the top, fig.2, and some superficial drainage measure indications. At the beginning of the flattening a long crack appeared crossing the railway. The design was changed and the slope was more flattened. During the work two minor slides (2 000 cubic meters each) occurred. One of them near the crest and the other, with a shallow and circular shape, at midheight.

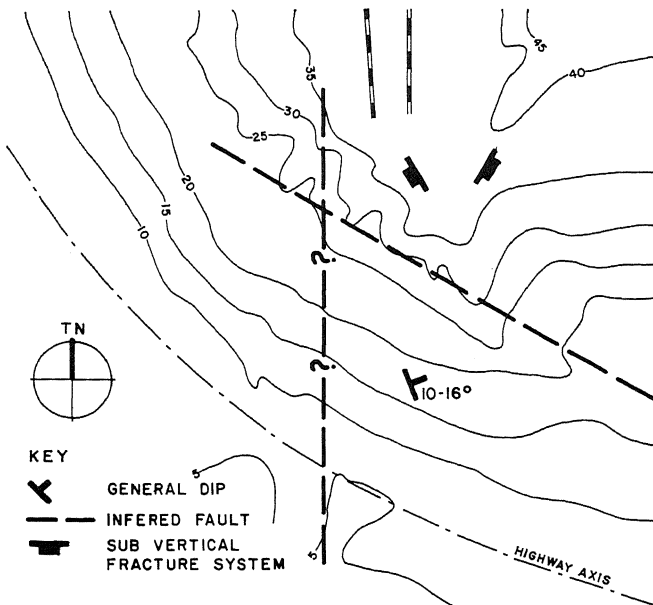
Fig. 3a

Location of the inferred fault

The second slide occurrence suggests an underestimate of the inferred fault presence on first re-design studies. Slope stability estimation from block analysis, considering the dip bedding only measured on slope surface, leads to high factors of safety, although lower strenght parameters had been assumed, fig.6. The election of plane failure method is due to the following field observations:

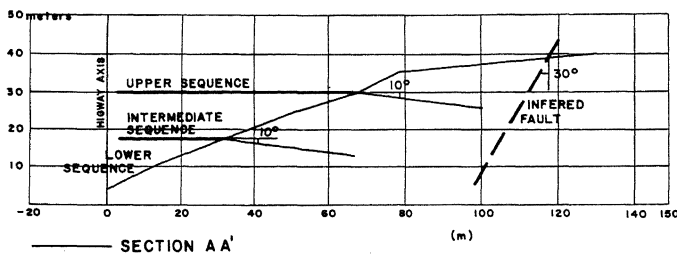
Fig. 3b

The slope can be divided into three sequences: the upper, the intermediate and the lower sequence, fig.3b. The upper sequence is formed by sandstone and siltstone with short intercalated layers of shales, with an overburden of residual soil. The other two sequences are composed of shales with interbedded layers of siltstone and sandstone. The clay mineral predominances are:

The systems of fractures on sandstone in the upper sequence (fig.3) with the bedding, during the excavation could form joints that filled with raining make it easy toppling failure and rock fall.

Typical slope profile assumed from surface inspection

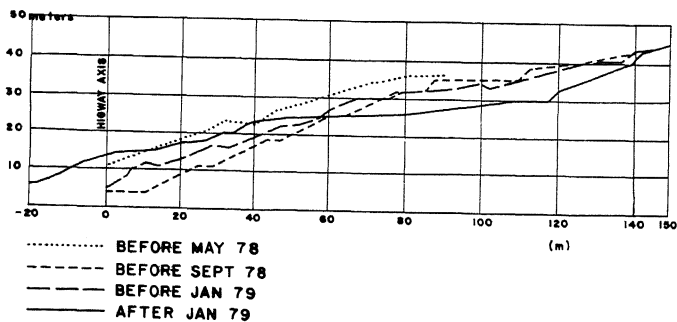
Fig. 3c

Typical sections from each slides

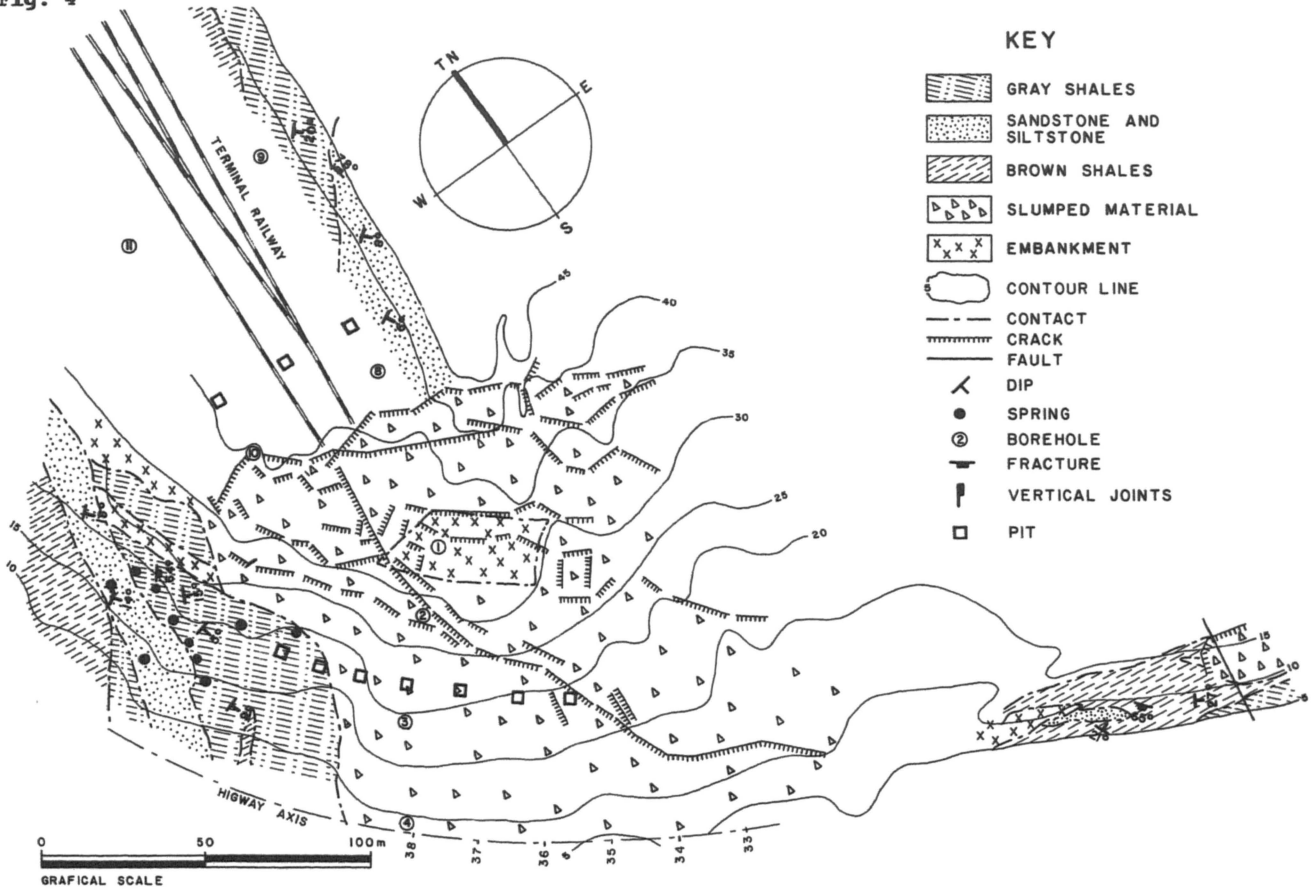
Fig. 4

The second stage of the geological survey was done after the second slide and its results are presented in fig.4. Photo from this slide are presented in fig.5. The large discrepancy between the bed dip and strike measures, taken from the first survey stage (fig.3) and those taken from the second stage (fig.4), rise the need to emphasize the high degree of discontinuities in so restrict area.

The last stage of the geotechnical/geological exploration was the opening of pits on may 79, whose positions are shown in fig.4. Seven were open on the slope, three had springs from slided material, another one from untouched material and the other three were completely dry. This fact reflects the difficulties to get efficient drainage in such material. Sowers (1976) wrote some remarks on similar problems. These pits were thought to be used for dewatering.

Geological map

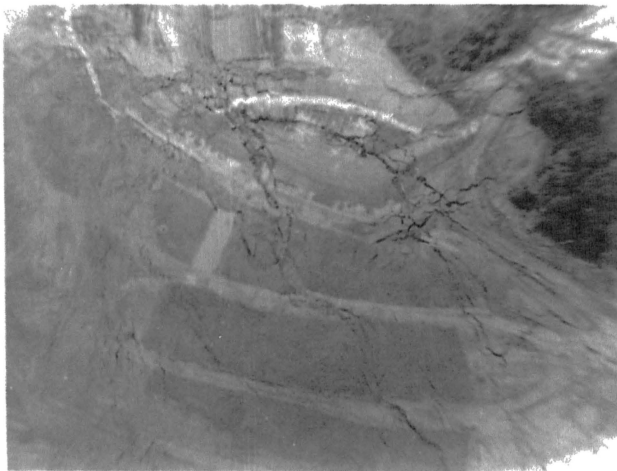
Fig. 5

Aerial photo sliped area

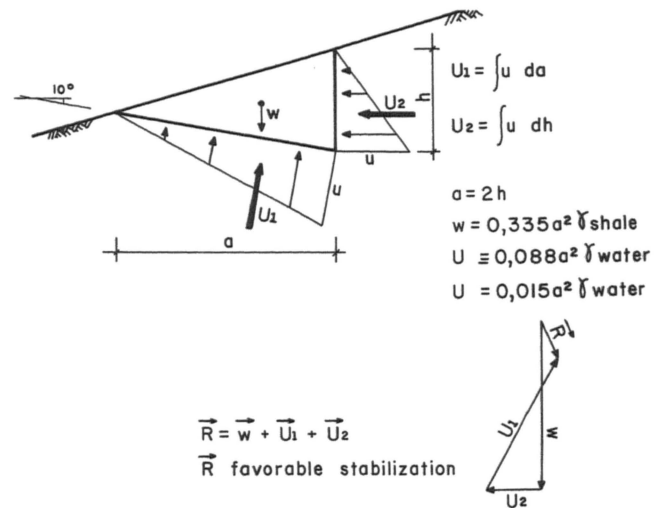
Fig. 6

Stability analysis

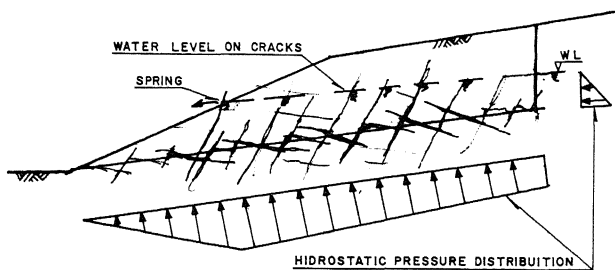
Fig. 7

- a) The slip surface is composed of two intercepting planes. The former is subhorizontal intercepting the toe, the last is vertical passing through the last top crack. The subhorizontal plane intercepts the vertical plane at the same water level from borehole 8 measured after the second slide, fig.7.
- b) Valid Mohr-Coulomb shear strength envelope.
- c) The state of stress is uniform for all points of the failure surface.
- d) Hydrostatic pressure distribution as in fig. 7.
- e) End restrains effects neglected.
- f) Possible effects of the state of tension on the slope neglected (refers to those analyzed by Chowdhury, 1976).

In fig.7 shows the positions of field slip zone and the failure plane assumed for back analysis.

Back-analysis assumptions

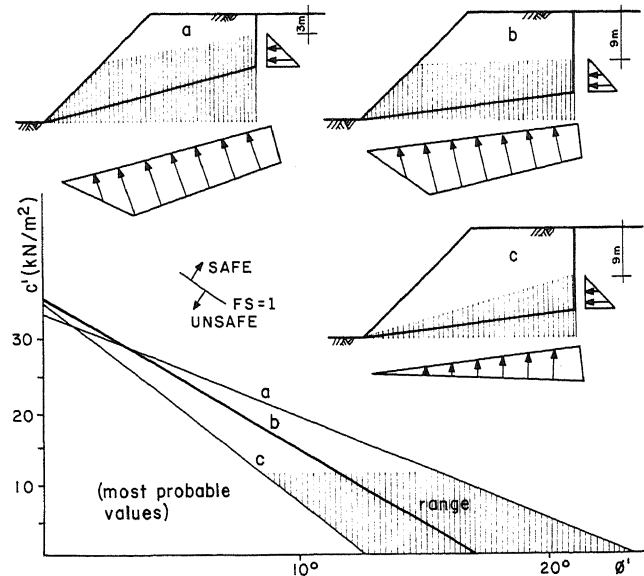
Fig. 8

The back-analysis results are shown in fig.8 in which a few different assumptions were considered. The most probable c' and ϕ values are:

- effective cohesion $c' = 0 - 15 \text{ kN/m}^2$
- effective angle of internal friction $\phi = 13-17^\circ$.

Back-analysis results
