Geotechnical and Geologic Features of U.S. 189 in Provo Canyon, Utah

GEOTECHNICAL AND GEOLOGIC FEATURES OF U.S. 189 IN PROVO CANYON, UTAH

Paper No. 5.13

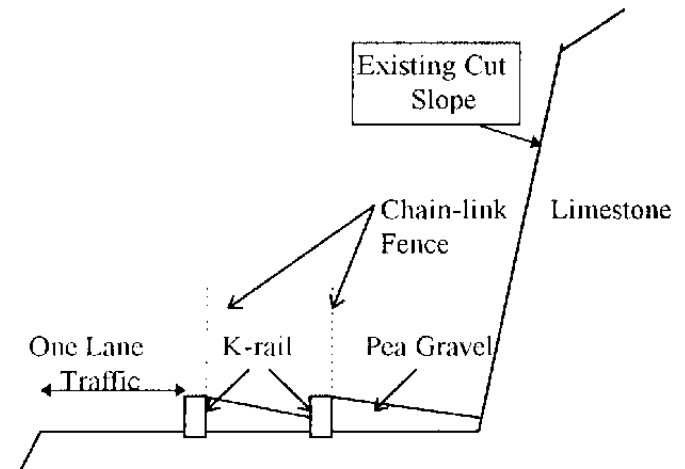
Figure 2. Double Rock Fence System (Schematic)

On March 12, 1997, boulders rolled down from the top of the cut at Station 606+00 (approximately) and hit a truck traveling on U.S. 189. This slide caused a temporary closure of US-189 for several days until a temporary rock fall zone was installed. The temporary rock fall zone consisted of a double rock fence system with aggregates placed from the toe of the cut to the rock fences (Figure 2).

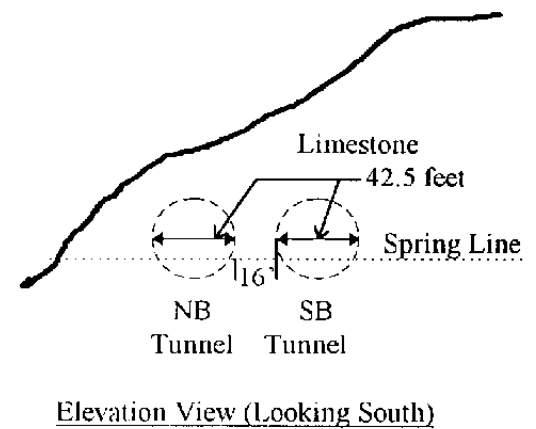
Figure 3 Twin Tunnels at the Narrows Project

Cracks were noticed in December of 1996 forming approximately 20 to 30 feet inside from the north portal face of the twin tunnels. The cracks extended from the crown to the springline of each tunnel. At the time the cracks formed, the northbound tunnel had been completely excavated to the invert subgrade. The southbound tunnel had the top heading, which extended to the springline of the tunnel, excavated for its full length. The lower bench of the southbound tunnel had approximately 60 to 70 feet of excavation remaining to its terminus at the north portal.

The tunnels are both 32 feet tall with a 21.25-foot radius at the springline (Figure 3) and approximately 300 feet long. Support for the tunnel consisted of 12-foot long rockbolts on a typical 4-ft. x 4-ft. pattern with 6-inches of shotcrete for primary support. The tunnels were excavated through shaly limestone of the Oquirrh Formation. There were no notable problems in the driving of the tunnels. The ground was generally massive and presented good tunneling conditions until the time of the cracks forming. After the cracks were noted, all tunnel blasting and excavation were halted by UDOT until the cause of the problem was established.

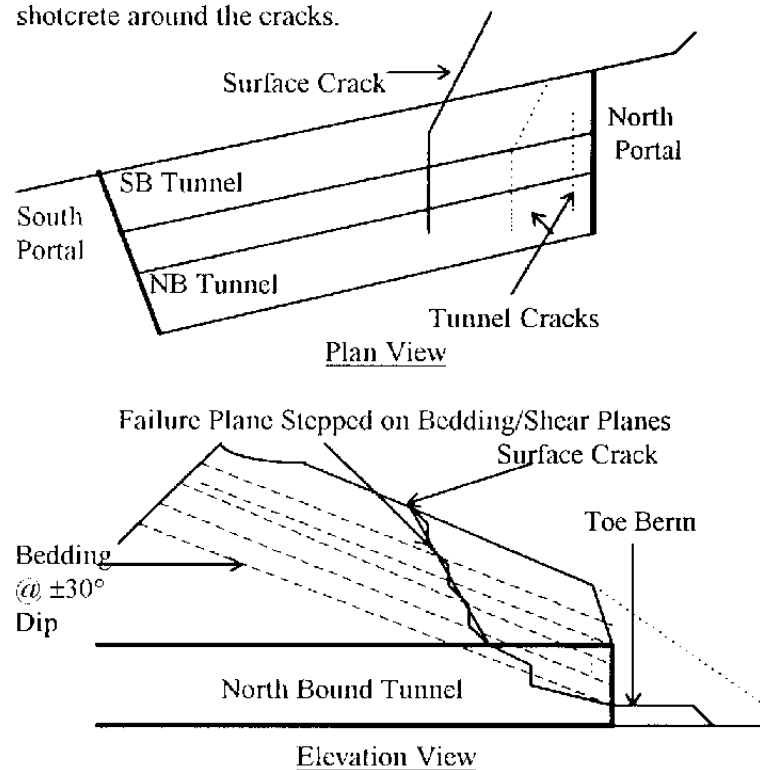
Figure 4. Assumed Failure Plane at the North Portal Cut

Inspection of the northbound tunnel revealed a shear plane dipping approximately 30 degrees toward the north portal cut (Figure 4). This shear plane was assumed to be the base of a wedge that was projected as daylighting through the north portal cut. Cracks were also noted at ground surface above the tunnel and approximately 45 feet behind the portal cut. The postulated failure mechanism is that a stepped failure pattern exists along a series of discontinuities that are oriented parallel with the bedding and dip approximately 30 degrees toward the north portal excavation.

The investigation into this problem consisted of convergence measuring points in both tunnels, drilling five NX-size cores from above the tunnels, and the installation of inclinometers in four of the five bore holes. Monitoring of the inclinometers started before excavation was allowed to resume in order to establish background baseline values. Convergence measurements were taken on number of chord locations across the tunnel openings on a daily basis. Throughout the period of monitoring, no movement was recorded in the inclinometers and only minor changes were noted in the convergence measurements. These were likely attributed to the thermal expansion and contraction in the shotcrete around the cracks.

The stabilization of the portal cut was accomplished by the installation of 40-foot long untensioned rebars (1.375 inch diameter) installed on a 5-ft. x 5-ft. pattern across the cut

face. Excavation of the southbound tunnel was allowed to continue once the support was in place. Monitoring of the convergence points and inclinometers continued until after all tunnel and portal excavation was completed and no further movements have been recorded.

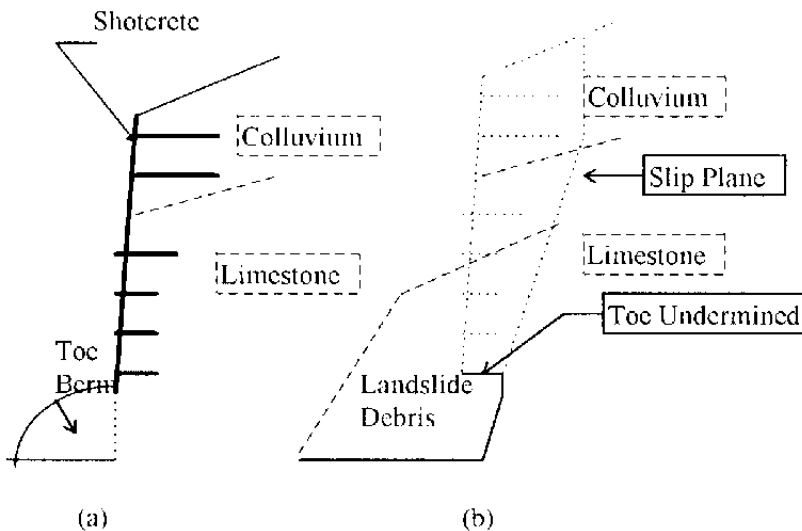
Figure 5. Cut Slope at Station 599+80 Before and After Failure (Schematic Diagrams)

A cut slope at Station 599+80 for a length of about 100 feet failed on April 17, 1997, two weeks after a toe berm was removed to the proposed final grade. The 90 foot-high cut has 10 to 25 feet of colluvial overburden overlying bedrock (Figure 5a). The overburden soil was supported by soil nails of lengths varying from 10 to 20-ft long on a 4-ft x 4-ft pattern. The bedrock was reinforced by 5-ft x 5-ft patterned 15-ft long rock dowels. The design cut angle for this portion of the project is a 0.1(H):1(V) (~84 degrees).

Inspection records indicated a block of rock (approximately 10 feet long x 5 feet deep x 4 feet in height) was dislodged five feet from the toe of the cut after the toe berm was removed (Figure 5b). No rock dowels and/or steel fiber reinforced shotcrete were in place at the toe of the cut before the failure.

Post failure reconnaissance showed that the cut slope at Station 599+80 was triggered by progressive failure starting from the toe of the cut where the block of rock was dislodged, progressing upwards along subvertical and daylighting joints within the rock mass and then extending upwards to the unreinforced soil mass (i.e., beyond the soil nailed portion). At the time of failure, the following observations were made:

- The soil nailed wall came down as one whole mass, indicating the slip surface actually passed beyond the reinforced mass.
- Grout did not stick to the epoxy-coated reinforcing bars. Grout was only present on the centralizers of the rebar.
- No seepage of water was noticed at the failure scarp and the soil/rock debris were moist but not wet.
- Discontinuities dipped at approximately 65 to 75 degrees out of the cut face and were smooth and occasionally slickensided.

Slide stabilization work consisted of laying back the cut slope to 0.5(H):1(V) with soil nails and rock dowels. The final cut face was covered with steel fiber reinforced shotcrete and weeps to facilitate water seepage.

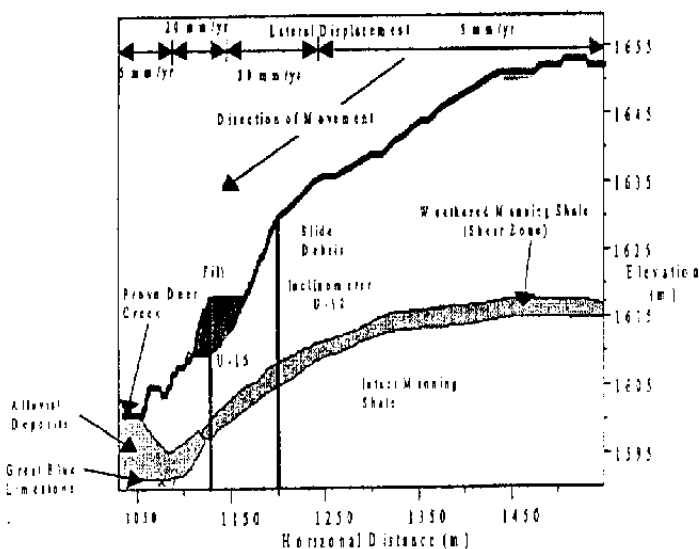
Figure 6. Inferred Geologic Cross Section at the Canyon Meadows (PBQ&D, 1995)

Canyon Meadows: Three of the five landslides on existing US-189 are found near the Canyon Meadows housing development. Based on the inclinometer data, two sliding planes appear to exist in each of these three landslides. One slide plane is located at the interface between the fill and the landslide debris (herein called the upper slide), the other slide is in the weathered Manning Canyon Shale (which is called the lower slide) as shown in Figure 6. The upper slide occurs primarily where fills have been placed on top of ancient clayey landslide debris which is derived from the underlying shale. This upper slide is the most active and moves on the average of 0.5 to 1.5 inches per year. The deeper sliding zone is the base of the ancient landslide debris where it overlies highly weathered Manning Canyon Shale. The shale weathers rapidly when exposed to the atmosphere and

becomes highly plastic when wet. The weathering process appears to have been accelerated by the presence of springs along the thrust fault zone. The shales have been weathered to a soil consistency to a depth of 16 to over 65 feet in this area.

The data from inclinometers in the Canyon Meadows slide area revealed that the upper slide is creeping at a rate of about 0.5 to 1.5 inches per year towards the river in a southeasterly direction, while the lower slide is moving very slowly at a rate (about 0.1 to 0.5 inches per year) generally to the southeast to south (toward the Provo River) as shown in Figure 7. The rate of ground movement on the downslope side of the highway increases as a result of the increased amount of road fill on the weak slide material as well as the close proximity to the river and high pore water pressures. Additional road fill is placed almost every year by UDOT as part of a maintenance program for the creeping highway. A boring drilled on the existing US 189 near Canyon Meadows encountered 15 ft of asphalt.

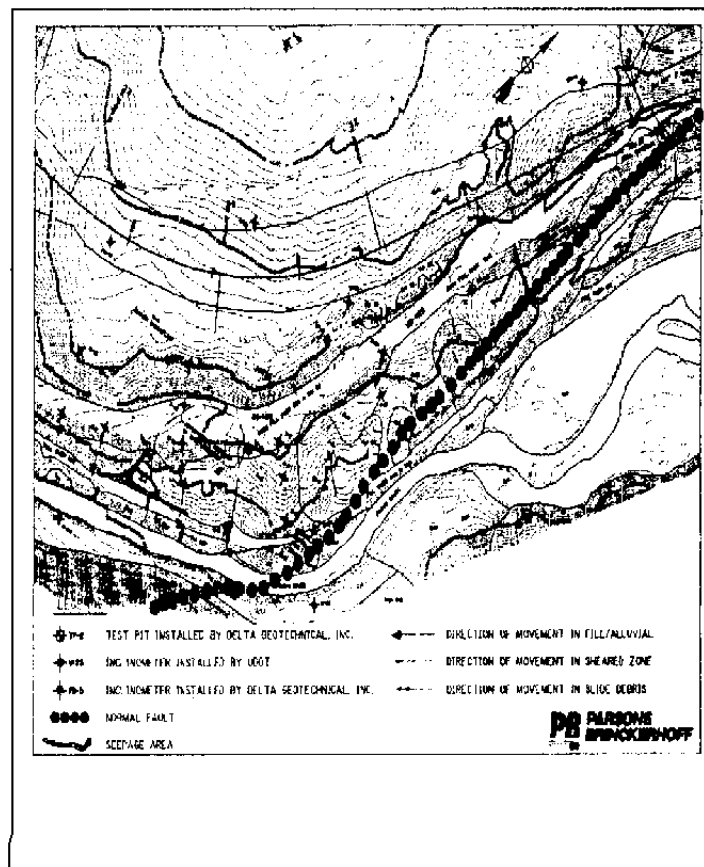
Figure 7 Movement Directions Recorded in the Canyon Meadows Area

In the northern part of the slide inclinometers indicate that movement is deflected to the south-southeast as a result of the presence of a resistant limestone unit called the Great Blue Limestone, which acts as a buttress to movement of the slide material. In the southern portion of the slide area where Manning Canyon Shale is present at the bank of the river, there is no buttress, and thus the toe of the slide has continued to erode over time because there is little resistance to

downslope movement within the alluvial soils in the river (Figure 7).

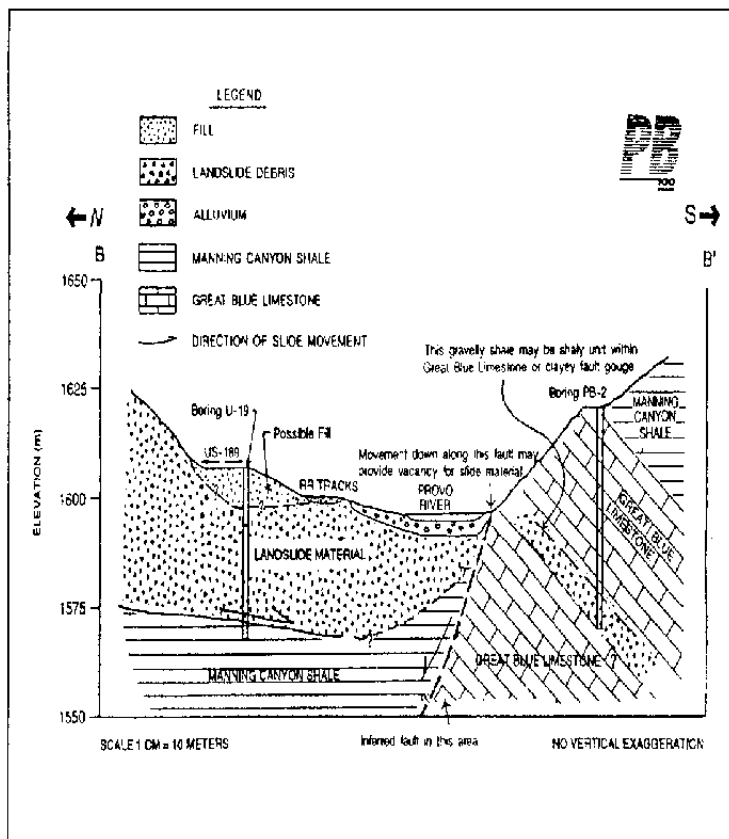
Figure 8. Inferred Geologic Cross Section at the North of Horseshoe Bend

2. In the northern portion of Horseshoe Bend (west side of the river in Figure 8), the weak Oquirrh Formation rock mass is resting on a plastic, sheared clay gouge that represents the top of the Manning Canyon shale. This weak Oquirrh Formation appears to be the result of landslide material that has slid

downslope toward the Provo River. The Oquirrh Formation has a high secondary permeability due to the fractured and weathered state of the rocks that allows water to percolate easily down through the unit. When the groundwater reaches the top of the Manning Canyon shale, which is nearly impervious, it saturates the shear zone as well as the top layers of the shale. Thus, the strength of this already weak zone is further reduced by the pore pressures created along the contact. Pore pressures may also be building in the clayey shales below the sheared contact zone. The saturated state of the shear plane probably also results in further chemical weathering of the shale, which gradually reduces its shear strength as discussed above.

Subsequent filling of a valley located in the northern portion of Horseshoe Bend in the 1930's has further accelerated movements in this local area as evidenced by inclinometer readings, resulting in roadway cracking. The cause of the movement appears to be due to subsurface groundwater flow at the interface between the fill and landslide debris as confirmed by the presence of localized springs at the toe of the fill slope below US-189 (Figure 8). Groundwater tends to exert pore pressure and weaken the shear resistance of the surrounding soils to slides. The movements are the greatest during the spring when snowmelt occurs.

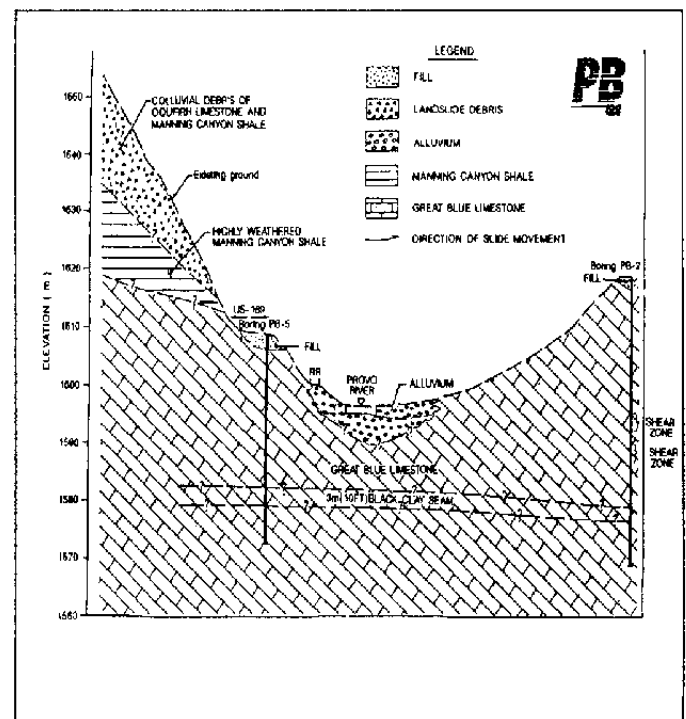
Figure 9. Inferred Geologic Cross Section at the South Horseshoe Bend

- The southern portion of the Horseshoe Bend area has distinctly different subsurface conditions as evidenced in borings PB-2, and PB-5 (Figure 9). After movement along the Deer Creek thrust, a normal fault trending east-west is postulated to have formed at Horseshoe Bend with the downthrown side on the north (upstream) side of the fault (Lee & Brandon, 1995). The upthrown block is composed of Great Blue Limestone, which crops out on both sides of the Provo River and the block dips to the south-southeast. A normal fault with the Great Blue limestone on the upthrown side would explain the cause for the Horseshoe Bend feature. The river deflects sharply to the west due to the hard resistant limestone at this location.

The geologic conditions in the southern portion of Horseshoe Bend are complex, as exemplified in the presence of overturned bedding in a southbound roadcut on US-189 at drill hole PB-5 (Figure 9). At this time, no reliable explanation of the geologic structure of the southern portion of Horseshoe Bend has been determined.

A shallow slide has occurred at the southern portion of Horseshoe Bend and is believed to have resulted from formation of local piping in the fill that connects to a 7-foot-deep sinkhole located about 5 feet south of drill hole PB-5. The formation of this sinkhole is attributed to groundwater flow within the loose fill that daylight in the slope downhill of the roadway.
