The World Trade Center “Bathtub”, a Case History

George J. Tamaro

Mueser Rutledge Consulting Engineers, New York, New York

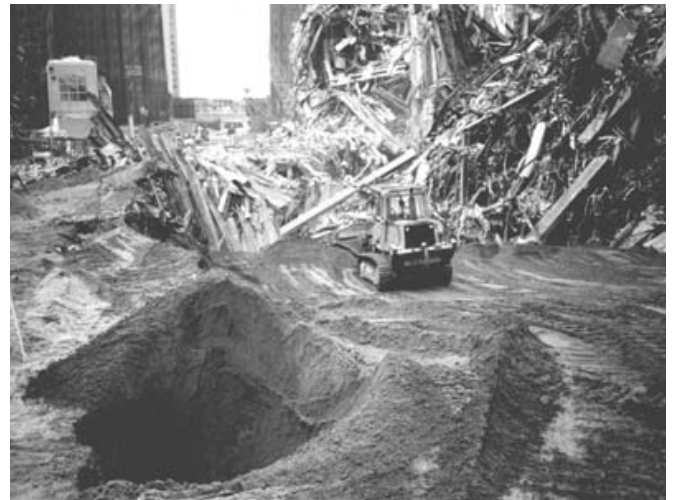
In the center sector, the walls were supported by debris that varied from loose to compact. Along the south wall at Liberty Street, the majority of the wall was unsupported for most of its 18m (60 ft) height. Ultimately, tension cracks developed in Liberty Street immediately south of the wall, and the top of the wall moved more than 300mm (12 inches) toward the site. Backfilling of the south sector began as soon as it became safe to work in the area and the extent of the problem could be determined (Fig. 6). Slope inclinometers, survey points, and monitoring wells were used to measure the behavior of the wall and the groundwater levels. Dewatering wells were installed to reduce water pressure on the walls by as much as eleven meters (35 ft) of head, and instrumentation was installed to measure wall movement. The instrumentation showed that backfilling had reduced the rate of wall movement to the point that an upper tier of tiebacks could be safely installed to stabilize the wall. The wall moved back as much as 75mm (3 inches) after the top tier of tieback anchors were tensioned. The diaphragm wall was eventually found to be mostly intact, except for minor leaks at a few abandoned tiebacks and at the upper half of four panels at the southeast corner that were crushed by falling debris, the damage and repair are described later.

Fig. 6 Backfilling operations at Liberty Street.

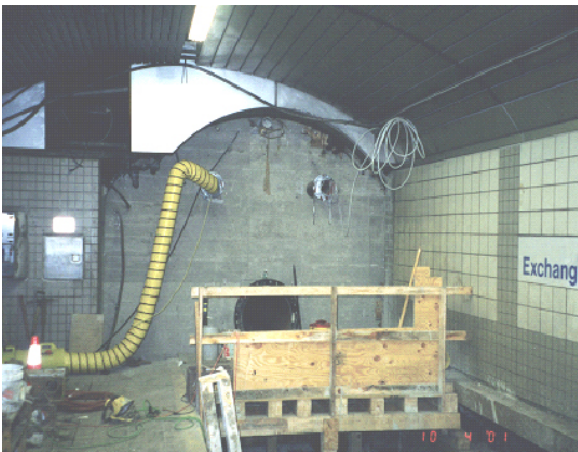
Fig. 7 PATH tube concrete plug.

Within days, a 5m (16 ft) long low-strength concrete plug was placed in each tube as a seal in the event that the bathtub walls were breached and the tunnels fully flooded. The plugs were designed to withstand a 24m (80 ft) head of water pressure and were removed once the diaphragm walls were considered secured in mid-January 2002 (Fig. 7).

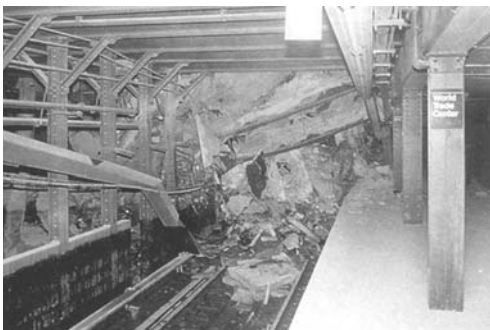
An inspection of the 1 and 9 subway tunnels immediately east of the diaphragm wall indicated that the south half of the tunnel was either collapsed or had been pierced by falling structure (Fig. 8); the north half was relatively undamaged. Bulkheads were designed at both ends to prevent inundation of an adjacent section of tunnel that was secure and operating. The damaged sections of the line were reconstructed and the line was restored to service in the Fall of 2002. The more easterly N and R subway tunnel was found to be almost undamaged and was returned to service late in October 2001.

Fig. 8 Damaged subway tunnel.

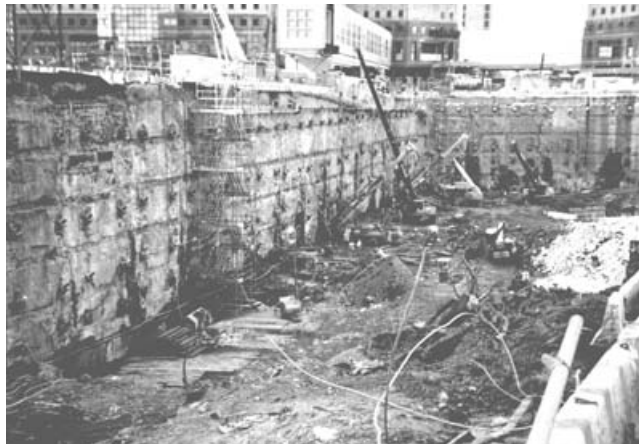
Fig.10 Tiebacks reinstalled at Liberty Street.

The anchors at the Liberty Street wall were completed first (Fig. 10). Anchor installation on West and Greenwich Streets proceeded from south to north as workspace became available. Tiebacks were also installed on a segment of the Vesey Street wall where falling debris had punched through WTC 6 and three levels of basement floor slabs. The recovery effort was completed on May 30, 2002, within an eight and one half-month period working 24 hours a day, seven days a week (Fig. 11). At that date approximately 950 temporary anchors were installed to provide lateral support to sections of slurry wall left unsupported as a result of damage to the below grade slab structure. An additional 120 anchors may be needed if and when the remnant basement structures at the north end of the site (Fig. 12) is removed to accommodate development of the site. Eventually all anchors are to be de-tensioned and sealed before they corrode and lose capacity.

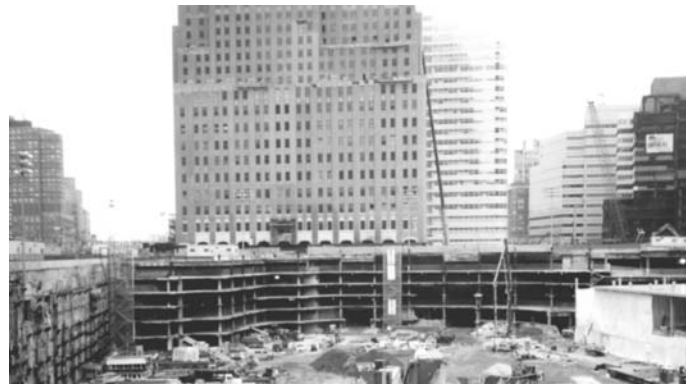
Fig. 12 Remnant basement structure at Vesey Street.

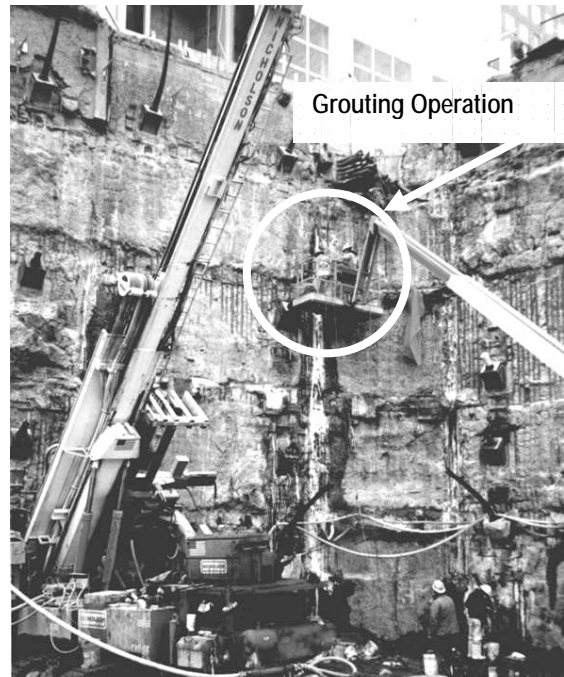
Chemical grouting of diaphragm wall joint leaks is an on going operation. (Fig. 13) Climatic changes cause small movement and the re-opening of previously sealed joints. A continuing program of joint grouting to reseal joints will be required until the diaphragm walls are permanently re-supported. Where the diaphragm wall is to be exposed permanently, it will be necessary to provide quick access in the event of leaks and a continuing program of grouting in order to prevent flows of water into the “bathtub”. A climate control enclosure will also be necessary to protect the wall during prolonged periods of below freezing weather and to minimize damage from ice. (Fig. 14)

Fig. 13 Sealing of leaks is a continuing operation

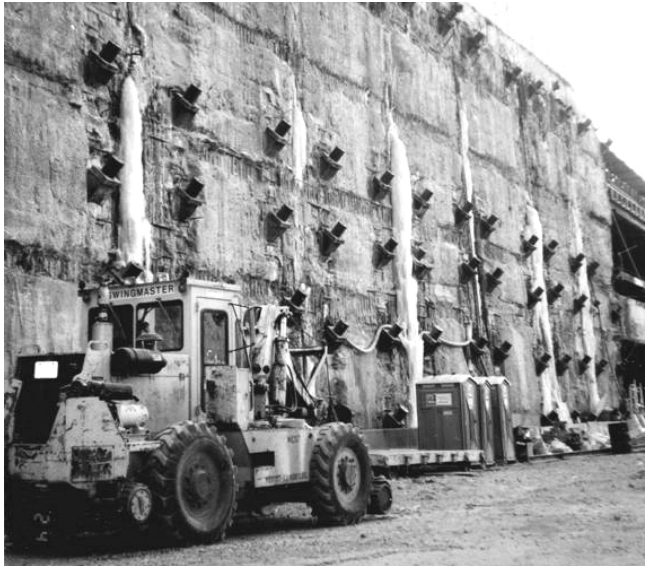
Fig. 14 Icicles form at leaking joints during freezing temperatures

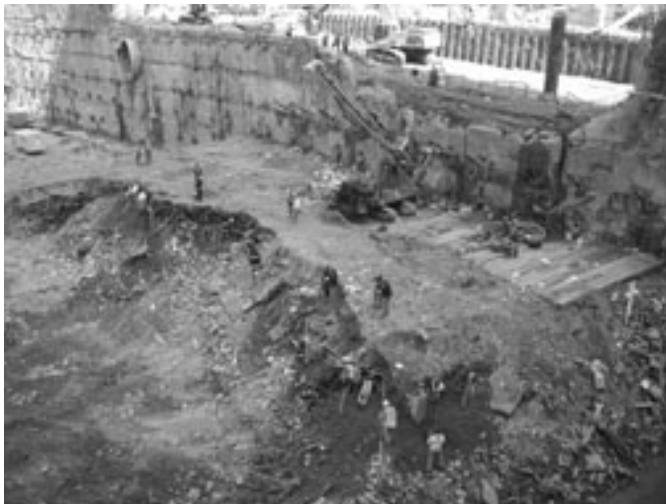
The east top section of the WTC 2 tower collapsed to the east, crushing both the IRT subway tunnel and about 30 meters (100 feet) of diaphragm wall along Greenwich Street. The top of the remaining diaphragm wall moved 1.4 meters (4.5 feet) west into the bathtub. (Fig. 15)

Fig. 15 Section of crushed wall at Greenwich Street

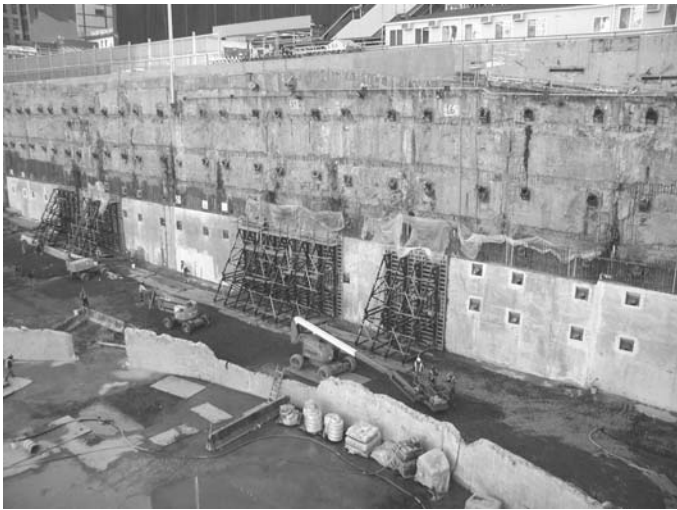
Figure 17 – Construction of liner wall at Liberty Street

A 76 meter (250 feet) long by 6 meter (20 foot) high section of liner wall was installed along the lower level of the Liberty Street wall and forty two 325mm (12.75 inch) diameter drilled shafts for future liner wall construction were installed at the south end of the West Street diaphragm wall. Reconstruction of PATH tracks will preclude construction of the liner wall at a later time (Fig. 17). The liner wall along Liberty Street is supported by concrete piers to rock and is doweled into the original diaphragm wall. The tiebacks installed during the recovery effort will provide temporary support for the two walls. Windows that are 760mm square (2.5 feet) have been provided in the liner wall to permit de-tensioning and sealing of the tieback sleeves in the future.

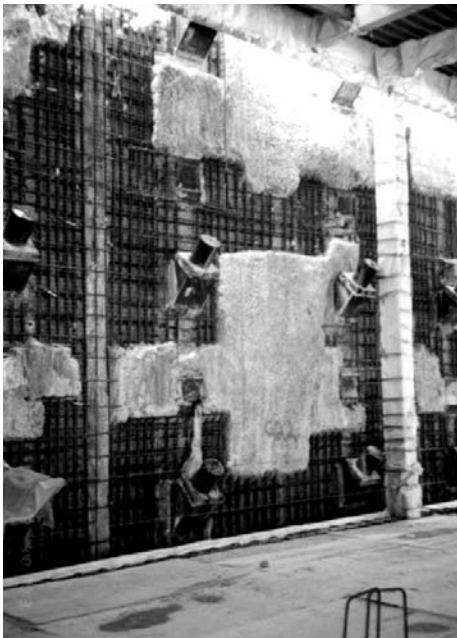
The slurry wall was damaged by the impact of the collapse, by subsequent fire and by continuing exposure to the elements. Temporary repairs, maintenance and protection of the diaphragm wall is being provided by sandblasting the exposed concrete surfaces, removal of delaminated concrete, realignment and anchoring of diaphragm wall reinforcement and application of a shotcrete cover. Depending upon future conditions, these sections of slurry wall may or may not require additional support and protection by a liner wall. (Fig. 18).

Fig. 18 Repairs of damaged slurry walls

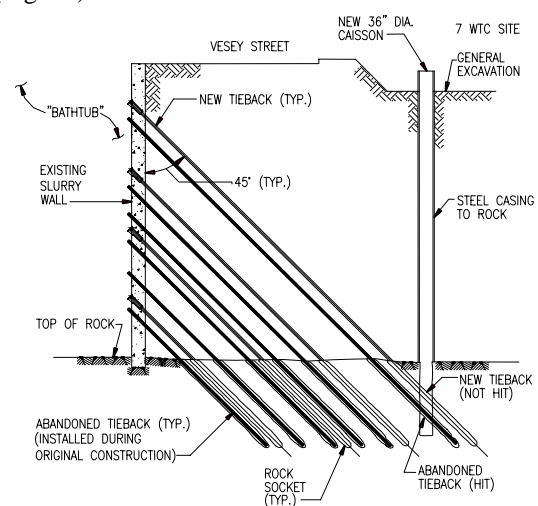
4. Utilities in the perimeter streets.
5. Remnant basement structure of the former Hudson and Manhattan Terminal (between Courtland, Fulton, Greenwich and Church Streets).
6. Remnant foundations of WTC 4 and WTC 5.
7. North and south diaphragm wall projections into West Street.
8. Temporary diaphragm wall rock anchors in the bed of Vesey, Liberty, West and Greenwich Streets. The rock sockets for anchors in Vesey and Liberty Streets are within adjacent properties and conflict with future work. (Fig. 21)

Fig. 21 Anchor/Caisson conflicts in Vesey Street
