Settlement of a Light Rail Pier Supported on Large Diameter Bored Piles Remediated by Jet Grouting

SETTLEMENT OF A LIGHT RAIL PIER SUPPORTED ON LARGE DIAMETER BORED PILES REMEDIATED BY JET GROUTING

A support Pier (Pier 161) for a Light Rail line being constructed for the Metro Manila Light Rail Project encountered large settlements after the installation of the Precast Deck Girders. This pier supports bridge crossing across the *San Juan* River with a total span of sixty (60) meters. This Pier is supported on six (6) 1500 mm diameter bored piles designed to extend down to 17 meters or socketed into bedrock at least 2.0 meters based on design requirements. The structure started to settle during the erection of the superstructure when the dead load reached about 700 metric tons. Total settlement was about 42 mm when the erection was halted at a dead load of about 1600 metric tons.

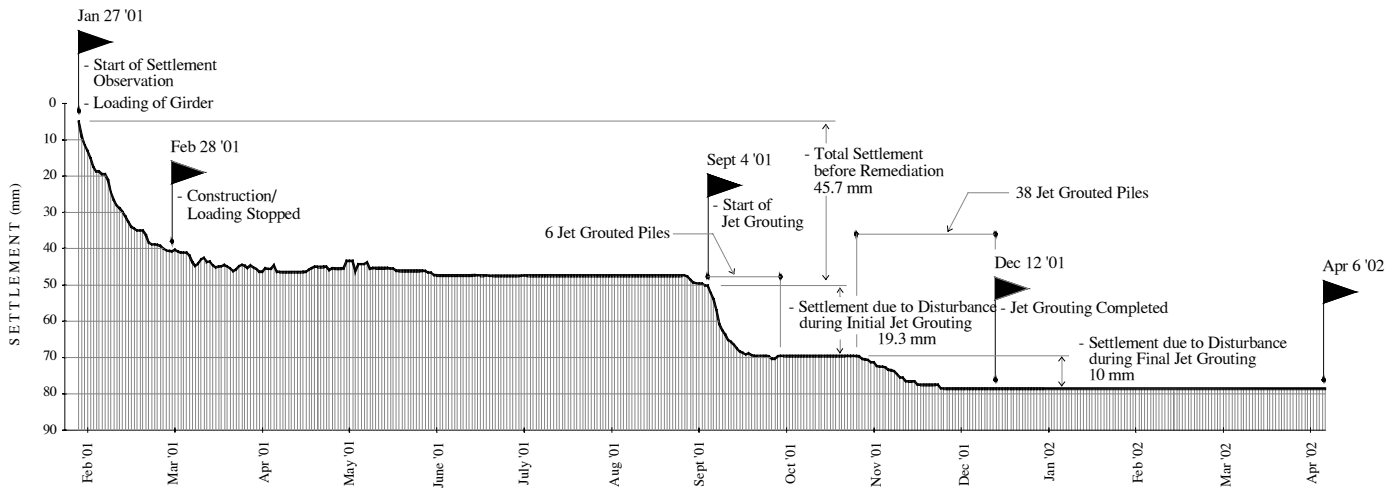
Fig. 1. Settlement History

The settlements were alarming as the pier was supported on bored piling that is supposed to be socketed at least 2000 mm into bedrock. This initial settlement of 36mm caused concern and was continuing progressively until loading and other construction activities were halted. By that time, a total of 45.7mm maximum settlement had already resulted. *Fig. 1* shows the settlement profile.

The erection subcontractor for the Precast Concrete Box Girder segments specified a maximum short-term settlement of 30mm and a total maximum long-term settlement of 45mm. Clearly, the recorded initial settlements have already actually violated these values and the Box Girders have to be raised by jacking in order to level the Girders.

The settlement record for the project is shown in Fig. 3. The milestones are flagged. It can be seen that with the initial Jet Grouting, additional settlement of 19.3mm was experienced due to further disturbance of the weak soils near Bored Pile Tips, although care was exercised to reduce such disturbances to the minimum by initially drilling far from the Bored piles. The Girders had to be releveled again by Jacking.

The Jetting was halted to allow for the curing of the Soilcrete and also because questions were raised about the effectiveness of the technology given the additional settlements. After Field trials were done to verify the effective diameter of the JGP and the Guaranteed Compressive Strength it was shown that the Test Piles satisfied or even exceeded project requirements. Subsequently, Jet Grouting was restarted for the final Jet Grouting of 38 Piles on November 1, 2001. Only 10mm

additional settlements were recorded. The Jet Grouting was completed on December 12, 2001. By this time settlements have tapered off and allowed work to be restarted on the superstructure including the laying of ballast stone.

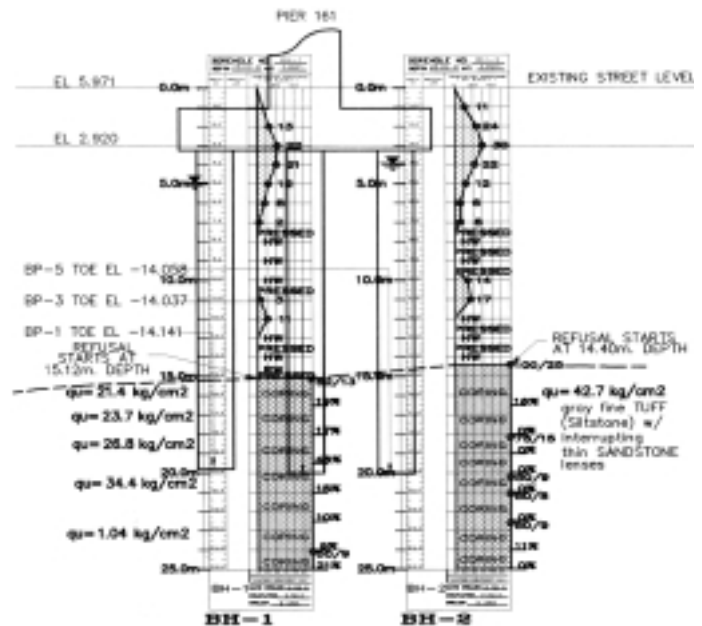
Fig. 2. Soil Profile near Pier Foundation

The check Borings (Fig. 2 below) indicated that the overburden soils are relatively poor to very poor beyond 7 meters as shown in the Soil Profile below for BH-1 and BH-2.

As can be seen, refusal was only encountered at a depth of 15.12 meters and 14.40 meters below existing Natural Ground Line.

Soil Profile taken across BH-1 and BH-2 as shown in Fig. 2 indicate the slightly sloping bedrock layer.

As can be seen from the above figure, two of the Bored Piles (BP-1 and BP-2), even when based on the assumed installation depth, were literally resting on very soft clay and the rest were socketed only about 0.24 meters into the possibly highly weathered Soil/Bedrock Interface.

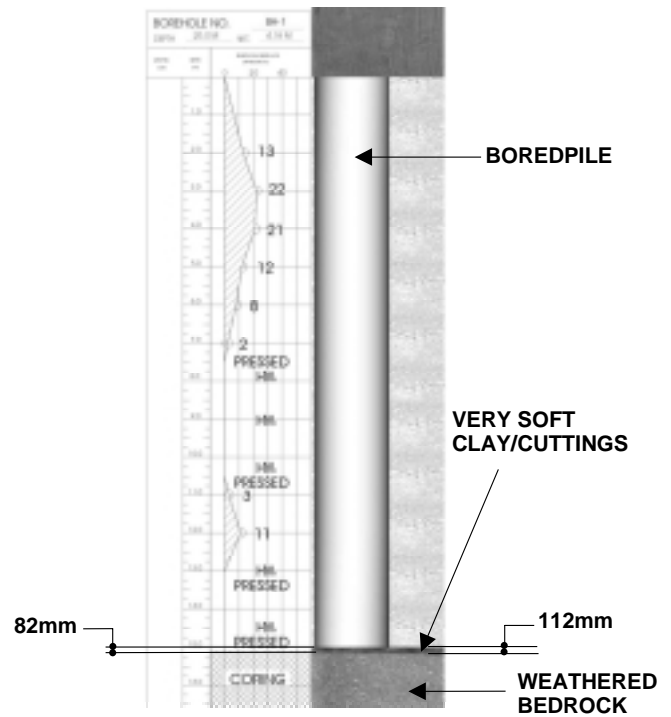
Fig. 3. Gap detected during coring at center of Bored Pile correlated with Soil Profile

It was suspected that the actual gap between some of the Bored pile tips and the bedrock are as thick as 150 mm before settlements occurred as detected from later corings done at the center of the bored piles as shown in *Fig. 3*.

Thus, the heavily loaded Bored Piles were either resting on very soft clay or on relatively weathered Bedrock very near the Soil Bedrock interface without adequate socketing.

Since the Bored piles were terminated prematurely, and were mainly resting on very soft clays or cuttings, settlement had to ensue. This was the primary cause of the relatively large settlement that was experienced at this particular Pier location.
