## Deteriorated Concrete Foundation on the Gulf Coast

**SYNOPSIS:** An investigation into the deteriorated condition of a concrete mat foundation under saline water table on a coastal sabkha sand in Qatar, the Arabian Gulf coast, was undertaken. The investigation aided by visual examination, testing (destructive and non-destructive), analysis and consideration of different soil-structure interaction schemes resulted in re-approval of the foundation from a structural integrity point of view; however its water tightness role was judged inadequate and required remedial works. Options for repair of the foundation were examined and proposed. To safeguard against the adverse effects of salts on foundation concrete, appropriate design and construction measures are required.

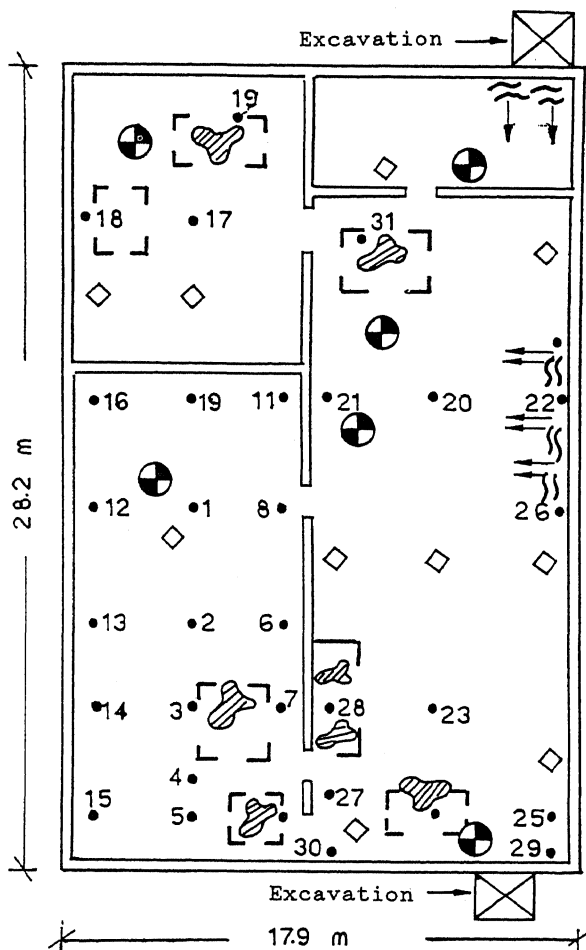
Fig. 2. Basement plan showing deteriorated areas and test locations

Table I shows results of tested samples from mat surface and basement wall. Fig. 2 shows inspected areas, test locations on mat and defect type noted. Thirty two locations were closely examined (Fig. 2) and were subjected to testing by the Schmidt hammer device. The Schmidt hammer is a spring-loaded impacting device that incorporates a scale to measure the energy of the rebound following the impact. The test gives a quick means of estimating the concrete strength.

- (i) spalled concrete cover (SC) was noticed at six different locations as shown in Fig. 2. Measured concrete strength at these locations was relatively low indicative of hollowness, delaminations and rusty upper reinforcement.
- (ii) Badly rusty upper reinforcement was noticeable at three locations with signs of water leaking into the basement from these

- locations.
- (iii) previously repaired areas (Fig. 2) have not properly withstood the onslaught of the aggressive environment and appeared to have failed; indicative of an inferior repair technique.
  - (iv) The relative variation in the Schmidt hammer readings from one location to another - not shown here - appeared consistent and reflected the relative condition of the upper concrete surface of the mat, i.e. relatively low values exhibited did correspond with damaged area identified visually and by sounding. Additionally, the Schmidt hammer readings agreed well with compressive strength data of tested cores reported on in Table I.
  - (v) A certain amount of convexity was noticeable at several places and is believed to be caused by corrosion of reinforcement rather than camber in the structure itself.

Overall, it appears that the damage (from the top) is widespread and covers an estimated surface area of about 30% of the overall mat area.

After consultation with the owner it was decided to go for a relatively high-cost fundamental repair that reaches down to all contaminated areas rather than a low-cost patch repair which had been tried with not much success in arresting deterioration. Bearing this in mind we recommended the following steps to be carried out from within the building:

1. To map out the whole slab and walls to locate all deteriorated areas including: delaminations, voids, weak concrete, cracks and rusty reinforcement.

2. To break out spalled concrete cover down to a depth below reinforcing bars. This is to be done vibration free.
3. To remove all contaminated concrete using methods and equipment that would maintain dust free environment in order not to adversely affect delicate equipment housed within the building.

4. To clean reinforcement and coat it with an appropriate rust inhibitor.
5. To replace all corroded reinforcement and restore it to its original cross-sectional area.

6. To inject and seal any visible cracks using suitable material.
7. To replace deteriorated concrete with an impermeable concrete mix to be prepared with relatively small maximum aggregate size and with shrinkage compensation admixture.

8. To apply a compatible finishing coat that will bond well to repaired and unrepaired concrete surface that possesses protective properties and provide a proper finish.

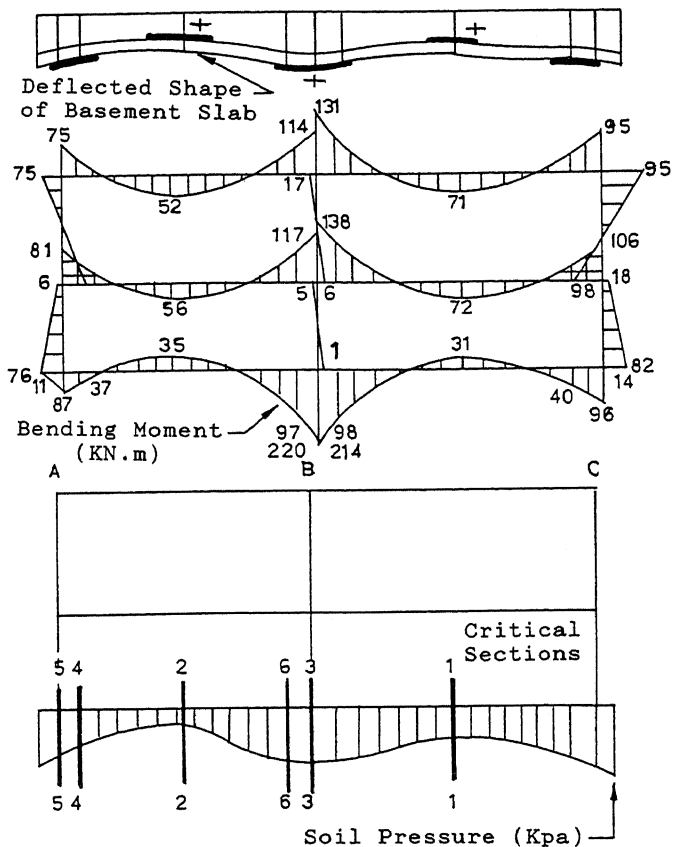
Fig. 3. The deflected shape of basement slab, bending moment diagram and soil pressure (Case 1)

- (i) should the first case of loading prevail (acting soil pressure + water uplift) then longitudinal stress induced cracking is eminent at several sections. As a consequence, longitudinal cracks could have occurred at the top and bottom of the mat.
- (ii) should the second case of loadings prevail (soil pressure under wall footings only + water uplift), no stress-induced cracking would be expected.
- (iii) the third case of loading (soil pressure under wall footings only with no water uplift pressure) corresponds with the assumption made in the original design; leads to stress-induced cracking at several sections. However neglecting water uplift is not realistic unless groundwater is drawn down permanently - which is not the case here.

Based on the outcome of the analysis, stress-induced longitudinal cracks could have developed at the bottom of the slab shortly after construction and commissioning. These cracks could have widened with time allowing salt water to seep upward through the concrete; particularly so since no water proofing was applied at the base of the mat.
