## Failure of Buildings Founded on Fills

## Failure of Buildings Founded On Fills

### CASE-1: FAILURE OF A DOUBLE STOREY BLOCK OF FLATS

## CASE II: FAILURE OF SEVERAL FOUR STOREY BLOCKS OF HOUSES

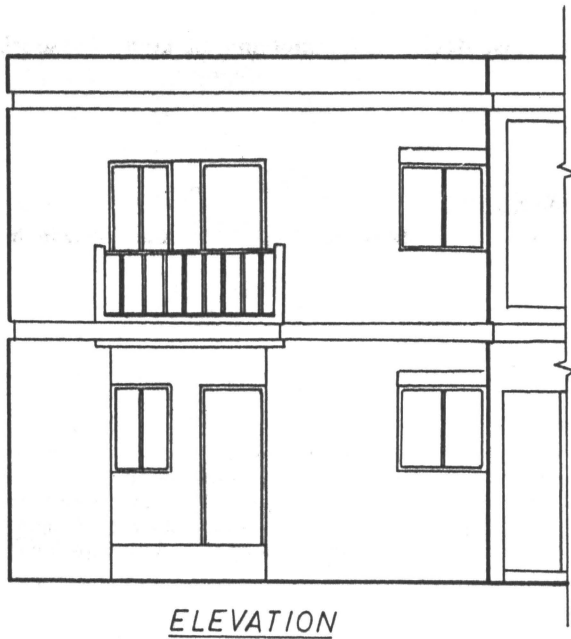
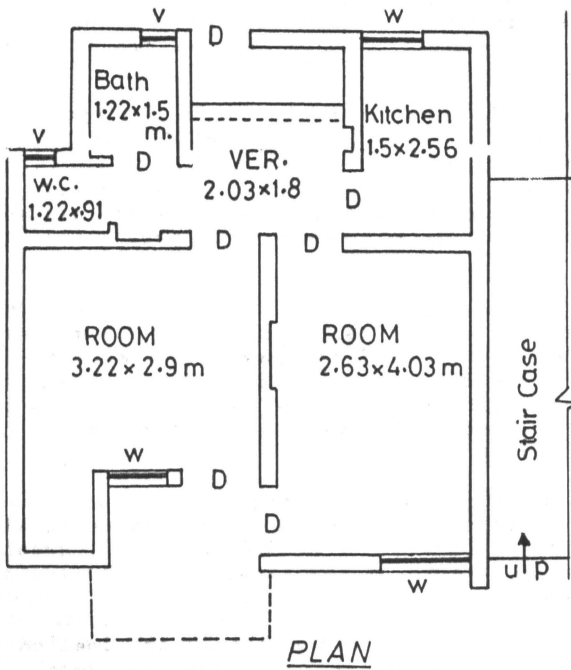
Fig.1. Case I: Plan & Elevation of the Building.

About seven hundred houses were constructed for people of low income group in an area south-east of Delhi. These are generally two storey blocks with two flats on each floor. (Fig.1) Two years

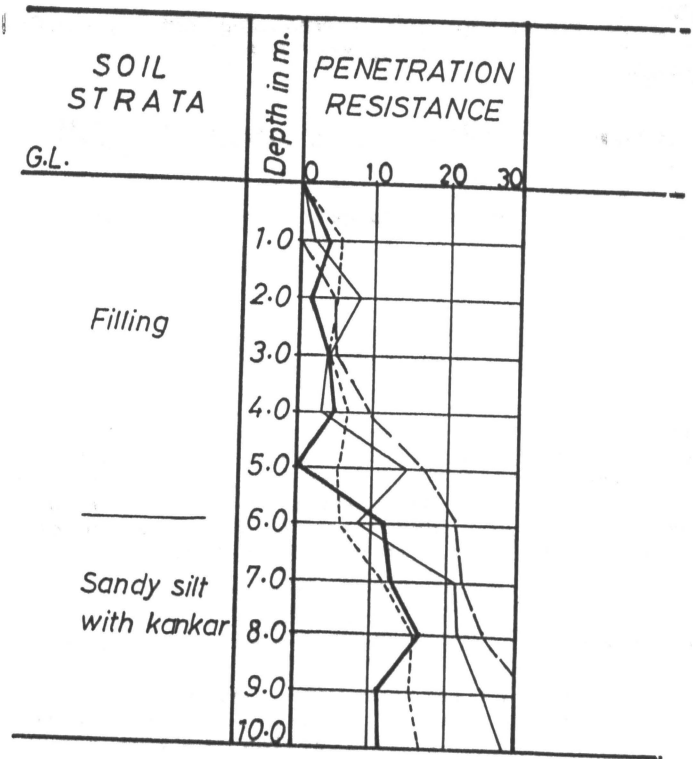
The soil at this site is loose silty sand (SM-ML) with N-values less than 4 upto 7.0 m depth; followed by medium-dense sandy-silt with  $N > 10$ . (Fig.3) In one borehole at 5.0 m depth, the sampler penetrated the full length under its own weight. Ground water table was not met with upto the depth of excavation.

FIG. 3. CASE I: VARIATION OF SPT & CPT.

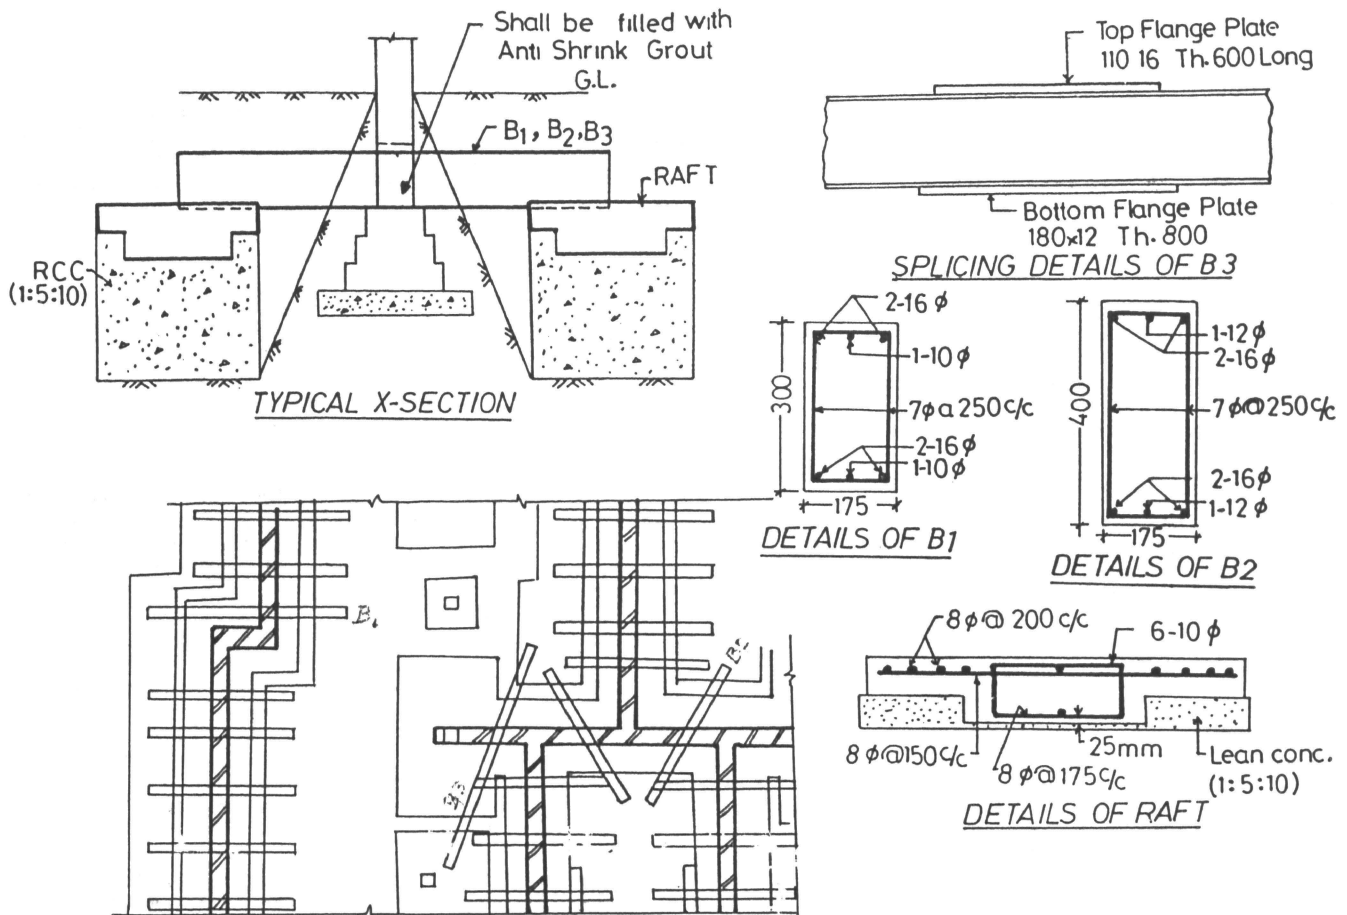
Fig. 5 FOUNDATION PLAN with Rectification Proposal. Case II

The objective of the corrective measures was therefore to transfer the major portion of the load to the firm strata existing at -2.0 to -7.0 m, so as to relieve the existing foundations of at least 60.0 to 70.0% of the load.

Excavation of longitudinal trenches along the walls on either side of it and constructing piers 1.0 to 2.0 m wide upto the required depth (-2.0 to -7.0 m). Precast beams shall then be pushed across the walls atop the piers. Here the load is to be transferred to the firm strata below through the piers supporting the beams. Originally it was contemplated to keep the beams at foundation level. However, it soon became apparent that it would require excessive excavation. This proposal was therefore, modified so as to keep the precast beams at the plinth level. Thus the wall segments were to be cut at the smallest thickness with consequent ease in pushing the precast beam (Fig. 5).

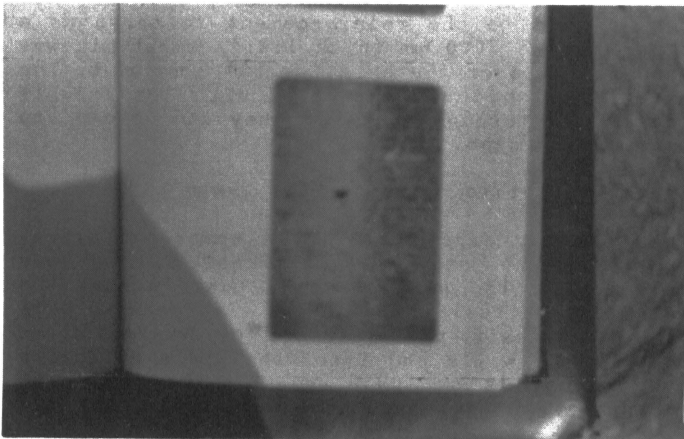
- i) Outer load bearing walls, (23.0 cm thick) suffered extensive cracking due to sinking. Tilting of walls resulted in their getting out of plumb. At several locations there was differential settlement as well. (Fig.4).
- ii) Interior partition walls, 11.5 cm thick, suffered cracking in most cases, and substantial sinking in some cases.
- iii) Beams on various floors sagged.
- iv) Cracking occurred in the slabs at most of the junctions. There was excessive sagging (3.0 to 4.0 mm) at the center of many slabs. Lintels also showed shear cracks.
- v) Staircases separated from the main walls and the gap increased with height.

Enquiries revealed that a brick kiln existed at this site. The kiln was demolished and the area filled up with earth without proper compaction. The contractor who also happened to be the designer as well, started construction without proper site investigation. The result was that wherever the foundations happened to be on the hard kiln foundation, no distress was observed. But in places where foundations of houses came to rest on filled up area, it suffered extensive settlements manifesting distress noted above.

Fig. 4 : Cracks on Outer Walls - Case II

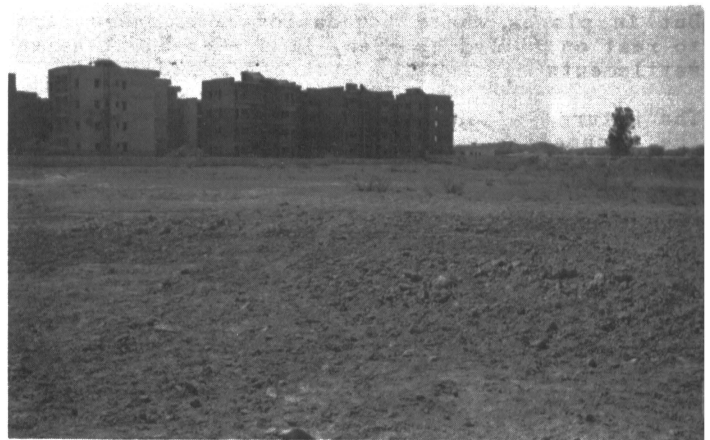
Figs. 6 Rehabilitated Structures - Case II

The slabs also needed to be strengthened as these were showing excessive deflection under this self weight. For this purpose the existing slabs were cut at 1.5 m. upto the reinforcement level. Generally two to five cuts were required in each room depending on its size. A vertical steel section with a horizontal plate was then spot welded to the reinforcement to serve as a shear key. A 50.0 mm thick 1:2:4 cement mix was then poured over the existing 100.0 mm slab. The existing slab thus integrated with the freshly poured mix through the shear key and formed one monolithic slab.

The rehabilitated structure is shown in Fig.6.

The work was carried out by a competent agency under strict supervision. Special care was required in the alignment of beams across the wall and in its levelling. The slab corners were fixed at their proper place by making holes through the walls and inserting RSJ's extending over the walls by 100.0 mm on either side and embedded into the fresh poured concrete.
