Mine Plug Integrity Evaluation

MINE PLUG INTEGRITY EVALUATION

ABSTRACT

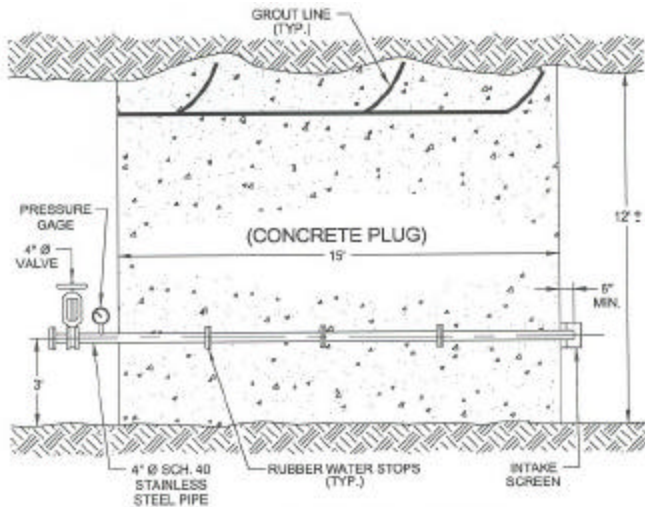
Fig. 1 Section through mine plug (SRK, 1985)

The drain piping consists of two independent 4-inch diameter stainless steel pipes that extend through the concrete seal. The as-built drawing (Figure 1) indicates that the pipes extend a minimum of 6 inches upstream of the seal face and the inlets are protected with screens. The drawing also shows that rubber rings were placed around each pipe at 4-foot intervals to serve as waterstops.

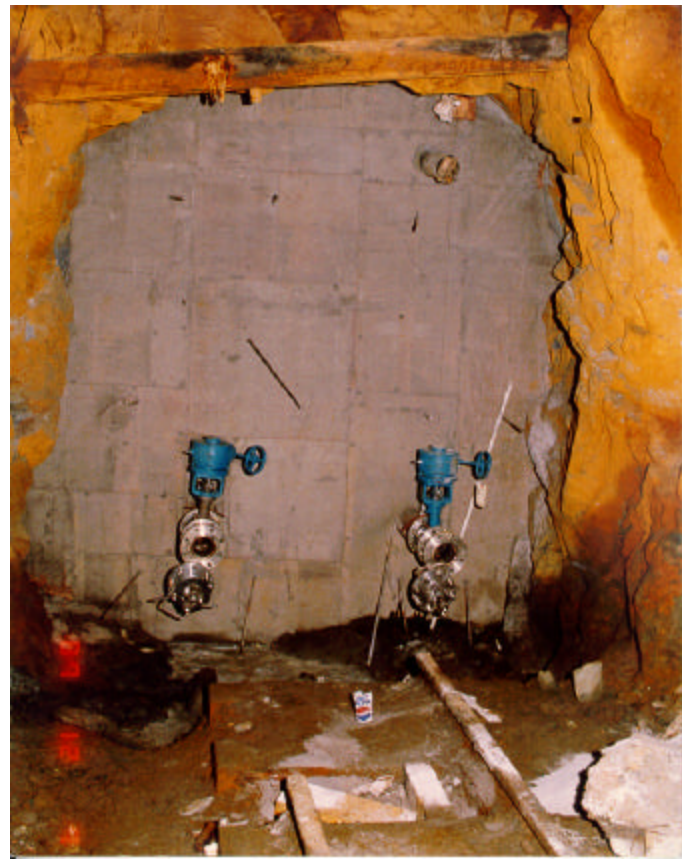
Photo 1. Seal after construction (December 1987).

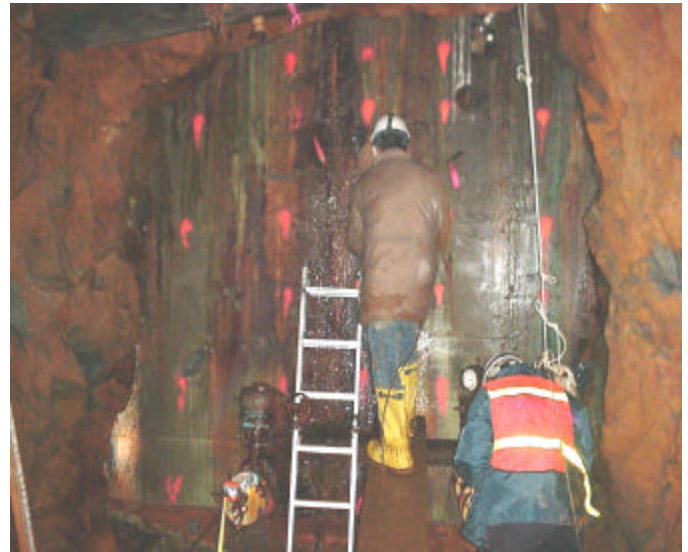
Except for those areas covered by deposits of iron hydroxide and calcium carbonate from seepage water, the original formed surface of the seal was plainly visible and in good condition (Mass, 2000). No surface erosion was observed. The concrete appeared dense and well consolidated. No cracking of any nature was observed on the seal face. The entire face of the seal was moist. Surface deposits appear to be associated with areas of seepage and seepage flow

(Photo 2). Efflorescence, whitish deposits of calcium carbonate, was isolated to two small areas at the lower left sidewall and upper right side of the seal. A green-colored copper sulfate staining was also observed on the right side of the seal and on the rock adjacent to the seal.

Photo 2. Seal on November 1, 2000. Red paint marks are impact points for nondestructive testing.

The center of the calcium carbonate deposit on the lower left side of the seal (Photo 2) was wet from active seepage flow. It was found that the thickness of the deposit ranged from 1 to 2

The area immediately below the protruding steel pipe that had been used for pumping concrete into the seal (Photo 2) was moist but there did not appear to be any evidence of seepage flow. The surface paste was found to be hard and sound and could not be removed by scraping.

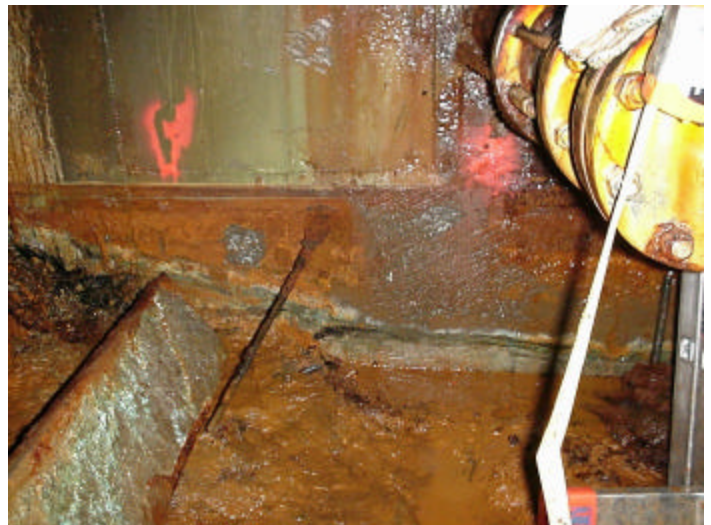
A horizontal water line on the concrete face, as evidenced by iron staining, was observed approximately 18 inches above the floor of the adit (Photo 3). This water line was generated by the presence of the ponded seepage against, and immediately downstream of the seal. The ponded water was removed for access and inspection.

The area above and below the water line that had been created by the ponded seepage were observed. Below the water line the concrete surface paste and mortar could easily be removed by scraping to a depth of 1 to 2 mm before hard, sound concrete was reached. Above the water line the depth of soft paste and mortar was approximately 1 to 1.5 mm (Photo 3).

Photo 3. Closeup of bottom left quadrant showing water line of seepage pool (Nov. 2, 2000)

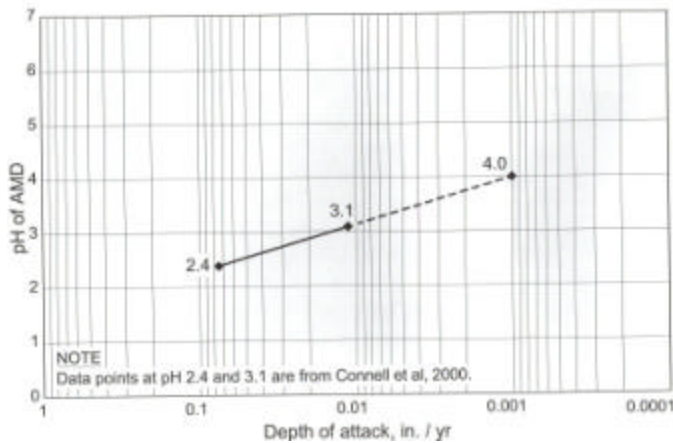
Fig. 2 Estimated rate of AMD attack of concrete based on Iron Mountain Mine studies.

this mixture, calculated as an average depth of surface loss, is plotted on Figure 2. Extrapolation of the curve predicts approximately 0.4 mm of surface softening in 13 years of service. Visual observations during inspection of the seal in November of 2000 indicated that the maximum depth of surface softening was on the order of one to two mm. The difference in these values may be attributed to differences in water chemistry, concrete composition, and exposure factors or to data inaccuracies.

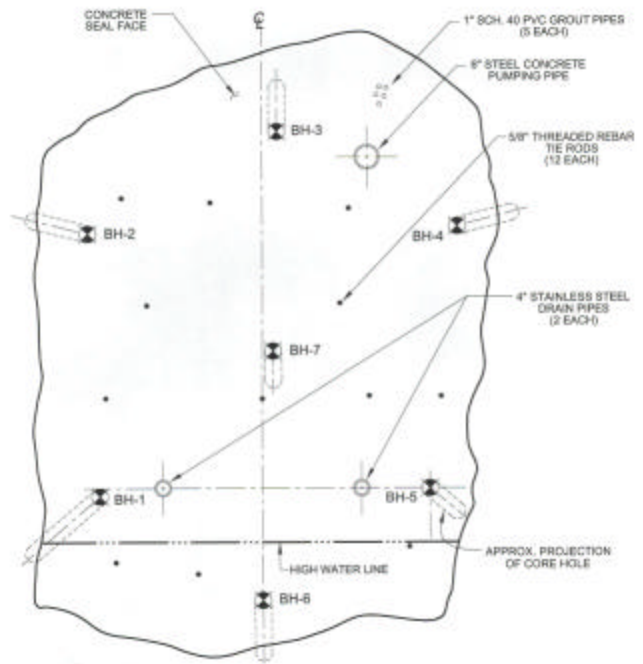
Fig. 3 Approximate borehole locations and orientations.

Seven HQ (3.78-inch-diameter) holes were cored through the downstream portion of the seal and adjacent rock to recover concrete and rock samples and to allow further nondestructive testing of the seal and the rock-concrete interface. The locations of the core holes are shown on Figure 3. Six of the core holes, BH-1 through BH-6, were located along the perimeter and angled away from the axis of the seal, with the objective of intersecting the rock-concrete interface within the middle third of the seal's length. This was in order to obtain maximum information on concrete and rock conditions while at the same time minimizing the risk of intercepting a pressurized seam. However, due to the extreme roughness of the rock walls, only four of the six holes intersected the rock-concrete interface. The seventh hole, BH-7, was drilled through the center of the seal and subparallel to its axis. The core hole lengths ranged from 7 to 10 feet.

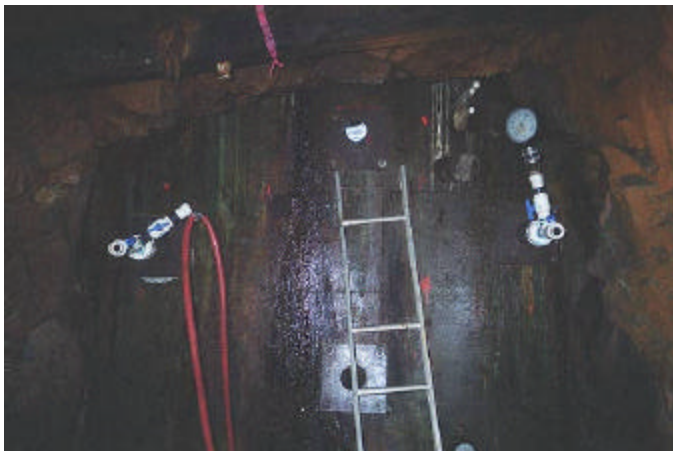
Photo 5. Core holes BH-2, -3, -4 and -7 in the upper half of the seal. Holes BH-2 and BH-4 are equipped with shutoff valves (September 10, 2001).

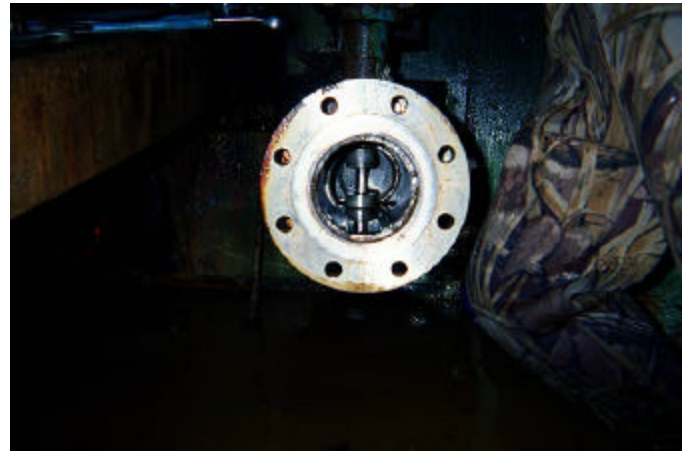
All valves in the drain pipe system were exercised and were found to be functional. The actuators of the shutoff valves were not frozen and operated smoothly. The valves gave tight shutoff upon closing. During the testing activities, the interior of the valves was observed from the downstream side (the nonpressure side, see Photo 6). Although this side of the valve contained AMD prior to the inspection, there was no discernible corrosion of the visible interior stainless steel components of the valves.

Photo 6. Interior of 4-inch control valve (June 13, 2001).
