The Failure of a Soil Blanket Lining Caused by the Action of Bacteria

G. W. Plant

P.B.B. Voslo

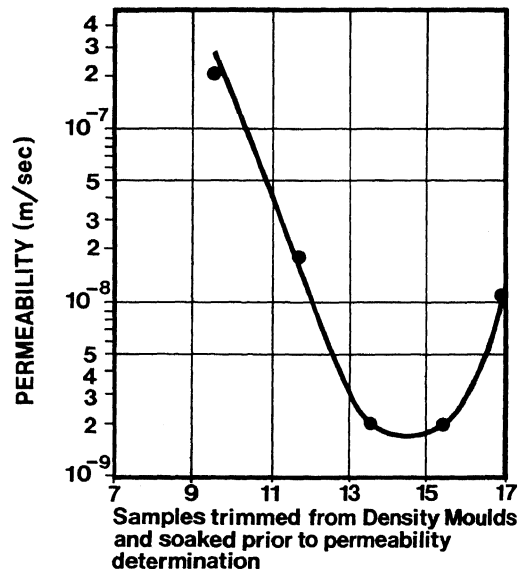
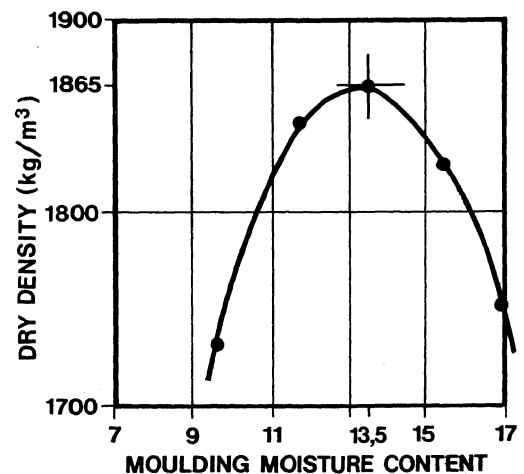
Fig. 3 Dry Density and Permeability Related to Moisture Content

- Sample 'C'
- LL - 23
- PI - 9
- % Clay - 11
- % Silt - 27
- % Sand - 62
