# The Stability of Shannon Embankments

**SYNOPSIS** During the operating life of the Shannon Embankments, stability and seepage problems have occurred which caused concern regarding long term safety. The geology was studied, a comprehensive scheme of field and laboratory investigation was undertaken and the stability was analyzed and back calculated under failure conditions. The relative significance of various parameters was studied and provided the basis for the design of remedial measures. This paper deals in detail with the study of the stability of one embankment section (Fort Henry) and the recommendations on remedial measures.

The Ardnacrusha hydroelectric project on the river Shannon near the western coast of Ireland was constructed by Siemens in the period 1926 to 1929. This project included a 12 km long headrace canal and the reservoir embankments called respectively the Fort Henry and the Ard-clooney embankments. During the operating life of the project stability and seepage problems have occurred and gave rise to concern regarding the long-term stability and safety of the installation. In 1980-81 a major engineering study was undertaken to determine the remedial measu

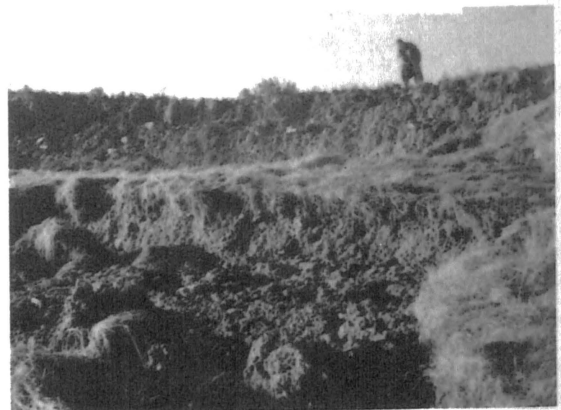
Fig. 2 Slide of downstream slope in 1948

On the night of 4th January, 1948, a slide occurred, affecting the downstream face over a length of 50 m. Heavy rain had been falling for some days previously and over 29 mm in the preceding 24 hours. The reservoir level before the slide was at 33.16 m and the level of a small river in the vicinity of the embankment toe was at 29.1 m. No indication of incipient slope failure, such as cracks or slumps, was observed before the slide. After the slide the top of the embankment (34.80) was lowered to 34.1 m. The whole surface of the slide area was found extremely soft.

Before construction of the embankment in 1926, the surface soil was stripped from the foundation and a longitudinal trench was cut to intercept long drains and to form a core trench. Timber sheet piles were driven to a depth of 5 m. The material used for construction of the embankment was sandy silt. A soil boring was reported in the vicinity of the slide area, suggesting the following layer sequence: surface soil (0.5 m), yellow sand (1.5 m), blue gravel (0.5 m), running sand (1.0 m), clay and sand (3.0 m), yellow clay (0.50 m) on coarse gravel.

After the slide, the reservoir was slowly lowered to 32.6 m. The immediate repair work consisted of temporary measures such as sealing of cracks with dry clay and flattening of steep slopes. For the permanent repair, the slide area was filled with dry bank material to form a flat slope of 5:1 up to 32.0 m. Stone-filled drainage trenches were provided in this area. Above that level the bank was refilled to the original slope of 2.5:1.

Based on a total stress analysis, assuming undrained shear strength for the embankment and foundation material, a stone berm was designed to increase the factor of safety to approximately 1.45 on a length of 1 200 m. A detailed description of the repair work has been given by Harty (1953).

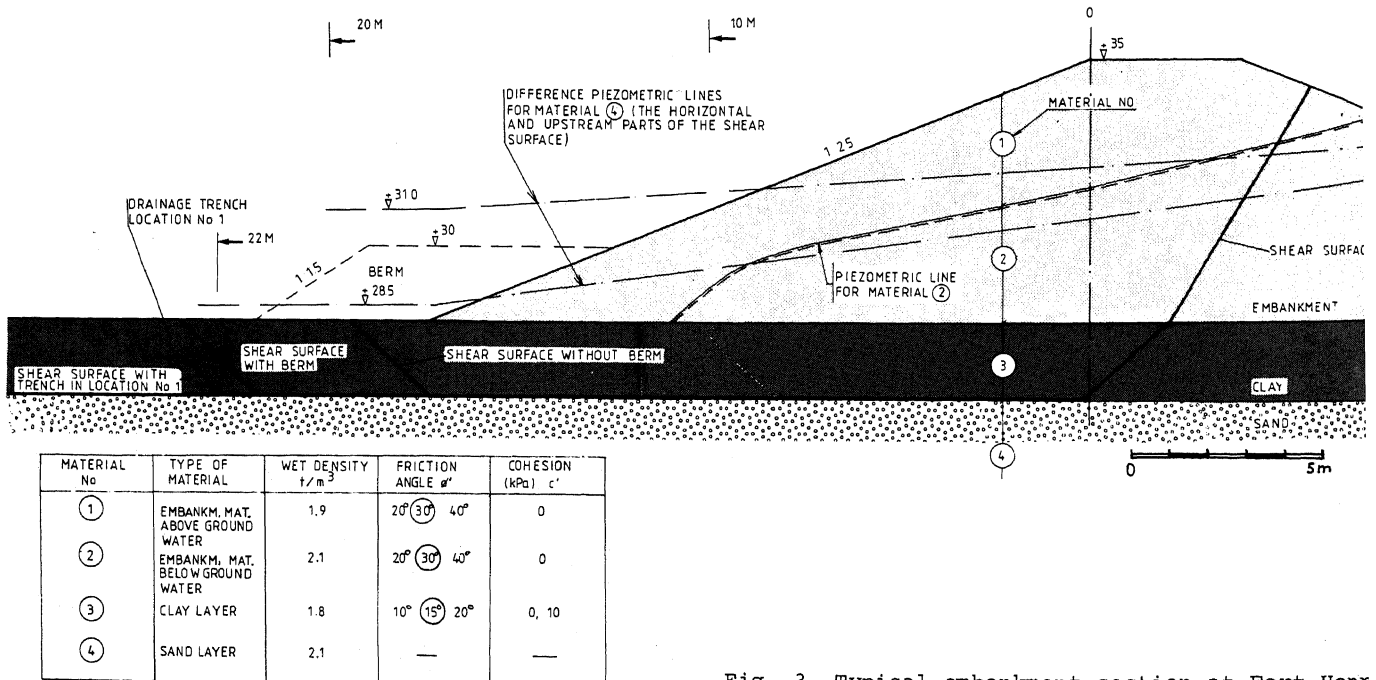
Fig. 3 Typical embankment section at Fort Henry

A typical embankment section at Fort Henry is shown in Fig. 3.

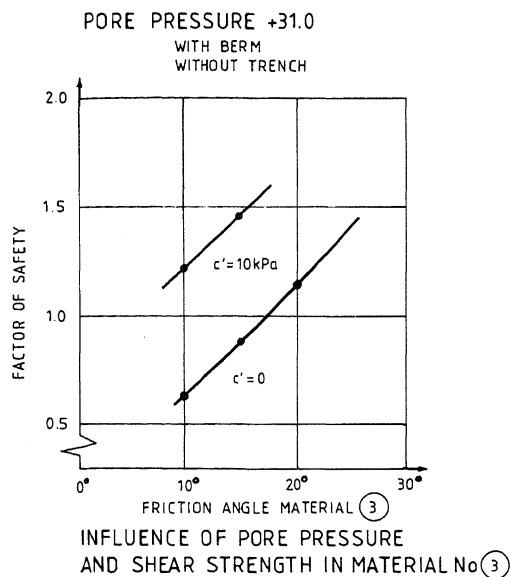
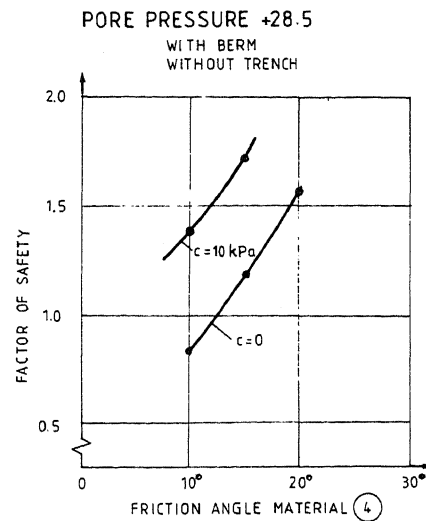
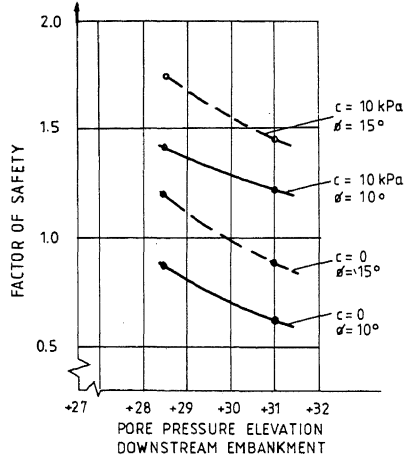
Fig. 4 Results of parameter study

The results of the stability analysis are summarized in Fig. 4. The relative significance of various geotechnical parameters on embankment stability are shown.

The stability analysis showed that embankment instability is a result of alternating layers of clay and sand with high pore water pressure below the embankment. Excess pore water pressures are caused by the water pressure in the reservoir and can significantly reduce the embankment stability. The stability analysis also suggests that embankment sections, where drainage trenches have been constructed in the past have a detrimental effect on the downstream stability. The parameter study also provides valuable information on the effect of variations in geotechnical parameters on the analysis result.

FRICITION ANGLE	FACTOR OF SAFETY	CHANGES %
30°	1.187	0
20°	1.115	-6
40°	1.260	+6

SLOPE GEOMETRY	FACTOR OF SAFETY	CHANGES %
WITH BERM	1.187	0
WITHOUT BERM	1.080	-10
WITH BERM AND TRENCH IN LOC. No 1	1.100	-8
WITH BERM AND TRENCH IN LOC. No 2	1.19	0

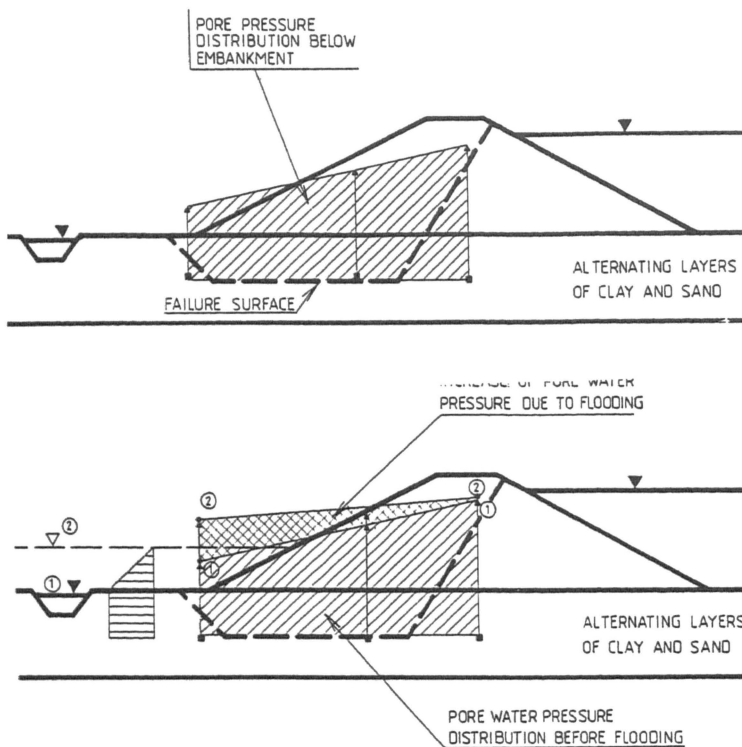
Fig. 5 Schematic sketch of pore water increase below embankment as a result of flooding downstream.

The reduction in effective stress in alternating layers of clay and sand below the embankment may be greater than the stabilizing effect of the water pressure, acting at the downstream face, Fig. 5.

The effect of flooding on embankment stability depends mainly on the location of the contact between the clay and permeable layers in the flooded area, and on the geometry of the embankment. Thus, under unfavourable conditions, flooding of the downstream face can initiate embankment failure.
