## Failure Investigation of a Fill Slope in Putrajaya, Malaysia

## FAILURE INVESTIGATION OF A FILL SLOPE IN PUTRAJAYA, MALAYSIA

### ABSTRACT

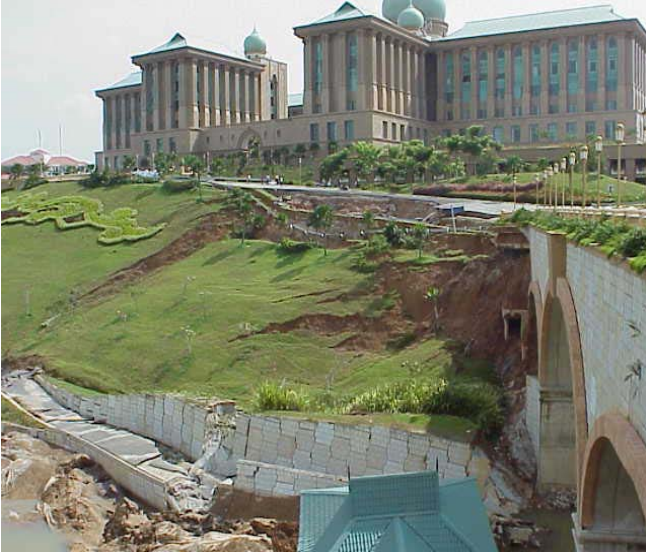
*Fig. 2. Extent of the failed area*

Failure reconnaissance of the area showed that the depth of the failure scar was approximately 2m deep and the length of the failure about 50m. The total height of the failed slope was

about 25m and the angle of the failed slope was about 22 to 25 degrees. The extent of the fill slope failure is shown in Fig. 2.

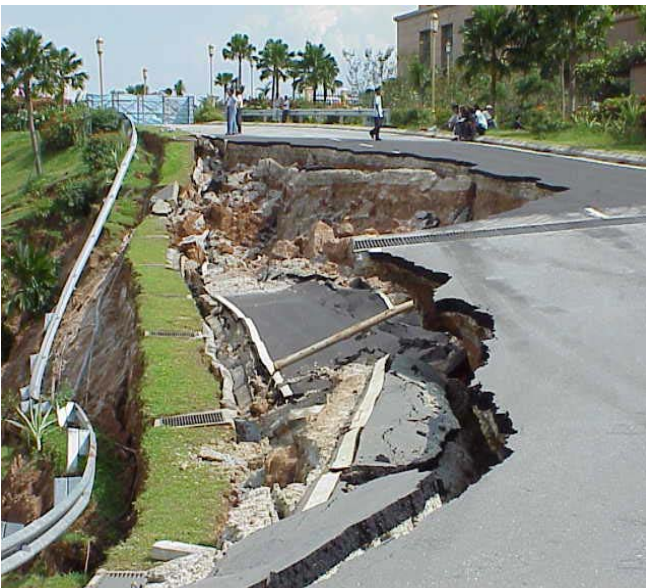
*Fig. 3. The top portion of the failed slope*

The failure caused half of the road at the top of the fill slope to collapse, Fig. 3.

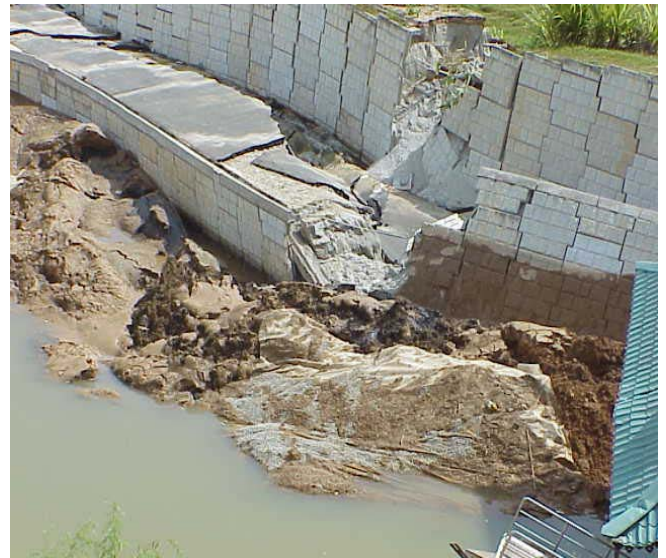
Seepages of water was also observed both at the toe of the fill slope and at the bridge abutment. Cracks were also observed on the road near the bridge area. The failure also caused two reinforced earth walls and a recently constructed small jetty berth located at the bottom of the fill slope to collapse, Fig. 4.

*Fig. 4. Collapse of the two RE wall due to the slope failure*

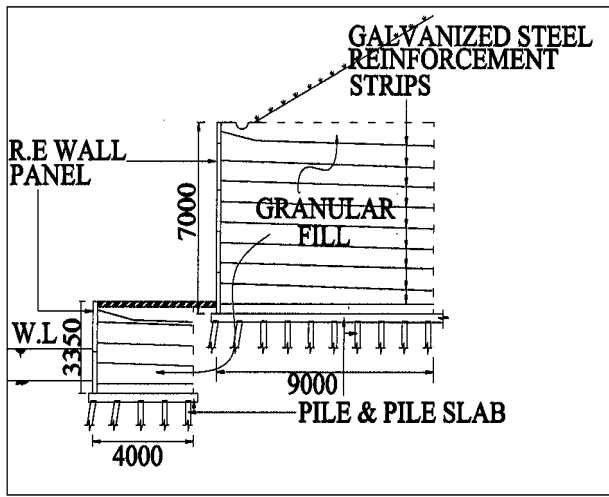
Fig. 5. RE wall design

The desk study also shows that the height of the two reinforced earth wall constructed namely RE wall W1 and W2 was about 7m and 3.35m. Both walls were supposed to have been constructed on piles with a pile slab on top of the pile group. Details of the RE wall design that was to be constructed is shown in Fig. 5.

At the RE wall W2 location, BH1 to BH3, which was carried out near the wall location indicated the presence of very soft to soft clayey silt up to 8m deep. However no pile slab was encountered.

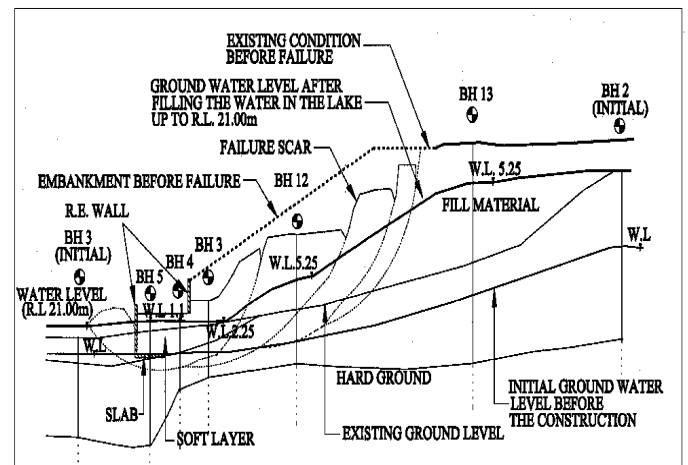
Fig. 6. Cross section of the failed area

A detail mapping of the cross section of the failed site was carried out as shown in Fig. 6. It can be seen that the groundwater table has risen to about 9 to 10m from the original groundwater table prior to the construction of the man made lake.

Detail investigation of the site shows the presence of a thin layer of soft clay that have been squeezed out at the bottom of the slope indicating that not all the soft material have been excavated during the construction of the fill slope as mention by the contractor's site staff.

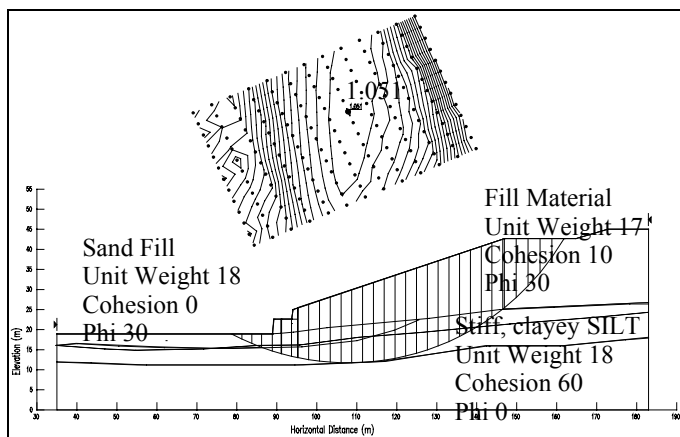
Fig. 7. Case I: Prior to Construction of the lake

For Case 1, Fig. 7, the Factor of Safety (FoS) was found to be about 1.051. This was much lesser than those obtained from the initial analysis carried out by the contractor, which was about 1.4 to 1.5. The differences in the Factor of Safety could

be due to the difference in values of the soil parameters use in the analysis although this could not be confirmed. Standard typical Malaysian soil parameters values were use as there was a delay in getting values from laboratory tests.

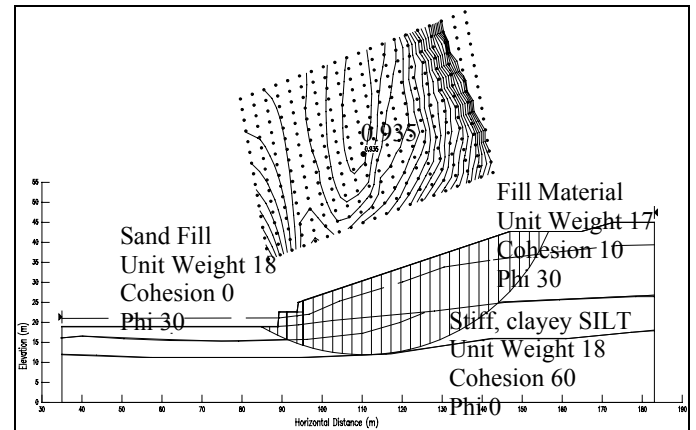
Fig. 8. Case II: After filling of water into the lake

For the second case, Fig. 8, the FoS was found to be just below one (0.935). This indicates that the slope was unstable, as the groundwater level has risen as a result of the filling of water into the lake.

3. There was a rise in the groundwater level in the failed slope after the filling of water into the lake. The rise in the groundwater level was about 9m as compared to previous readings of groundwater level before the construction of the fill slope. This has caused the slope to be unstable as the factor of safety (FoS) was reduced from 1.051 to 0.935 using assumed soil parameters.
