(2004) - Fifth International Conference on Case  
Histories in Geotechnical Engineering

## RECENT EARTHQUAKES IN JAPAN

### ABSTRACT

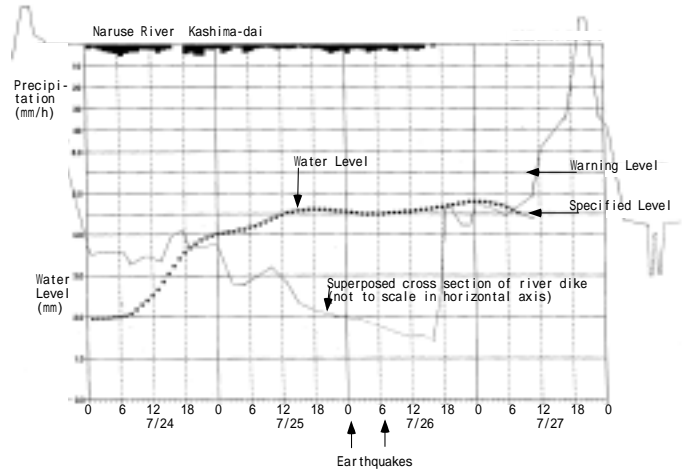
Figure 3 shows typical damage to the embankment at the Naruse river. A particular interest of this case history is the timing of the earthquake occurrence. It was coincided with the continuous rainfall for three days before the earthquake. As shown in Fig. 4, the continuous precipitation in the order of 1 to 5 mm/h for three days indicates that cumulative rainfall was in the order of 150 to 200mm when the earthquake hit the area. The water level was over the specified level, above the elevation of flooding area, and approaching toward the warning level.

Fig. 4 Water level, rainfall, and the warning and specified water levels at the Naruse river (After Tohoku Construction Bureau, MLIT)

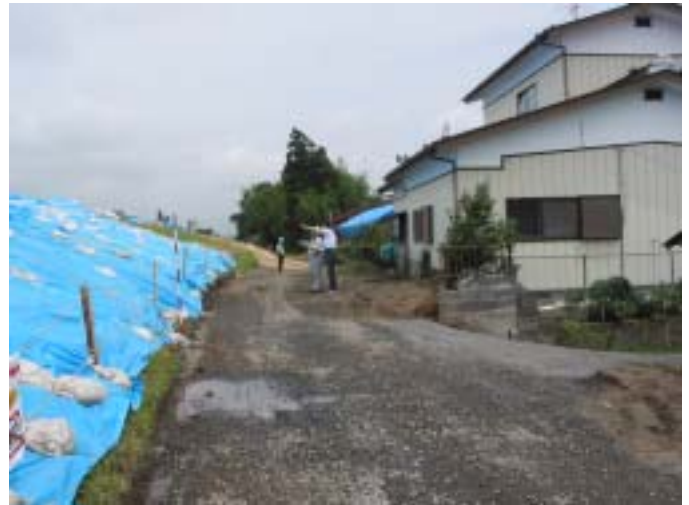
In typical design of river embankment, coincidence of earthquake occurrence and heavy rain is not considered. This is because the combined probability of the occurrence of both phenomena is very small. However, the case history obtained here suggests that the low probability event may not be easily neglected when the combined risk poses a very high consequence. This is especially true when the river embankment is located in the vicinity of residential area as shown in Fig. 5.

Fig. 5 Residence in the vicinity of the failed river embankment at the Naruse river

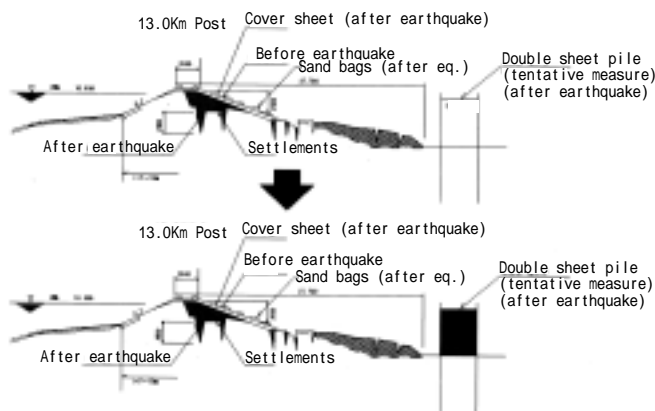
Fig. 3 Cross section of the failed river embankment and tentative measure for restoration (after Tohoku Construction Bureau, MLIT)

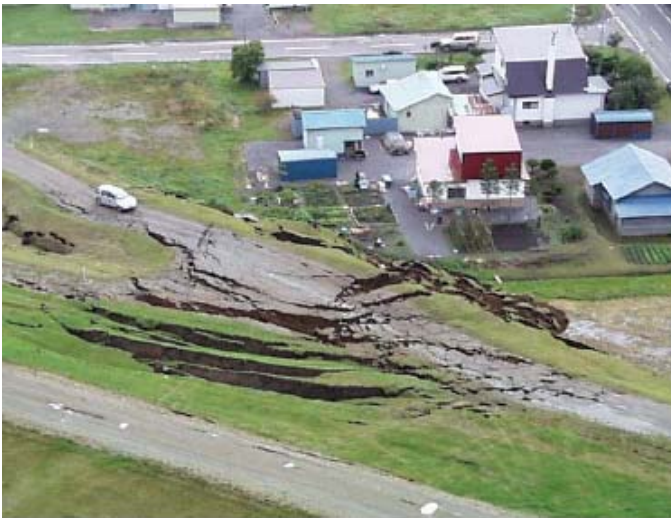
More significant failures and liquefaction occurred at the river embankments in Tokachi area during 2003 Tokachi-oki earthquake. These failures were widely reported by the mass media after the earthquake because they were wide spread and easily recognizable. Major cause of damage was the liquefaction

of foundation soils. Some of the photos are shown in Fig. 6.

Fig. 6 Damage to embankment at the Tokachi river (After Hokkaido Development Bureau)

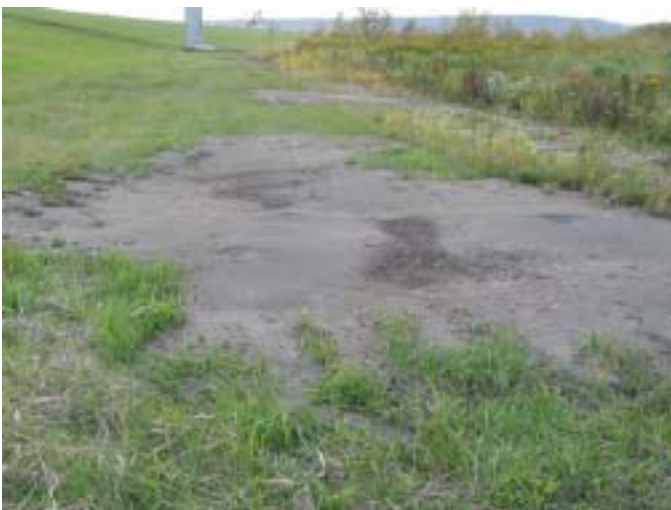
Fig. 7 Sand boils at the toe of an embankment

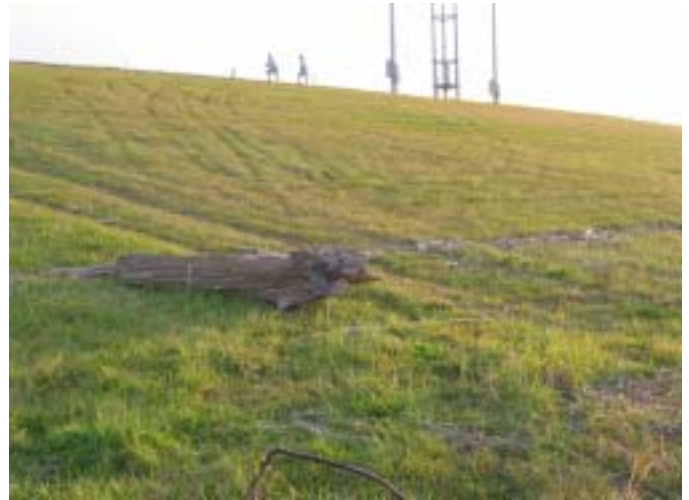
After the earthquake, a run-up of a tsunami occurred along the Tokachi river. There was no serious damage or flooding due to the tsunami. However, the incidence of the occurrence of a tsunami run-up immediately after the earthquake suggests that the failure of embankment should be design not only for potential flooding due to rainfall but also for a possible tsunami run-up after the earthquake especially for the river mouth area and in the vicinity.

Fig. 8 Traces of tsunami run-up along the Tokachi river

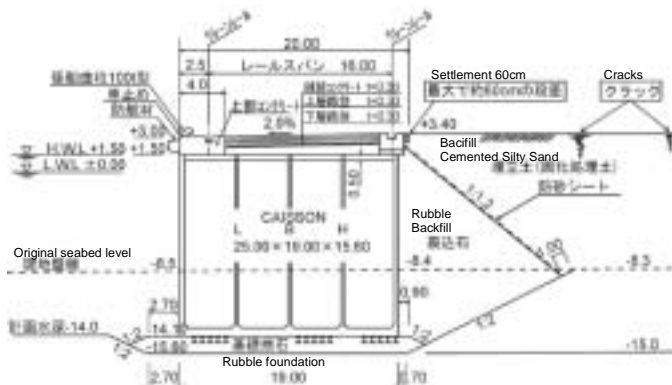
Figure 10 shows a cross section of a quay wall with backfill soil treated with cement for solidification. The backfill soil was silt dredged from the nearby sea bottom. The cement was mixed for solidification using an in-situ plant before filling. Cement added

were 80 to 110kg/m<sup>3</sup> for achieving unconfined compression strength in the average of 400kN/m<sup>2</sup>. Due to the earthquake, the backfill soil settled about 0.5m. There was no evidence of liquefaction in the cement treated zone.

Damage was minor or non to the quay wall having the similar cross section but with backfill treated by sand compaction piles or gravel drains.

Fig. 10 Cross section of a gravity quay wall at Kushiro port with backfill treated with cement for solidification (After Hokkaido Development Bureau; Port and Airport Research Institute)

The difference in the performance of these quay walls attracted a keen interest among geotechnical engineering profession. Various speculations have been made. Pseudo static analysis typically results in the smaller displacement when the stiffness of some portion of the soil-structure system is increased. Due to the dynamic response of a system, stiffening of one portion of system might not always results in the stiffness increase in the overall system. Highly non-linear nature of a system may also contribute to a complex response of a system. In particular, unbalanced stiffness distribution in the system may result in strain concentration to a remaining soft portion, thus casing unfavorable deformation in the system.

Another possibility speculated is the effects of stress history. The quay walls having backfill soil improved with sand compaction piles and/or gravel drains were constructed before 1993 Kushiro earthquake and underwent the stress histories due to 1993 Kushiro-oki (M=7.8) and 1994 Hokkaido-Toho-oki (M=8.1) earthquakes. The PGA recorded at Kushiro port at these earthquakes were 0.3g and 0.2g, respectively. Due to these stress histories, it might be possible that the backfill stones and foundation gravels may be sufficiently strengthened by obtaining the more solid particle contacts between the gravel particles. The backfill soil improved by sand compaction piles and gravel drains might also become more stable than the initial state immediately after the sand compaction piles or gravel drains installation. On the other hand, the quay walls having backfill treated with cement for solidification were constructed in 2002 just before the earthquake. There was none in the stress history in these quay walls before the 2003 earthquake.
