(2013) - Seventh International Conference on
Case Histories in Geotechnical Engineering

Wolf Creek Dam: Instrumentation & Monitoring

WOLF CREEK DAM INSTRUMENTATION & MONITORING

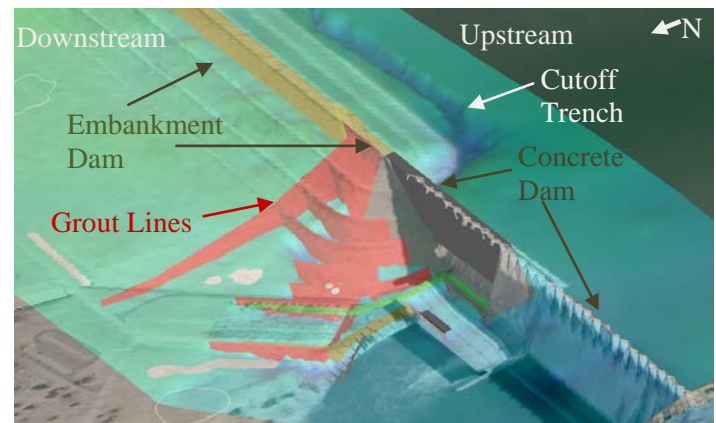
The development of sinkholes led to an emergency investigation and a subsequent emergency grouting program shortly thereafter. The grouting program consisted of a three-line grout curtain that began at the embankment/concrete dam interface on the crest and extended downstream for a distance of approximately 200 ft and extending to a depth of 273 ft, targeted the base of the Leipers formation. In order to protect the downstream embankment wrap around area, additional grouting was installed perpendicular to the downstream grout lines and extending toward the right abutment and following the curve of the wraparound. In addition, single line grouting was performed at select locations near the switchyard. Figure 3 identifies the grouted areas, highlighted in red, in a 3D rendering.

Figure 3: 3D rendering of remedial grout program (grout lines shown in red)

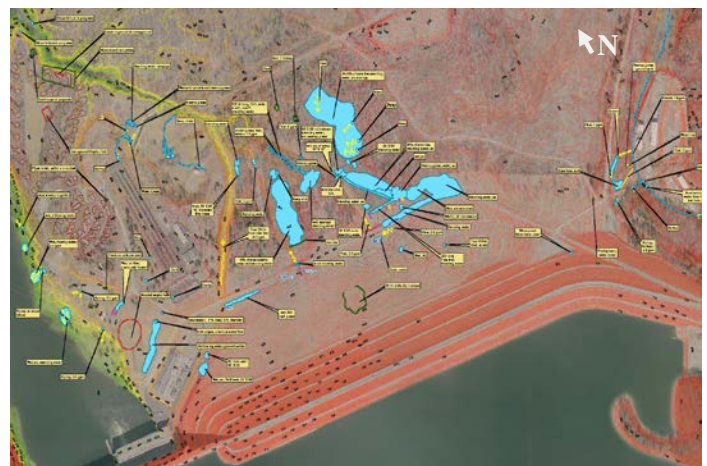
By 2004, wet areas were extensive throughout the downstream toe and switchyard areas. Figure 4 shows a map location of the wet areas that were identified in 2004.

Figure 4: Plan of wet areas (shown in blue) identified in 2004

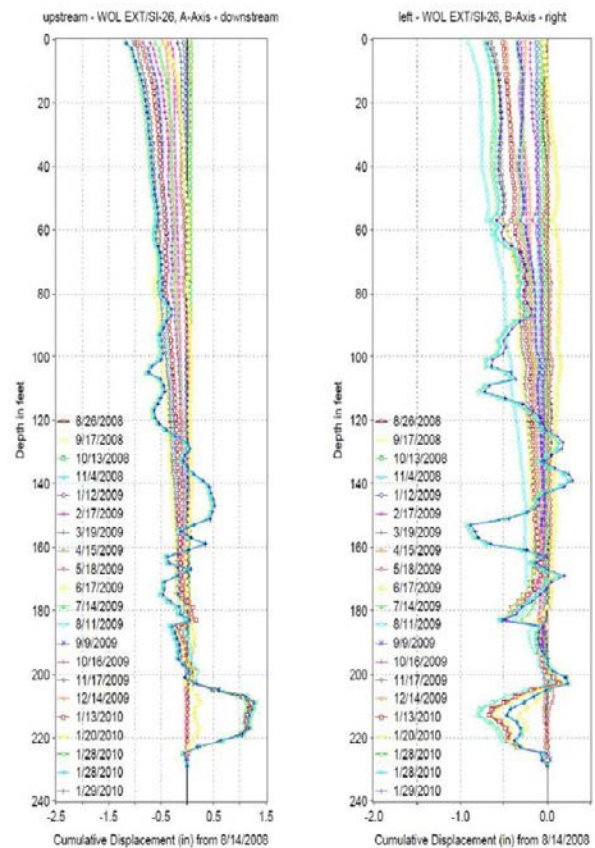
damage by traffic, flush mounted piezometers were installed on the crest of the dam in line with the roadway. Traffic running over the casing covers often dislodged permitting dirt and debris, especially after precipitation events, to enter into the piezometer casing. This resulted in high readings and on occasion the complete clogging of the instrument. Rubber stoppers were installed at some locations to help prevent the infiltration of water and materials, however at a couple of locations the rubber stoppers ended up lodged within the casing preventing the ability to insert the water level reading instrument. Another example is the inclinometer casing installed on the work platform. The casing was flush mounted to avoid damage by construction equipment; however construction materials, especially after precipitation events, permitted materials to enter the casing and settle at the bottom of the casing. The result is that the bottom of the casing filled with material altering the bottom elevation of the first reading, rendering all subsequent readings at an offset and an inability to analyze changes in reading over time. In these occurrences, the casings were cleaned and re-measured, however data in the interim was not valid for use. Figure 10 is an example of data recordings after infiltration of materials into the casing.

Figure 10: Inclinometer data with materials settled overtime within flush mounted casing
