Failure Investigation and Restoration of Two Cellular Sheetpile Structures

FAILURE INVESTIGATION AND RESTORATION OF TWO CELLULAR SHEETPILE STRUCTURES

Frank M. Clemente, Jr., Ph.D., P.E.

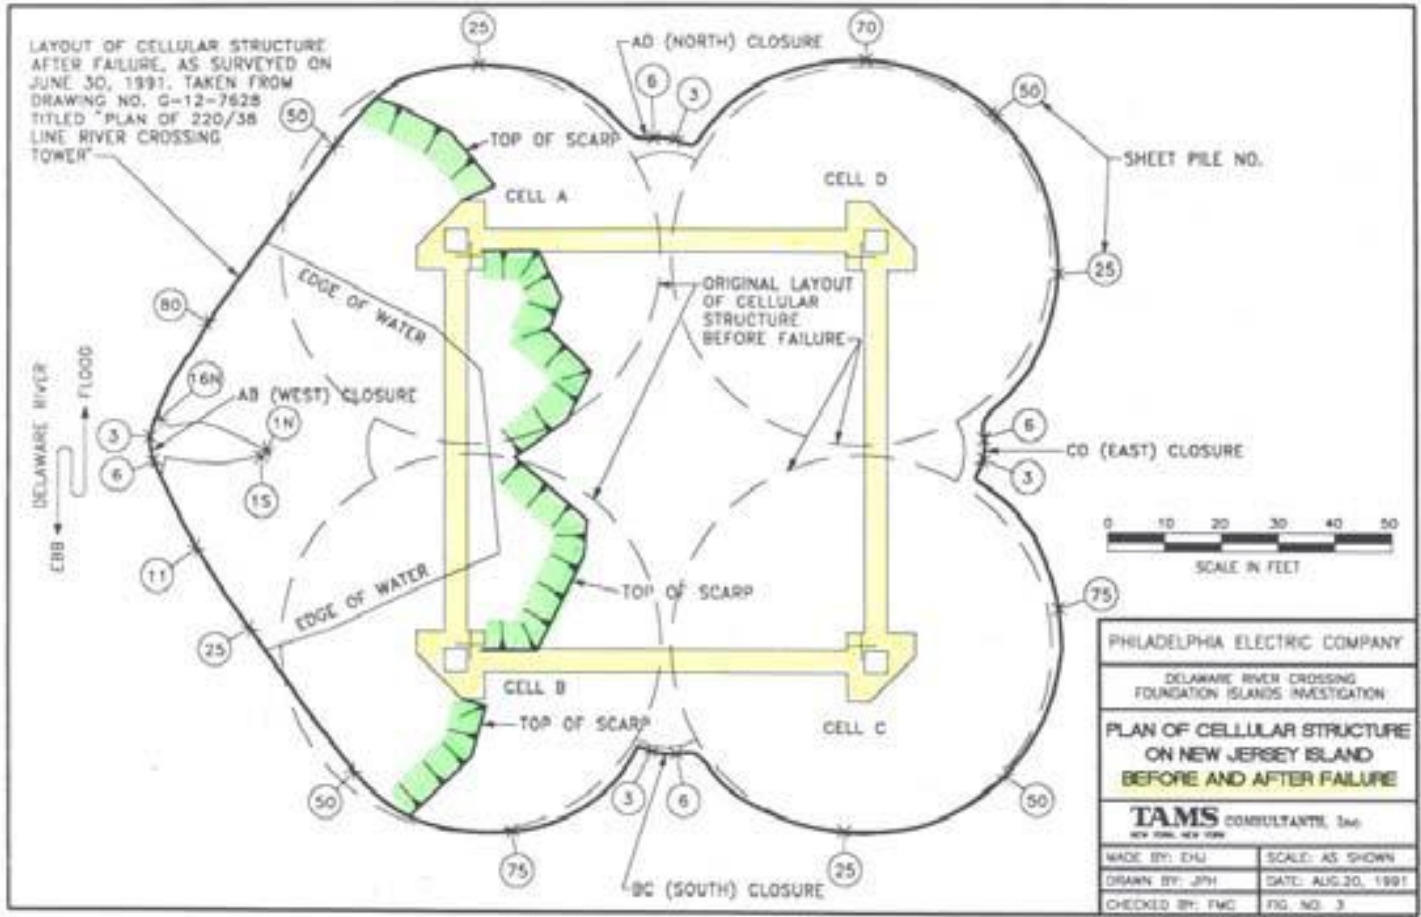
Fig. 3: Before and After Failure

New Jersey Island. Additional observations that may have a bearing on the failure of the New Jersey Island are summarized below. The numbering system used to identify specific sheetpiles that are discussed in this section is shown in Fig. 3.

PECO personnel surveyed the New Jersey Island to record the present configuration of the island. A plan of the New Jersey Island before and after failure based on the survey data is presented in Fig. 3.

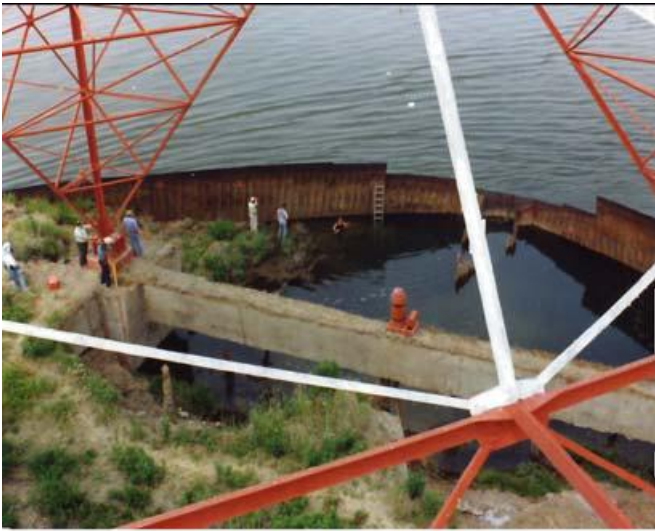
In early 1991 PECO performed a routine aerial survey in the vicinity of the transmission line crossing. The surveyors did not note any gross changes in the geometry of the New Jersey Island. A pre-existing sinkhole was observed, and it did not appear to have enlarged since the previous aerial survey. Nevertheless, on Sunday, April 14, 1991, a boater telephoned PECO to report that the New Jersey Island appeared damaged. PECO personnel visited the island on April 16, 1991 and corroborated the damage report. The two cells facing the channel had partially collapsed and leaned out toward the river. Sheetpiles were ruptured and severely distorted. This allowed the fill inside the cells to displace laterally downward, exposing two pile caps and the grade beam that connected them. Fig. 5 and Fig. 6 are photographs of the failure.

Fig. 5: Partial Collapse Exposing Pile Caps and Tie Beams

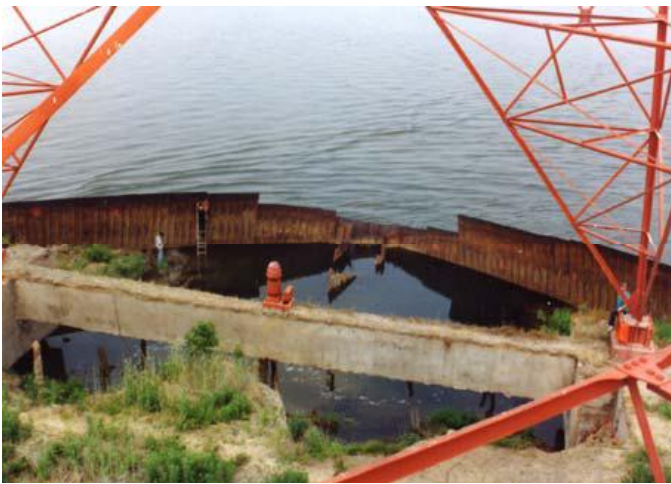
Fig. 6: Partial Collapse Exposing Pile Caps and Tie Beams

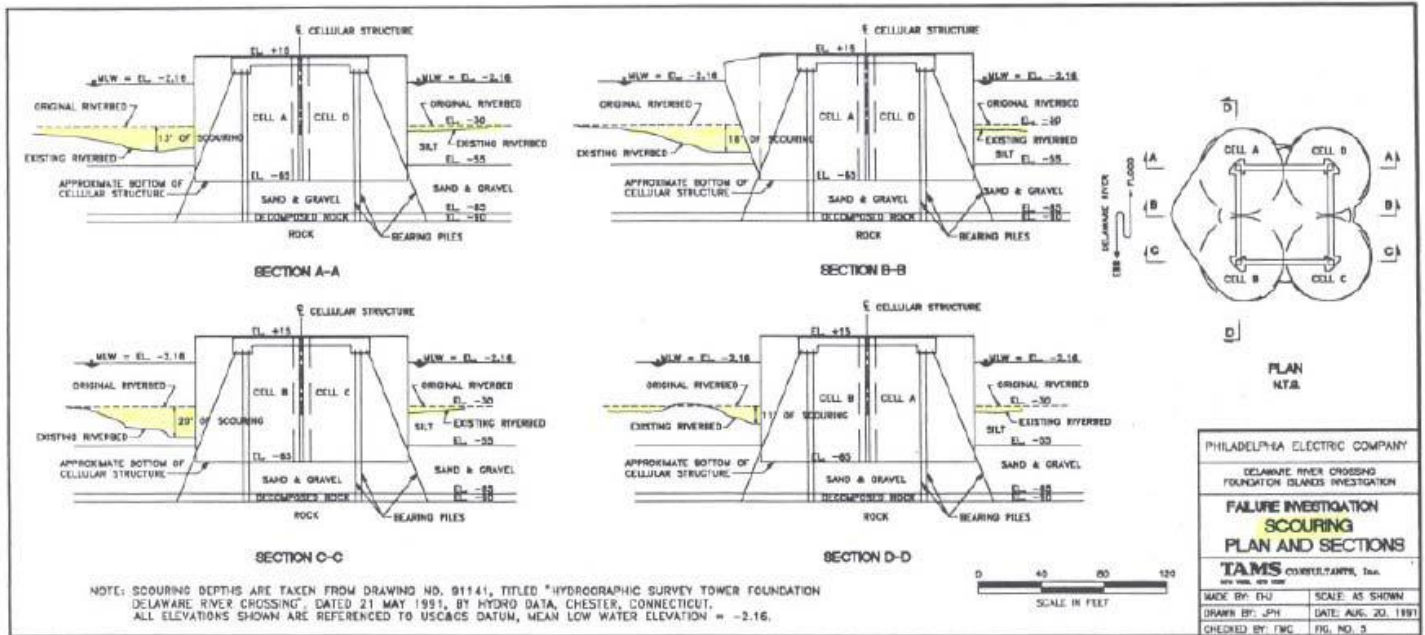
Fig. 7: Depth of Scour

The divers performed a pneumo-fathometer survey around the perimeter of the islands at the mudline. The results of this survey were consistent with the precision hydrographic survey, and indicated that about 20 ft of scour had occurred on the channel side of both islands since original borings were conducted in 1959. Divers observed several 1 to 6-ft vertical drops in the mudline profile around both foundation islands. These appeared to the divers to be at locations where current velocity increased.

Hydrographic surveys were carried out in order to investigate general river bottom conditions in the vicinity of the two islands and to document scour near the structures. Depth soundings taken by the Corps of Engineers in 1954 and riverbed elevations from the 1959 borings were compared with 1991 soundings. Soundings were not available for the period immediately before or after construction. Based on the comparison, approximately 20 ft of scour had occurred on the channel side of both islands.

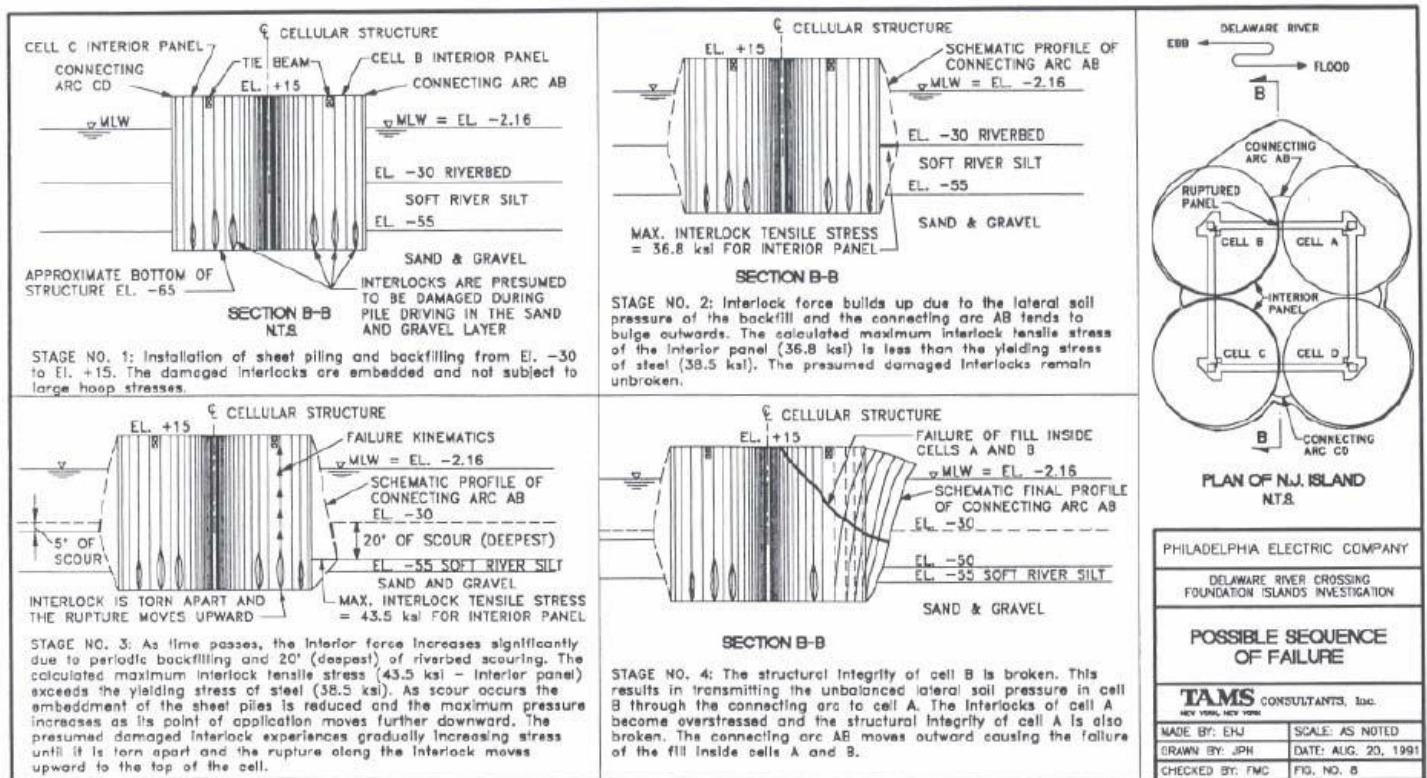
The following paragraphs describe the several factors that contributed to the failure. The role of each of these factors in leading to the eventual failure mechanism constitutes a failure hypothesis. The inferred sequence of events leading to failure is depicted in Fig. 8.

Fig. 8: Possible Sequence of Failure

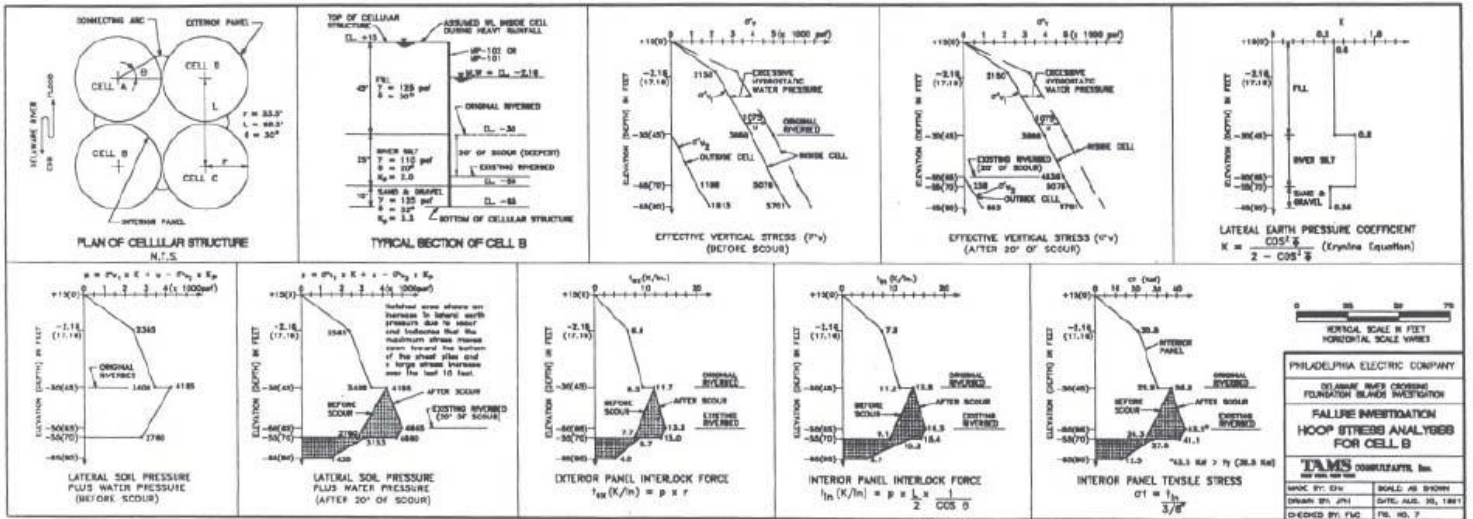
stress analysis of Cell B shown in Fig. 9 was conducted to estimate the maximum hoop stress in the cell, which occurs on the interior sheets at or near the connecting arc (TVA, 1957), the depth to the maximum stress was assumed to correspond to the depth of scour outside Cell B. This is based on Maitland and Schroeder (1979) who recommend a plane of fixity concept to estimate the location of maximum lateral earth pressure. The weaker the soil in which a cell is embedded, the greater the depth to the plane of fixity. Therefore, the maximum interlock tension should be calculated at a lower level for weak soils compared to strong soils, and may even occur at or below the dredgeline.

Fig. 9: Hoop Stress Analysis of Cell B

The analysis arrived at an estimated circumferential tension of 16.3 kips per inch under the conditions of scour, saturation of the backfill above MLW, and the presence of soft sediments inside the cell. This value exceeds the allowable force (8 kips per inch) as well as the ultimate interlock strength of 16 kips per inch. The corresponding stress is 43.5 ksi, which exceeds the yield point of 38.5 ksi. The analysis demonstrates that the tension was sufficiently high to exceed the ultimate strength for separation of interlocks and the yield point of the webs on the interior sheetpiles.

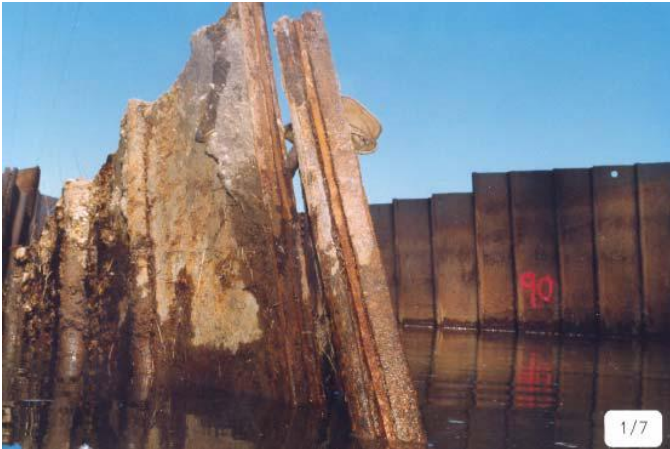
In the majority of interlock failures the contact friction between the interlocking fingers and thumbs holding adjacent sheetpiles together is overcome by circumferential stress and separate entirely one sheetpile from the other. However, this mode of failure was not evident at the New Jersey Island. Instead the failure mechanism consisted of the steel fracturing vertically through the narrowest dimension (root) of an interlocking thumb, leaving it behind and inside the thumb and finger of the other interlock. That is, the steel fractured before the interlocks could separate (Fig. 10).

Fig. 10: Brittle Fracture through Interlock

The fracture occurred along a vertical plane. Chevron or herringbone markings pointed downward, an indication that the fracture began below the mudline and proceeded upward unabated.

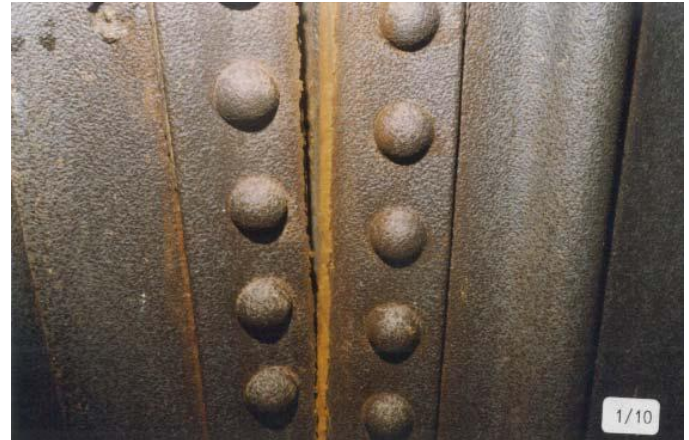
As the two cells failed behind the connecting arc they lurched outward trying to individually open up, but were restrained by their mutual connecting arc, as evidenced by the distortion and slight pulling apart of the T-connection from the top of the sheeting to a point several feet down (Fig. 11). This latter damage is a result of the collapse, not the cause.

Fig. 11: Connecting Arc A-B in Distress

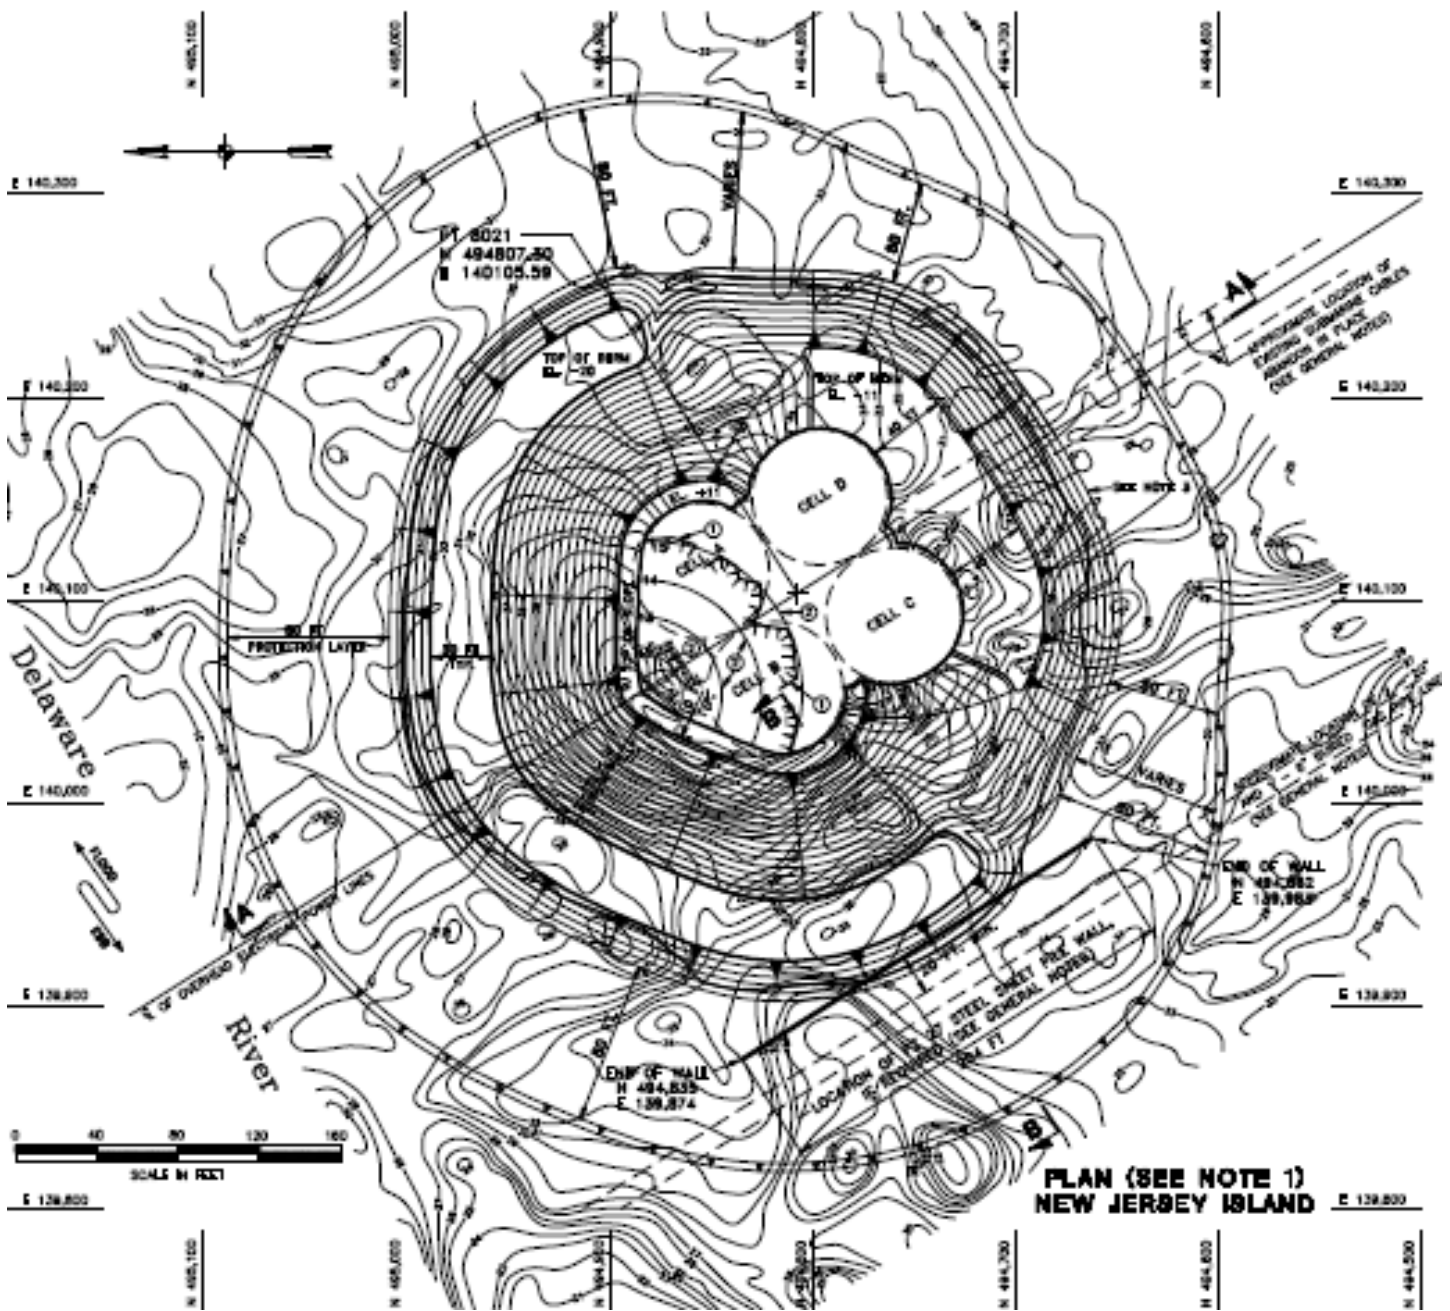
Fig. 12: Proposed Buttress of Crushed Stone and Riprap

Based on the above evaluations a large island-encompassing rock buttress was recommended for the New Jersey Island (Fig. 12) and a small localized rock buttress for the Pennsylvania Island. The buttress is shown under construction in Figs. 13, 14 and 15.

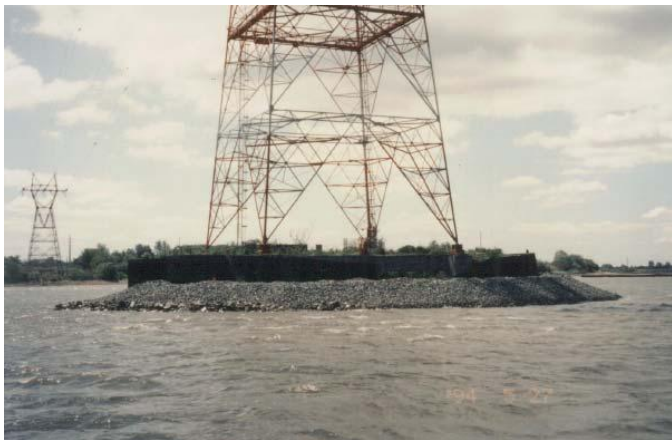
Fig. 13: Butress Topping-Out

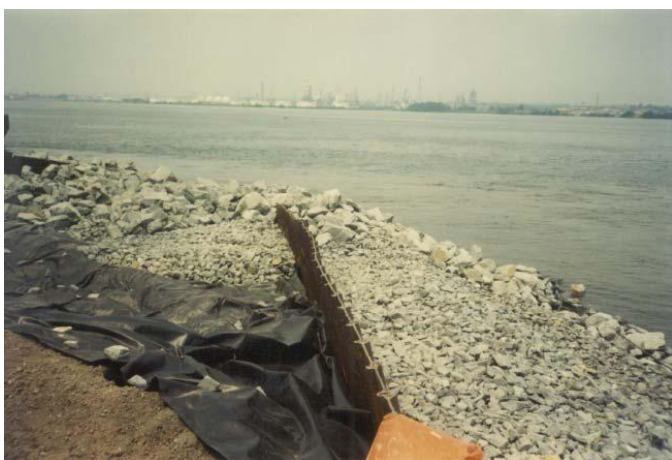
Fig. 14: Butress of Crushed Stone, Riprap and Geotextile

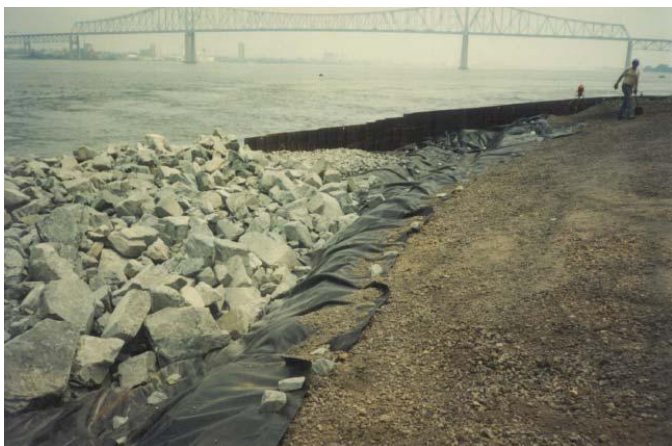
Fig. 15: Failed Area with Lightweight Backfill, Geotextile, Crushed Stone and Riprap
