International Conference on Case Histories in Geotechnical Engineering (2008) - Sixth International Conference on Case Histories in Geotechnical Engineering

Unexpected Caisson Problems, Soil Structure Interaction Predictions and Required Ground Modification

UNEXPECTED CAISSON PROBLEMS, SOIL STRUCTURE INTERACTION PREDICTIONS AND REQUIRED GROUND MODIFICATION

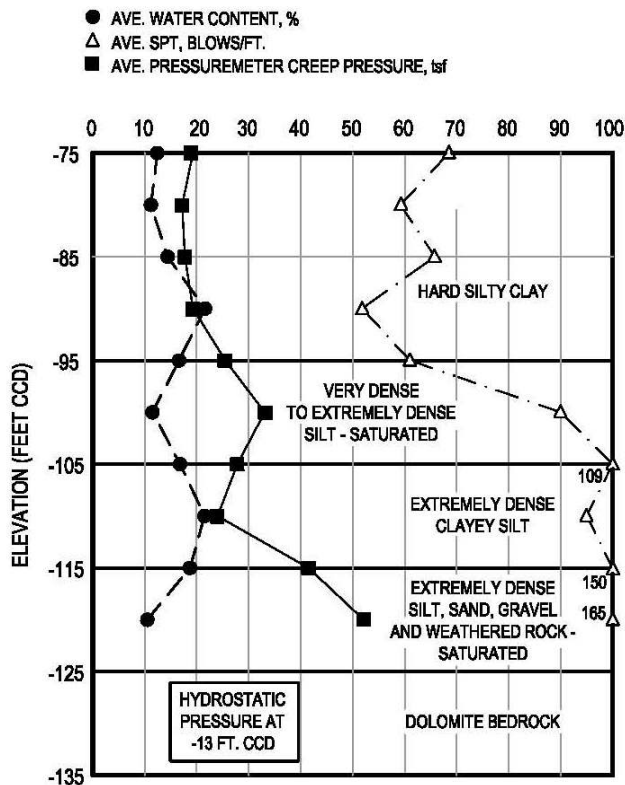
Fig. 1. Soil Profile based on Initial Subsurface Exploration

The building site had previously been occupied by a 3-story building on footings and a 4-story building on small diameter belled caissons. A previous investigation was performed at the site for a proposed 9-story building. Information from a number of projects within one block of the site included a total of 45 soil borings that were extended at least to the hardpan layer with some extending to the deeper underlying dolomite. An additional 5 borings were performed at the site (1 before building demolition and 4 after). The anticipated soil profile based on all of the available boring information is shown in Fig. 1.

The soil property information below -75 feet CCD at the time of design is summarized on Fig. 1.

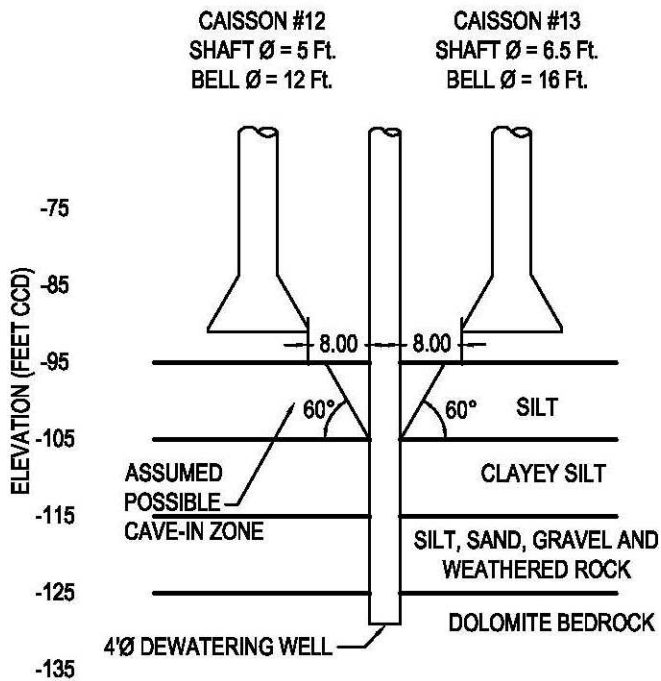
Fig. 2. Dewatering Well No. 3 Cross-Section

Construction of caissons with bells upon the hardpan at 36 ksf was completed before dewatering well installation since lowering of the water table was not considered necessary. Unfortunately, construction problems developed during the installation of the first dewatering well (Well No. 3). The 4-

foot diameter excavated hole was allowed to remain open all the way to bedrock over the weekend prior to installation of the well casing and filter backfill. During that time the borehole was stabilized only by polymer slurry. Some time over the weekend, the dense silt caved-in to a level 23 feet above the bottom of the shaft.

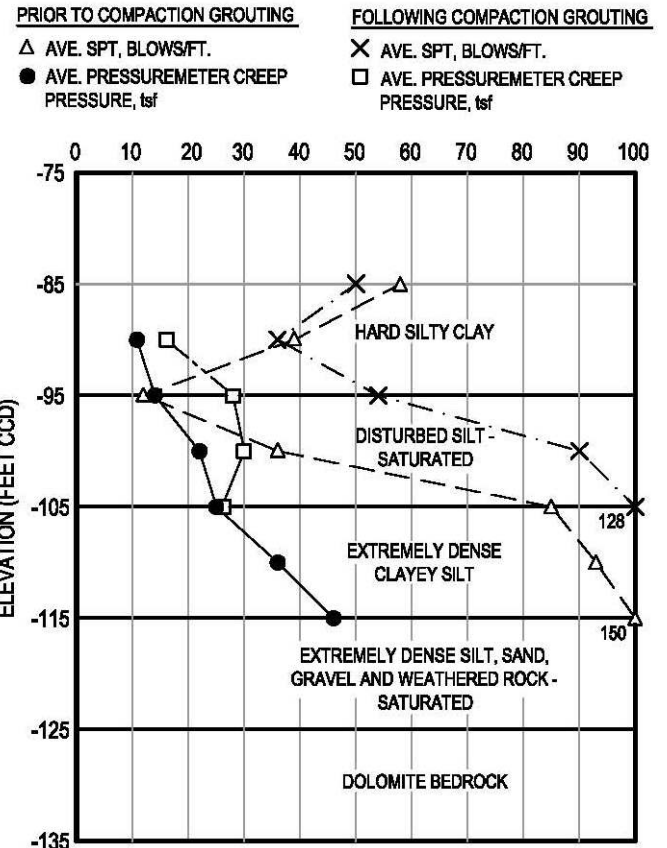
Fig. 3. Soil Profile Prior to and after Compaction Grouting

Subsequent soil borings and pressuremeter testing indicated a significant loss of density in the silt around Well No. 3. Since it was felt that this loss of density could affect the adjacent caissons, a compaction grouting program was undertaken to re-densify the silt. Approximately 18 cubic yards of grout was pumped into the zone from the bedrock surface to approximately -90 feet CCD to more than equal the volume of the silt cave-in. Figure 2 shows a sketch of the planned well, the level of adjacent caissons, and the likely cave-in zone. Borings and pressuremeter testing were performed to evaluate the soil conditions following construction of Well No. 3 and the effectiveness of the compaction grouting. The test data is summarized on Fig. 3.

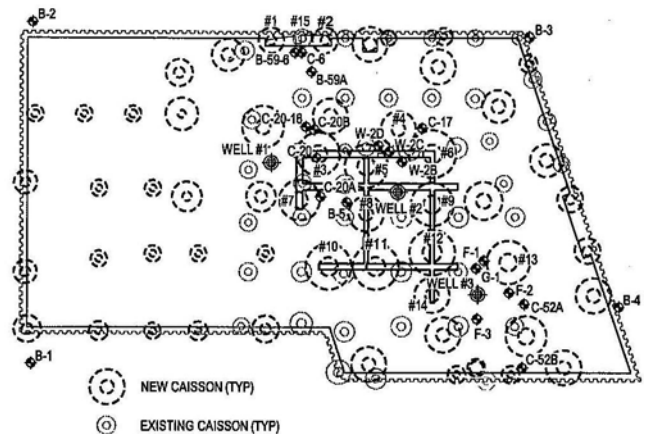
Fig. 4. Site Plan and Soil Boring Locations

The locations of the caissons, wells and soil borings are shown on Fig. 4. The compaction grout injection points and grout take summary are shown on Fig. 5. The grout take volumes indicate that the cave-in was not necessarily uniform around the shaft.

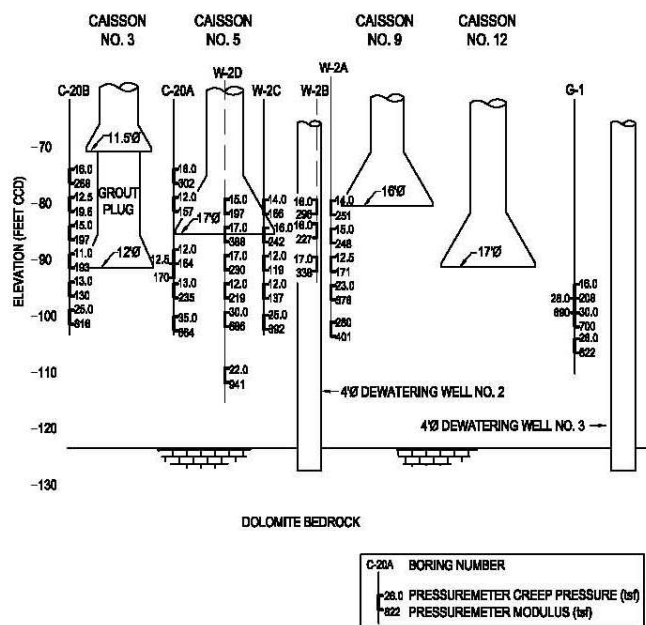
Fig. 6. Partial Cross-Section through the Core

Caisson 3 encountered water inflow and caving conditions when attempting to bell at the design elevation of -92 feet CCD. The water came in too fast for bailing so the partially excavated bell was plugged with grout extending up to the surface of the hardpan at which level another attempt to bell was made after allowing the grout to set because of the presence of existing old caissons and continued water seepage. It was not possible to adequately oversize the bell for the 36 ksf design bearing level. The as-constructed caisson consisted of an 11.5 foot bell at -71 feet CCD combined with the original 12 foot diameter bell plug at elevation -92 feet CCD as shown in Fig. 6.

Pressuremeter testing was performed around Well No. 2, Caisson 3 and Caisson 15 (which was actually replaced by Caissons 1 and 2). Because of the water problems encountered, there was some concern for loosening of the supporting silt. A check boring and pressuremeter testing indicated the marginal conditions at Caissons 1 and 2. Four compaction grout holes were recommended and installed to provide some insurance. The pressuremeter testing results near Caisson 3 and Well No. 2 are shown on Fig. 6.

In order to get the maximum capacity out of the as-built geometry, compaction grouting was undertaken beneath and adjacent to Caisson 3. The total volume of grout (38 cu.yd.) injected from near the bedrock to an elevation of approximately -90 feet CCD exceeded the estimated volume of loosened material that came into the excavation during the belling operation at elevation -92 feet CCD.
